Site Accessibility Evaluation

Local Rd. Shed

**3571 Utah Ave NE
Iowa City, IA 52240**

Inspection Date: 04/24/2019

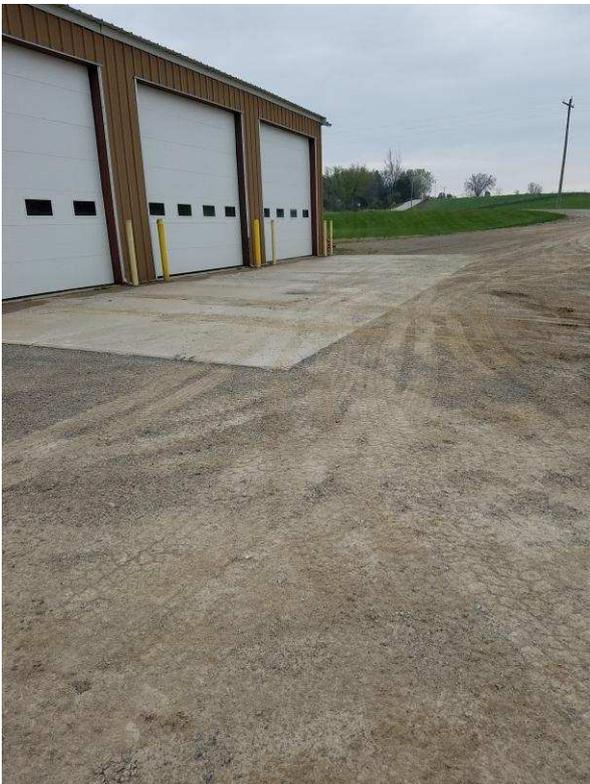
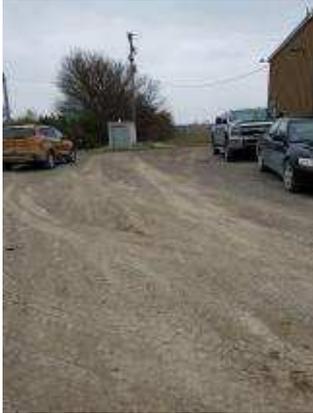
Finding: 1

There are no accessible parking stalls.

There are an unknown number of parking stalls in the parking lot that could be reasonably associated with this facility. There should be a minimum of one accessible stall with a minimum of one being designed as van accessible.

2010 ADAS Section: 208.2

lacks designated parking gravel lot only

Create one or more 8' accessible parking stalls, with one 5' adjacent access aisle, with proper signage and striping based on the total number of stalls

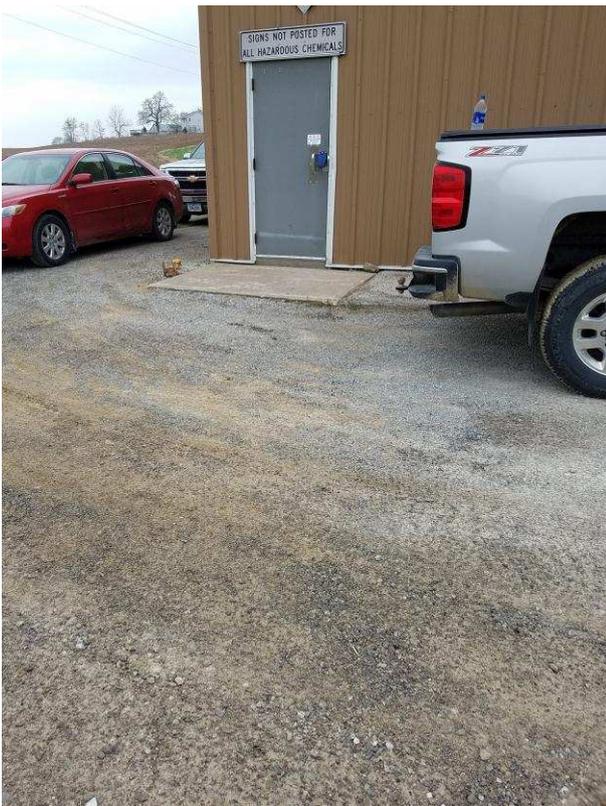
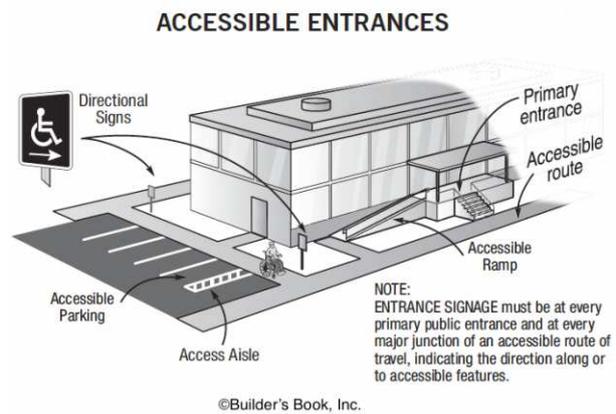
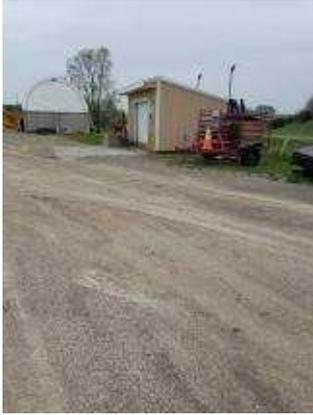
Finding: 2

There is no accessible route between the buildings.

2010 ADAS Section: 206.2.2

building lacks EAR
due to gravel parking
lot

Create AR with crushed and compacted stone or similar outdoor material from building to building within the site

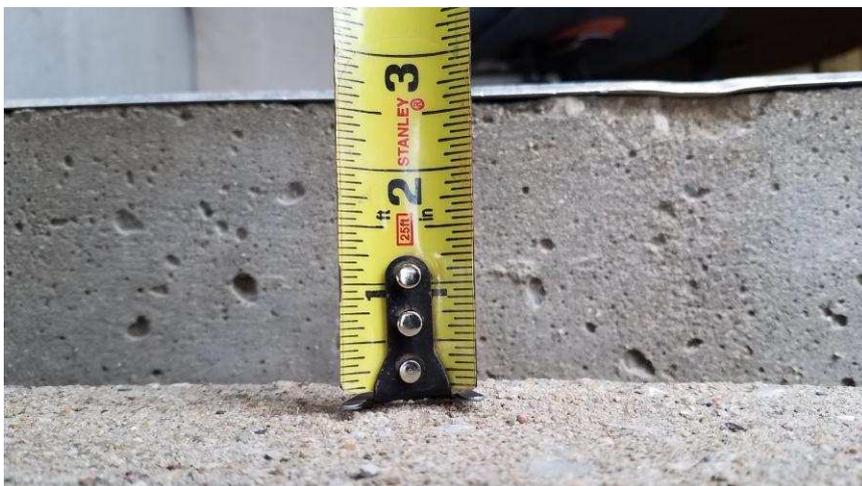
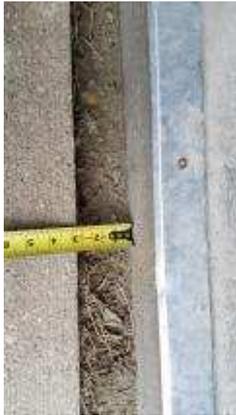
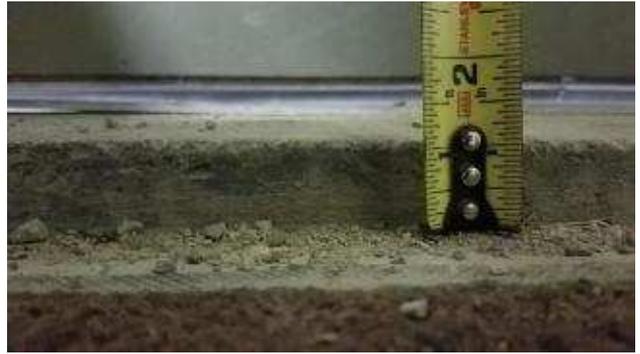
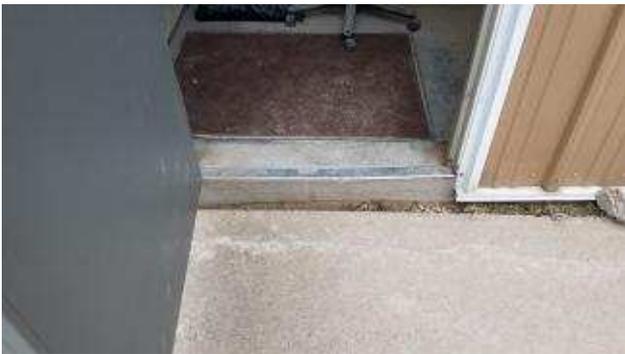
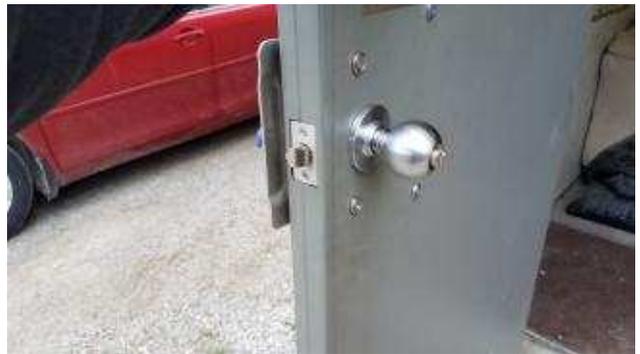
Finding: 3

The threshold has a vertical change greater than 1/4 inch high.

2010 ADAS Section: 404.2.3, 404.2.7, 404.2.4,
404.2.11, 404.2.11 Exception

entry- knob, CIL both
sides, gap, 10#

For all doors along the public circulation route, repair, bevel, or ramp CILs at door entries to max .25"

For all doors along the public circulation route, repair, provide beveled threshold

For all doors along the public circulation route, correct or fill gaps to max .5"

For all doors along the public circulation route, inspect, adjust, and maintain 8.5 lbf to open exterior doors as a smart practice

For all doors along the public circulation route, replace hardware with lever hardware or hardware operable without a tight pinch or grasp

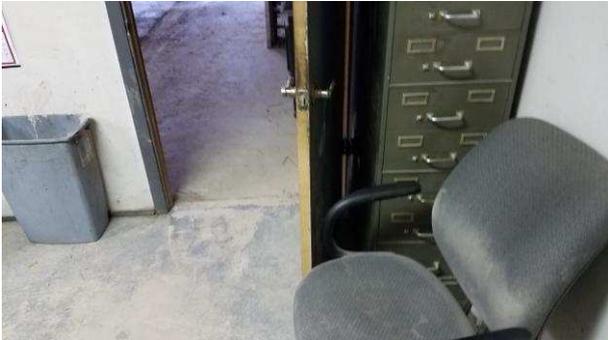
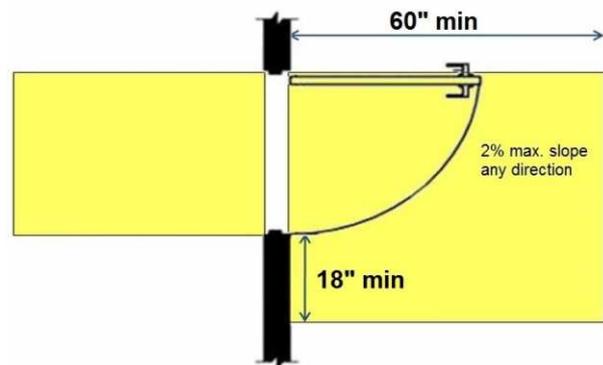
Finding: 4

The maneuvering space on the pull side of the door does not adequately extend beyond the latch side of the door.

2010 ADAS Section: 404.2.4.1

break room to shop-chair prevents door from opening to 90 degrees

For all doors along the public circulation route, relocate storage, furniture, and other obstacles to create 60" maneuvering space around doors

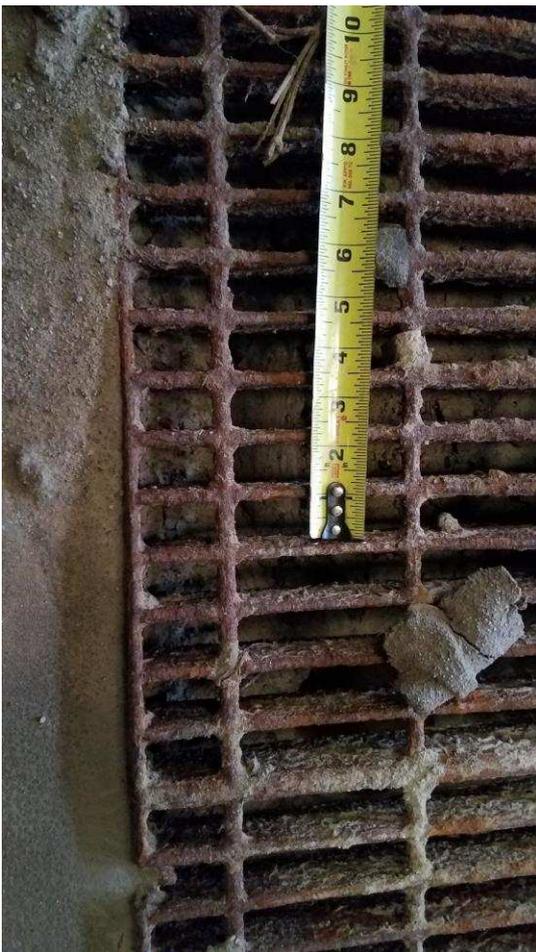
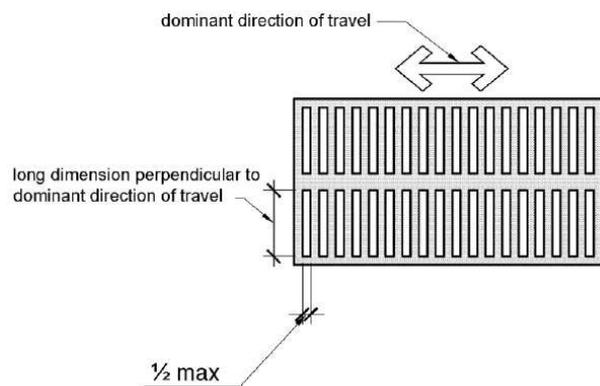
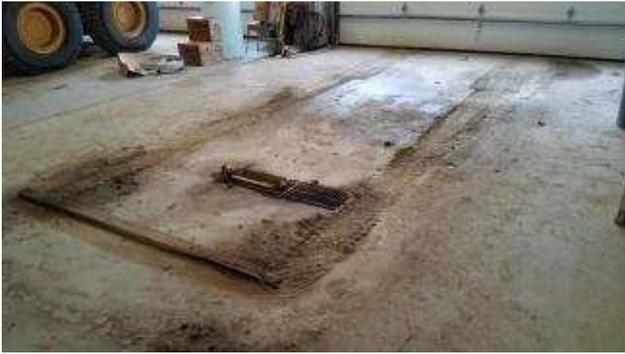
Finding: 5

Gratings are spaced greater than a 1/2 inches in the direction of traffic flow.

2010 ADAS Section: 302.3

1" in bays

Replace grate with one having max openings of 1/2 inch.

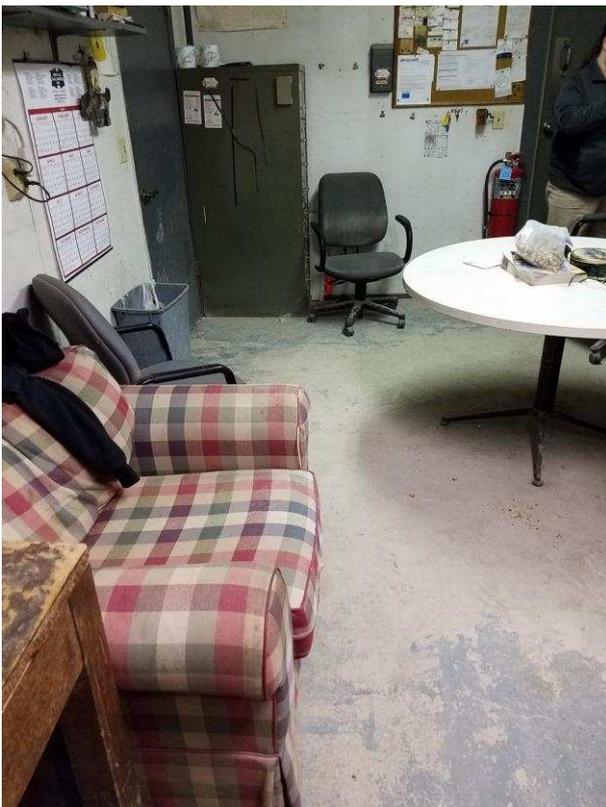
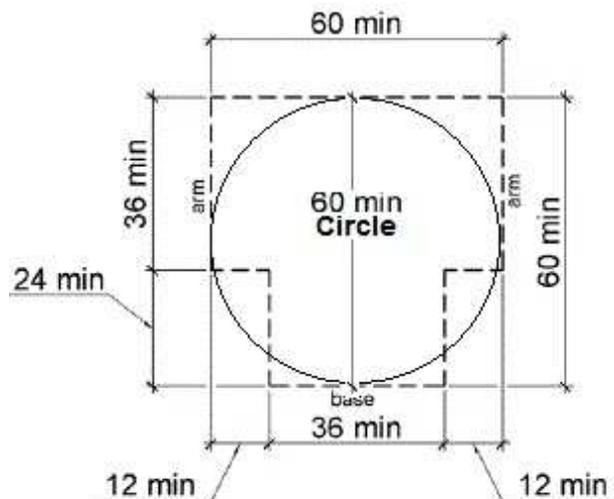
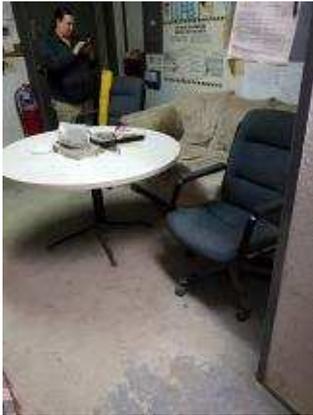
Finding: 6

There is insufficient turning space within this room or space.

2010 ADAS Section: 304.3.1, 304.3.2

breakroom lacks
turning and 36 inch
AR due to furniture

Relocate obstacles to create turning space in break room.

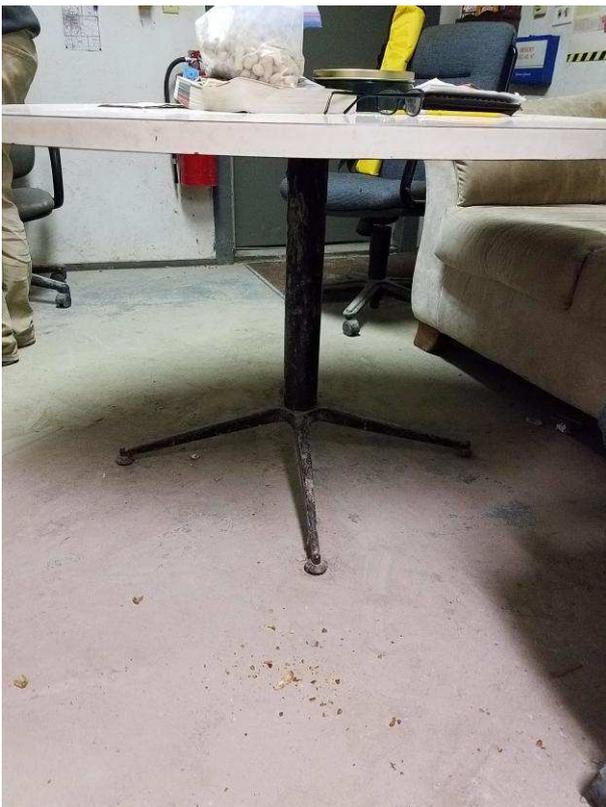
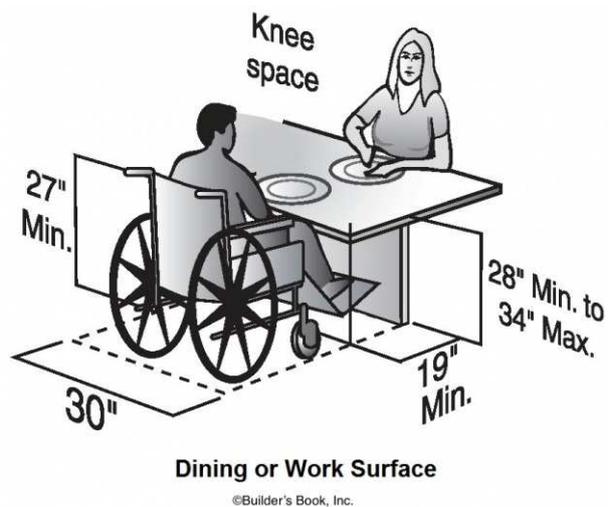
Finding: 7

Compliant knee and/or toe clearance is not provided.

2010 ADAS Section: 306.2.1

break room table
lacks toe clearance

Replace table with one providing required knee and toe clearances

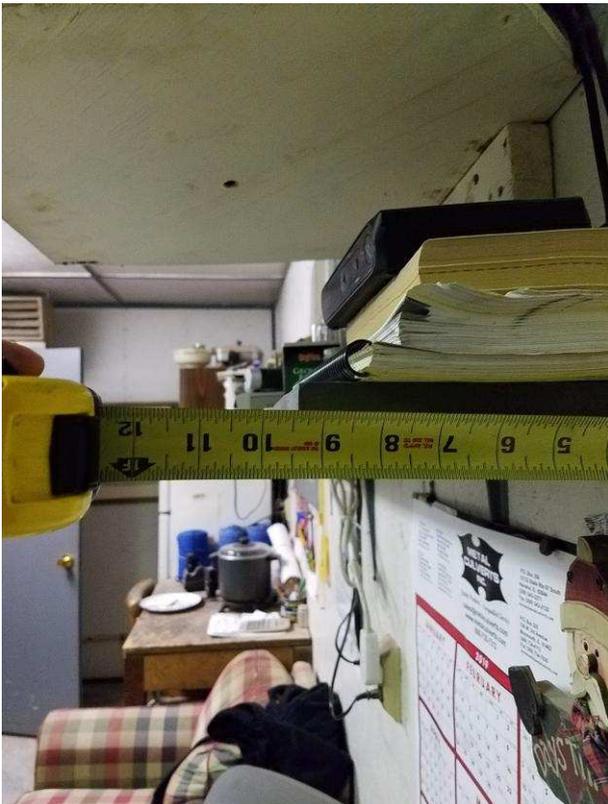
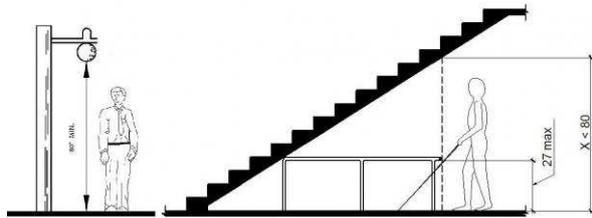
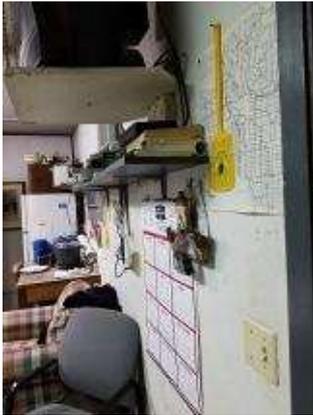
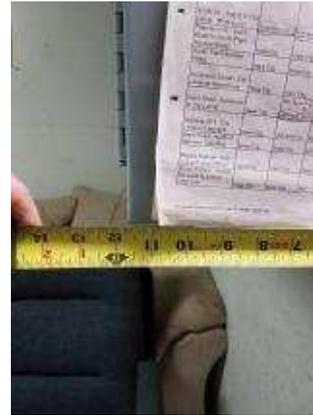
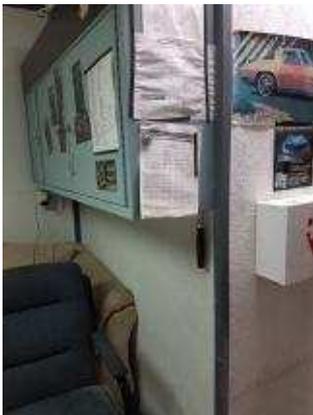
Finding: 8

The shelf and cabinet project more than 4 inches into the circulation path.

2010 ADAS Section: 307.2

shelf and cabinet
protrude

Relocate protruding objects or place cane detectable warning or bollard at foot of item

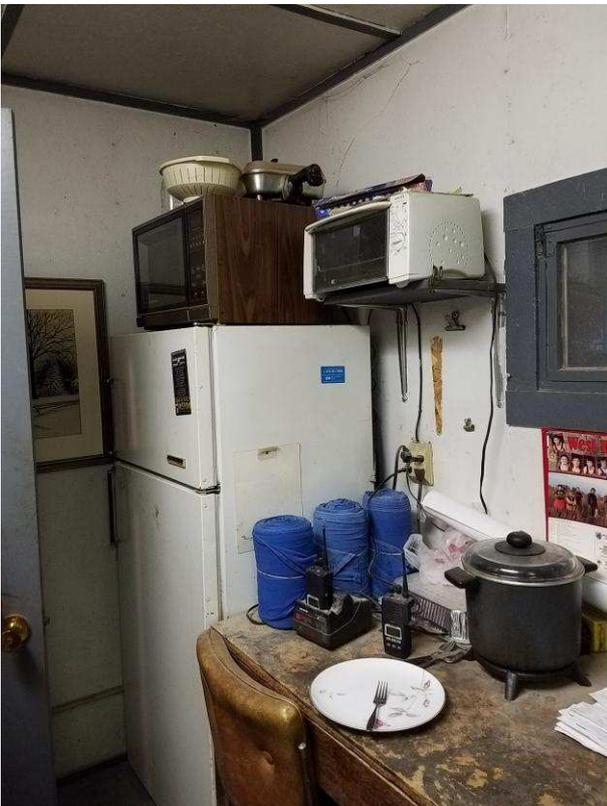
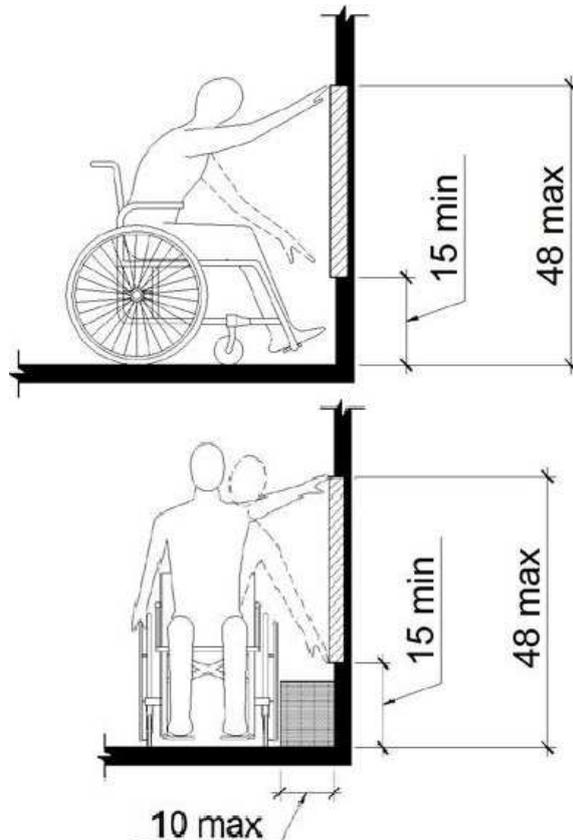
Finding: 9

The microwave and toaster are positioned too high for either a side or front approach.

2010 ADAS Section: 308.1

microwave and toaster oven high in break room

Remount operable parts to be in reach range of 15" min to 48" max

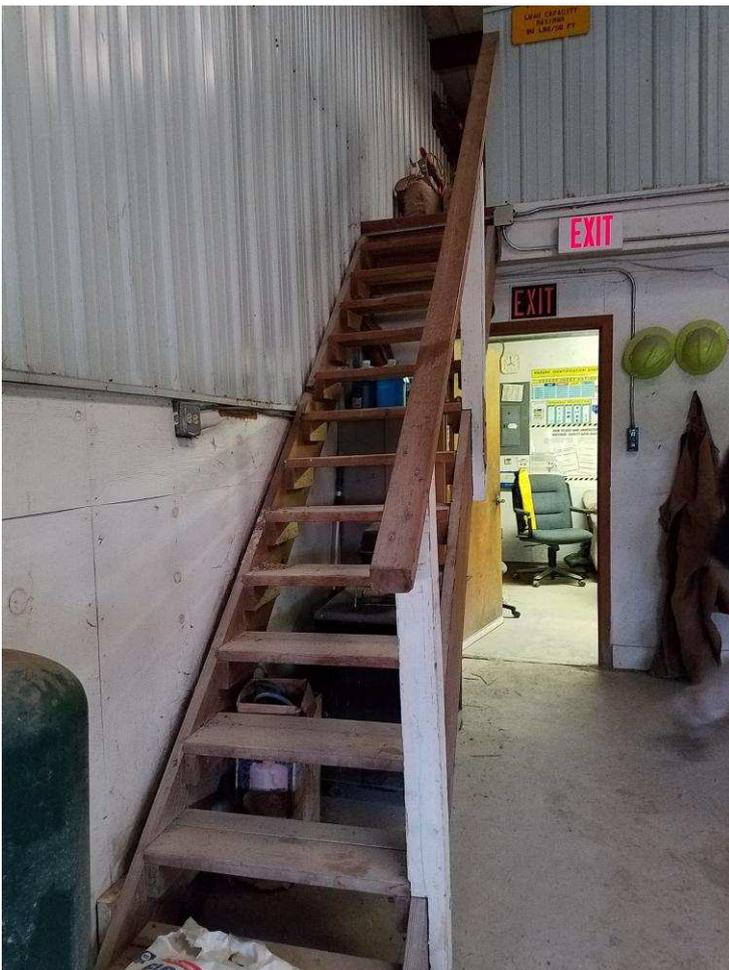
Finding: 10

There is no accessible route between the main floor and the mezzanine

2010 ADAS Section: 206.2.4

stairs to mezzanine

No AR to upper level employee area, leave as is, and reassign duties if an employee with disabilities requires access here

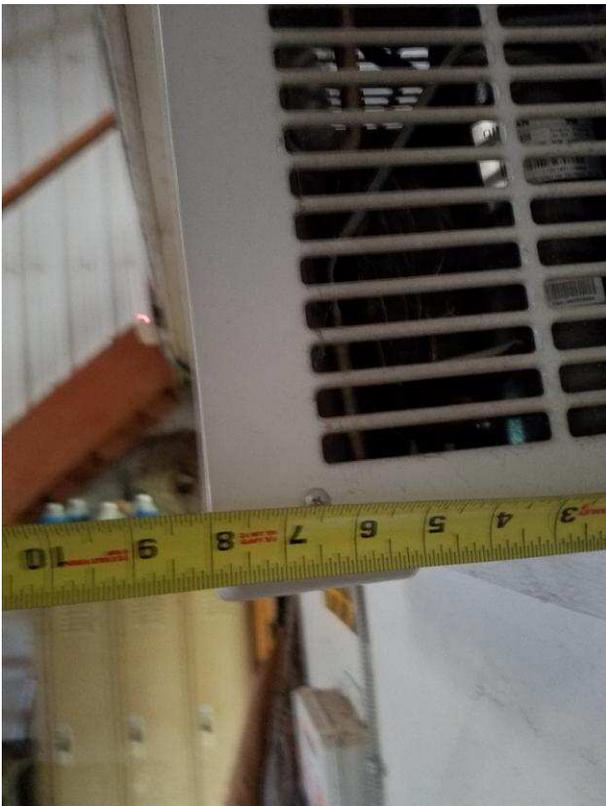
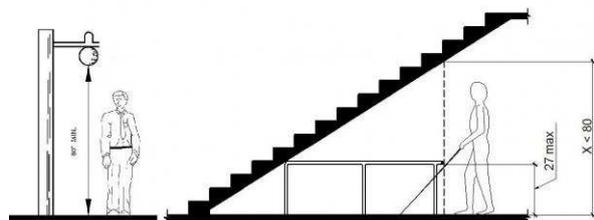
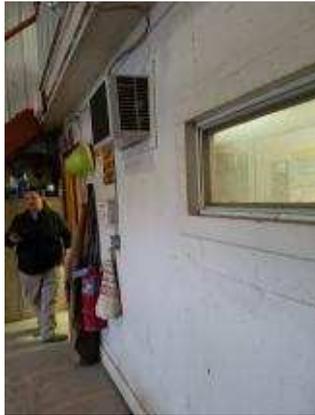
Finding: 11

The air conditioner projects more than 4 inches into the circulation path.

2010 ADAS Section: 307.2

air conditioner in
main room protrudes

For deficit, leave as is, employee work area pursuant to 2010 Standards 106.5 Defined Terms, until an employee with a disability works here

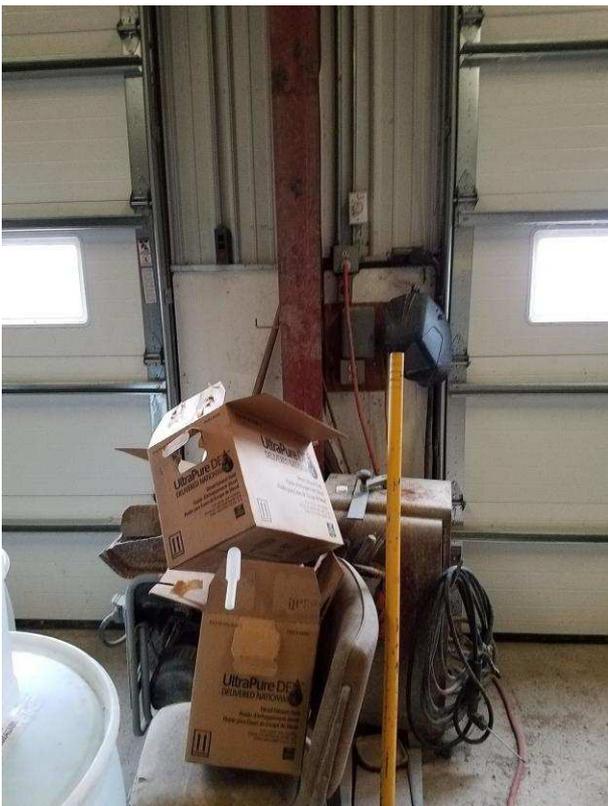
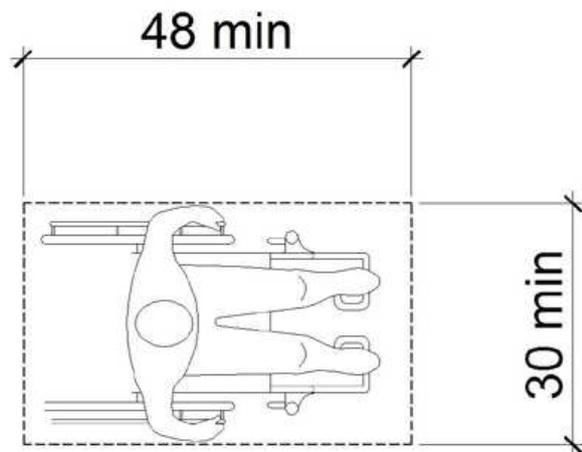
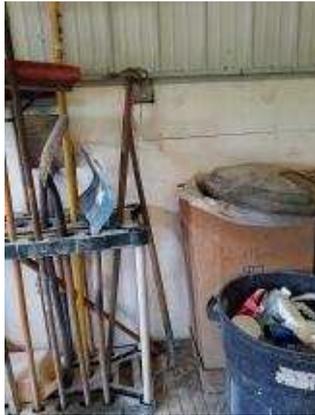
Finding: 12

The operable part is not accessible because there is not adequate clear floor space for either a forward or side approach.

2010 ADAS Section: 305.3

no clear floor space at
outlets and garage
door opener

For deficit, leave as is, employee work area pursuant to 2010 Standards 106.5 Defined Terms, until an employee with a disability works here

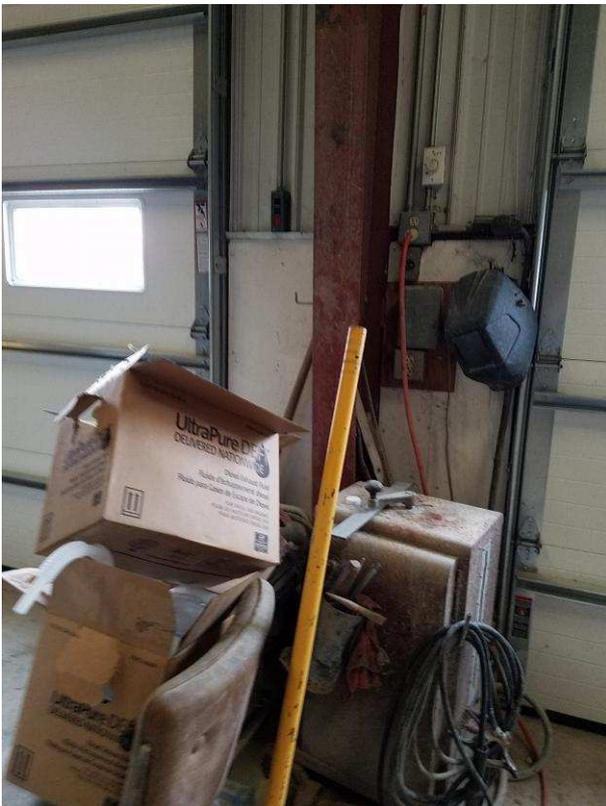
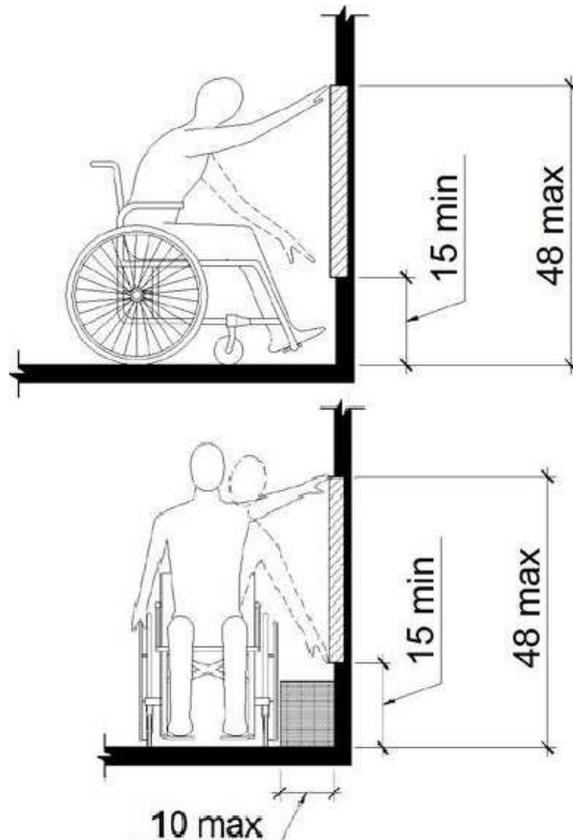
Finding: 13

The garage door opener is positioned too high for either a side or front approach.

2010 ADAS Section: 308.1

garage door openers too high

For deficit, leave as is, employee work area pursuant to 2010 Standards 106.5 Defined Terms, until an employee with a disability works here

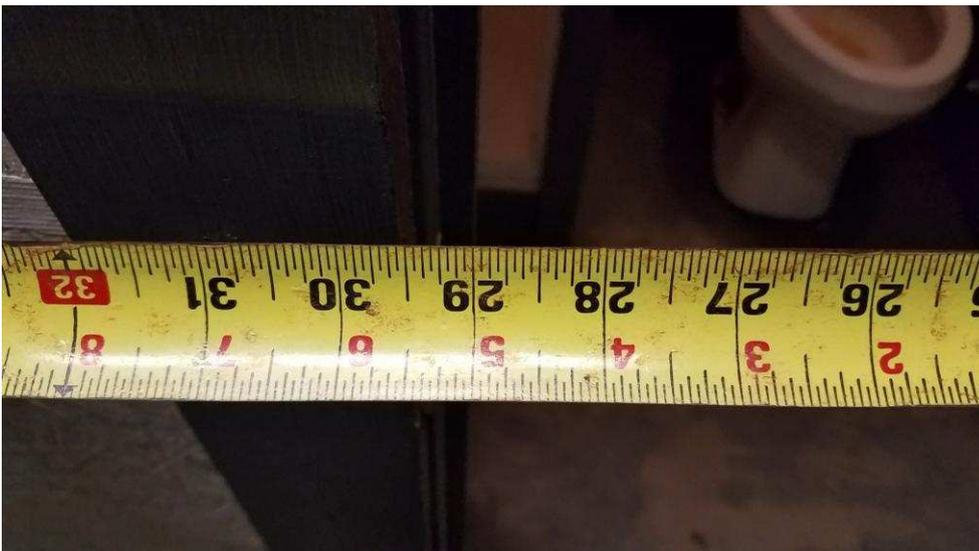
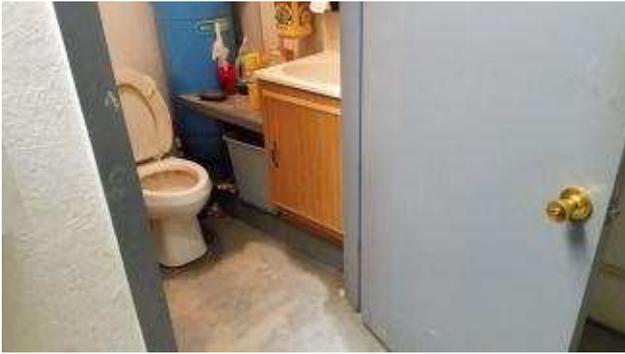
Finding: 14

2010 ADAS Section: 404.2.3, 404.2.7, 404.2.4,
404.2.11, 404.2.11 Exception

restroom- knob, 29"
wide

For all doors along the public circulation route, replace doors with doors having 80" overhead clearance and 32" clear width

For all doors along the public circulation route, replace hardware with lever hardware or hardware operable without a tight pinch or grasp

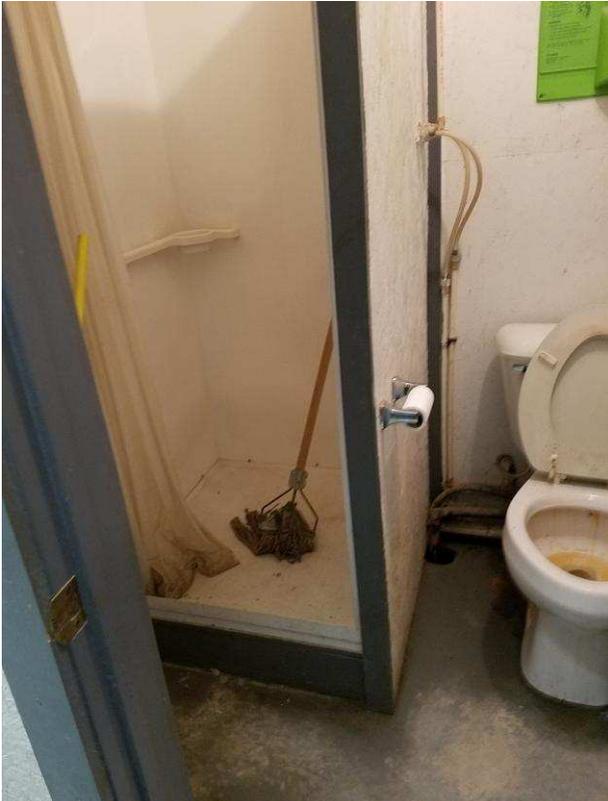
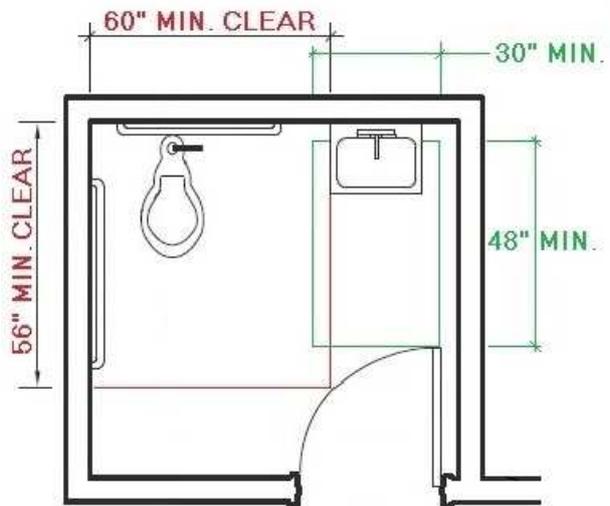
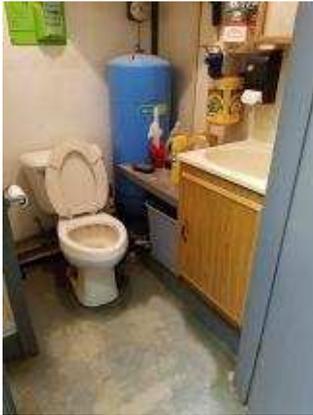
Finding: 15

The restroom is not nearly compliant.

The restroom does not have the required minimum clear floor space or maneuvering clearances for the toilet, The restroom does not have the required minimum clear floor space or maneuvering clearances for the lavatory, The entry door does not contain the required minimum maneuvering spaces on the pull/push sides, The entry door encroach into the required clear floor space for fixtures, Grab bars are missing and/or incorrectly installed, Accessories, such as toilet seat covers, paper towel holders, garbage cans, hand dryers, and mirrors are either too high or without clear floor space or both

2010 ADAS Section: 603.1

no accessible features

Create a compliant wheelchair accessible restroom and correct all features to be accessible
