# Site Accessibility Evaluation

## Lone Tree Shed

**118 W Kirkpatrick St  
Lone Tree, IA 52755**

***Inspection Date: 04/24/2019***

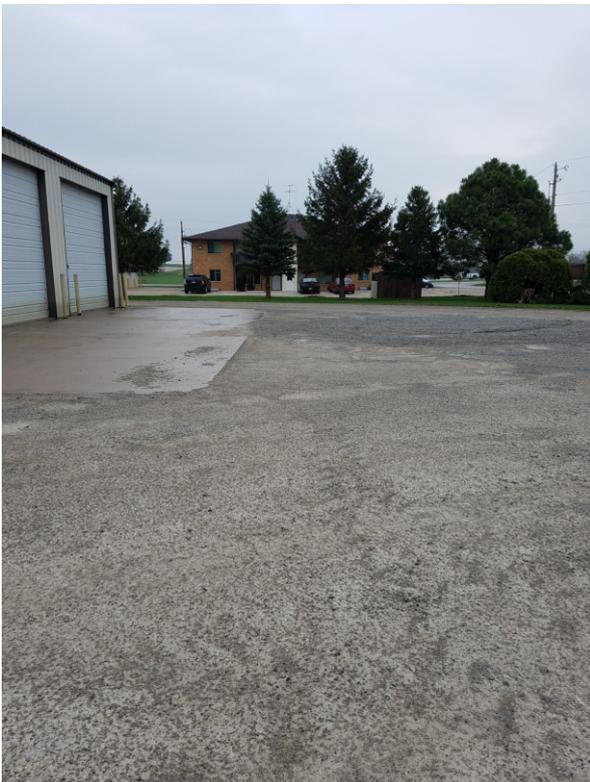
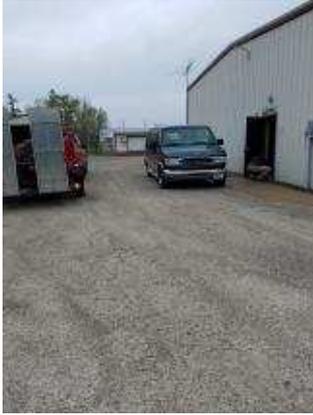
### Finding: 1

There are no accessible parking stalls.

There are an unknown number of parking stalls in the parking lot that could be reasonably associated with this facility. There should be a minimum of one accessible stall with a minimum of one being designed as van accessible.

gravel lot lacks stalls

Create one or more 8' accessible parking stalls, with one 5' adjacent access aisle, with proper signage and striping based on the total number of stalls

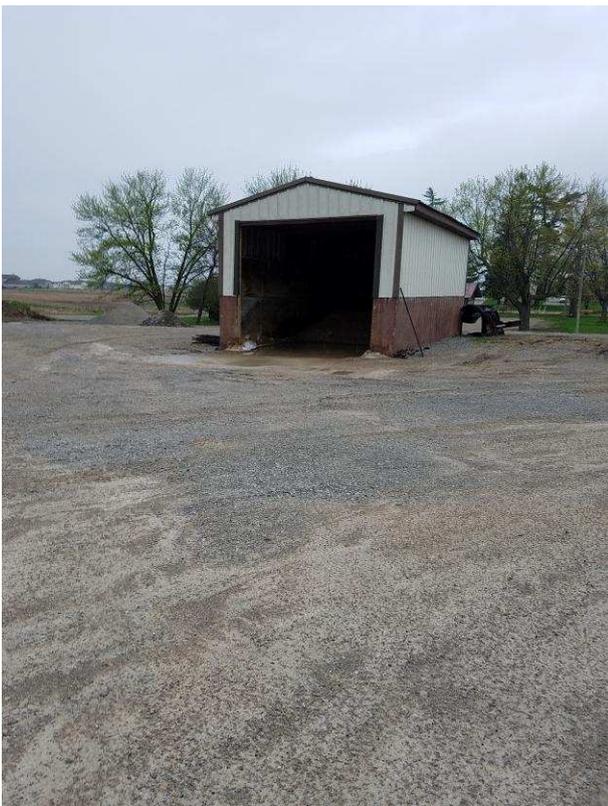
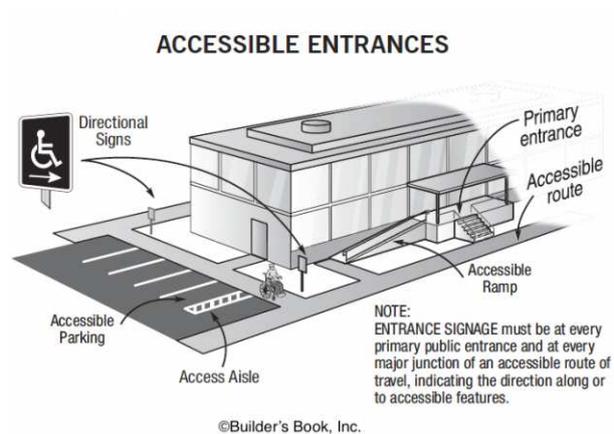
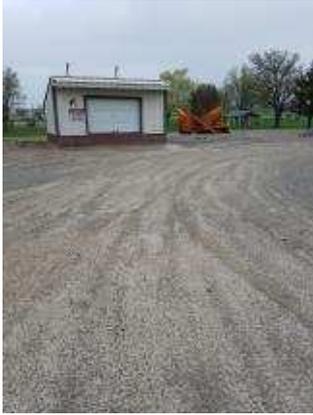
### Finding: 2

There is no accessible route between the buildings.

gravel lot, no AR to each bldg

Create AR with crushed and compacted stone or similar outdoor material from building to building within the site

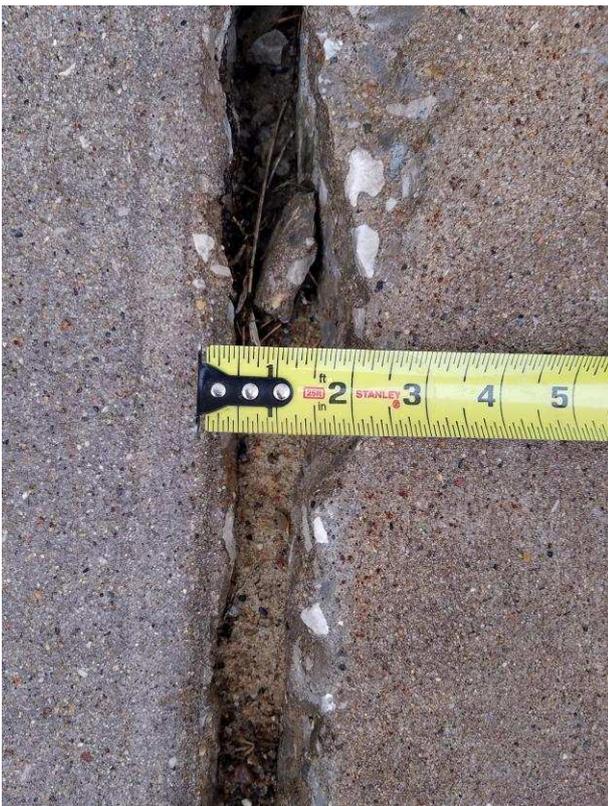
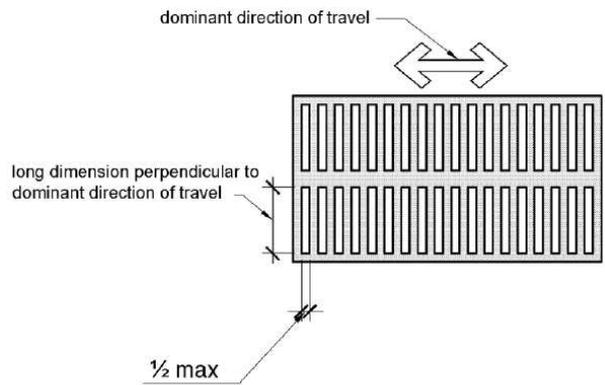
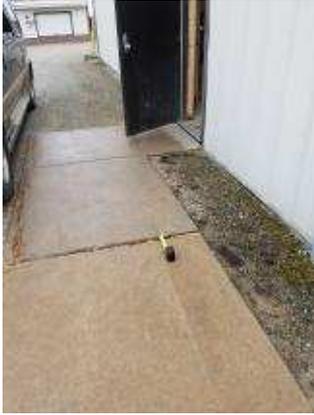
**Finding: 3**

There is a gap spaced greater than a 1/2 inch.

2" gap near door

Correct or fill gaps to be max .5"

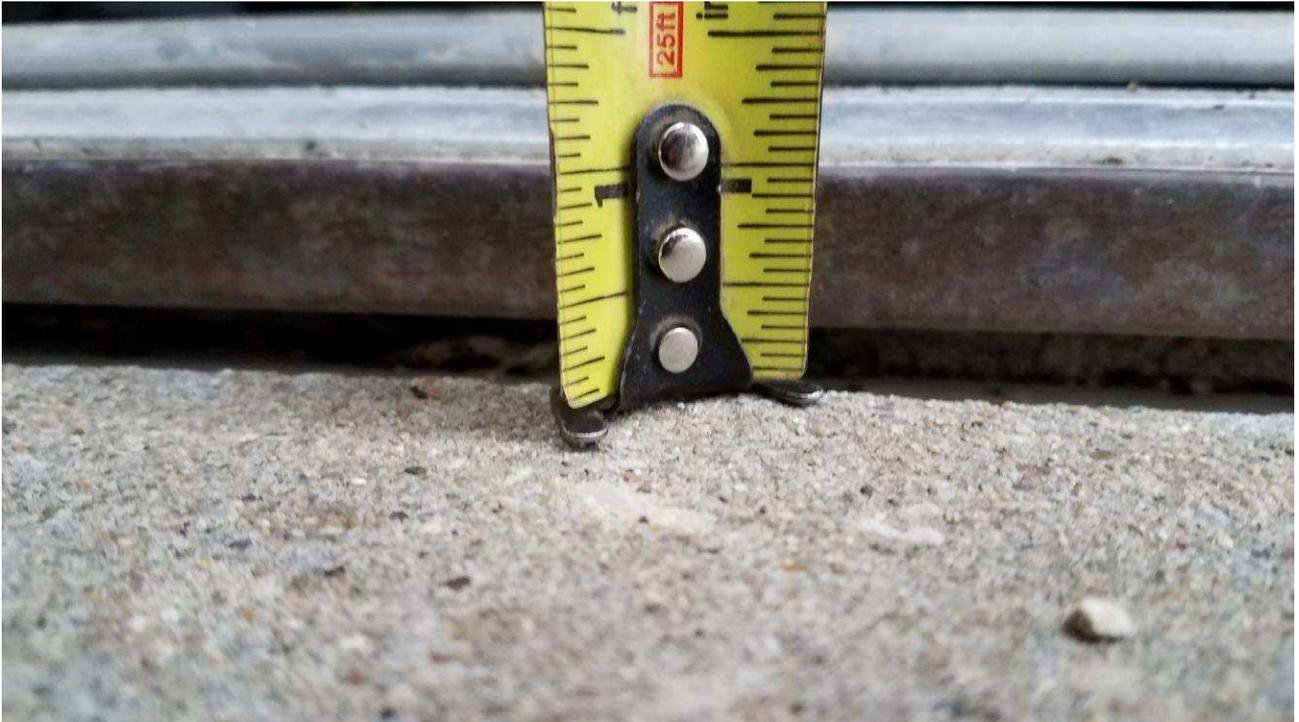
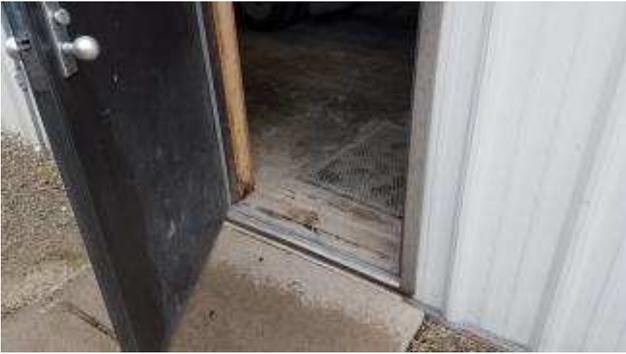
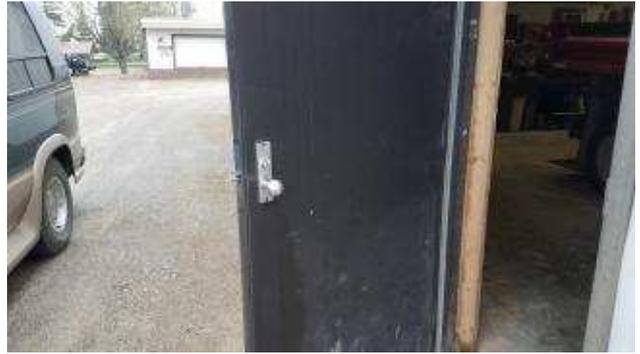
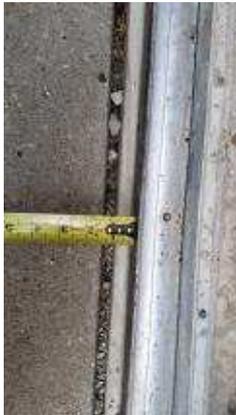
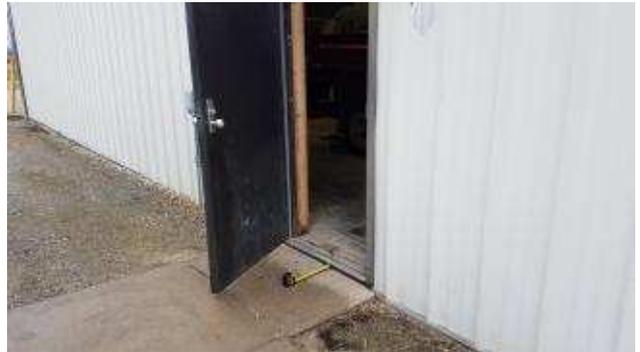
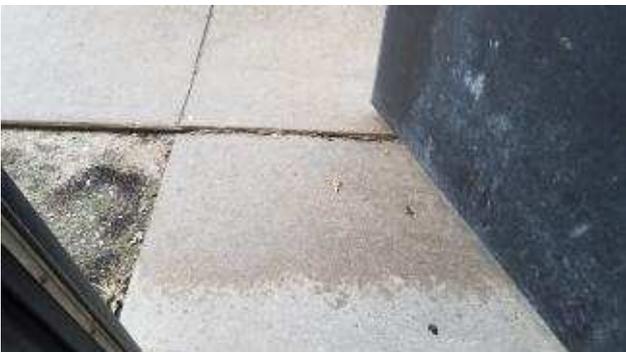
### Finding: 4

The threshold has a vertical change greater than 1/4 inch high.

bays entry- 1" gap, 1"  
CIL, knob, lipped  
threshold, CIL in  
maneuvering  
clearance

For all doors along the public circulation route, provide required maneuvering clearance on push and pull side of doors

For all doors along the public circulation route, repair, bevel, or ramp CILs at door entries to max .25"

For all doors along the public circulation route, repair, provide beveled threshold

For all doors along the public circulation route, correct or fill gap at doorway to max .5"

For all doors along the public circulation route, replace hardware with lever hardware or hardware operable without a tight pinch or grasp

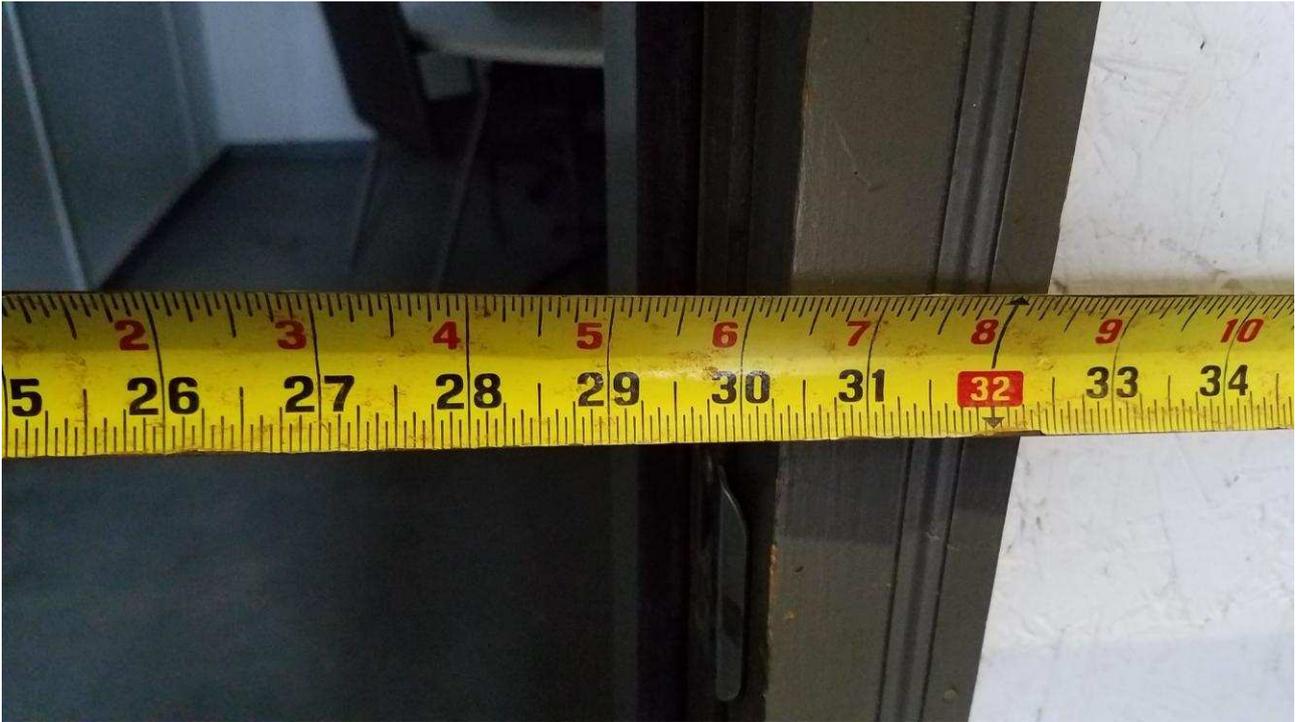
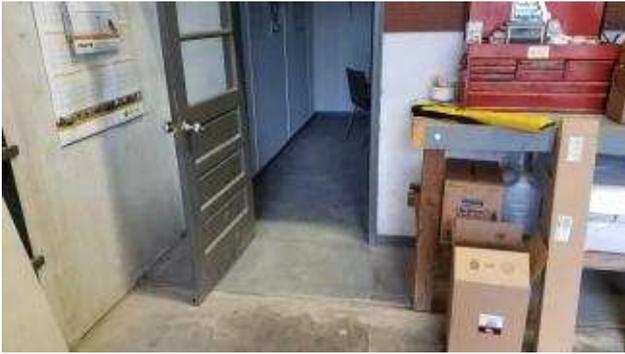
### Finding: 5

break room- knob,  
work bench pull side,  
29" wide

For all doors along the public circulation route, provide required maneuvering clearance on push and pull side of doors

For all doors along the public circulation route, replace doors with doors having 80" overhead clearance and 32" clear width

For all doors along the public circulation route, replace hardware with lever hardware or hardware operable without a tight pinch or grasp

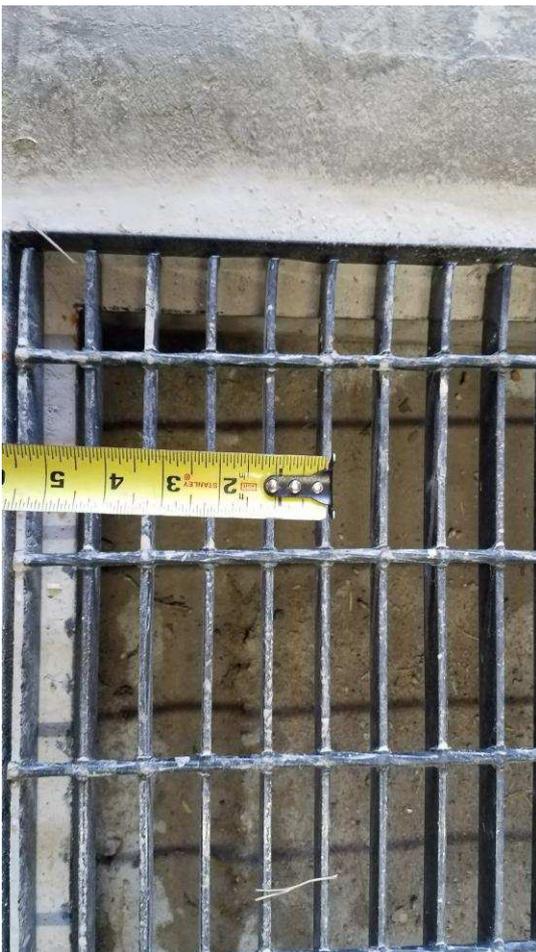
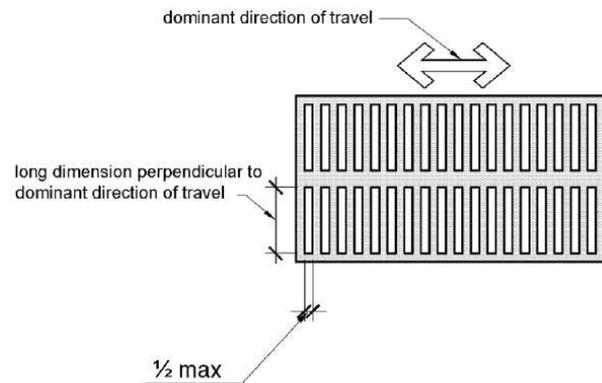
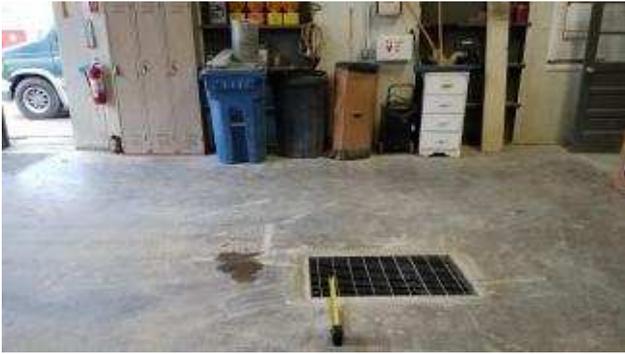
### Finding: 6

Gratings are spaced greater than a 1/2 inches in the direction of traffic flow.

1" in shed

Replace grate with one having max openings of 1/2 inch.

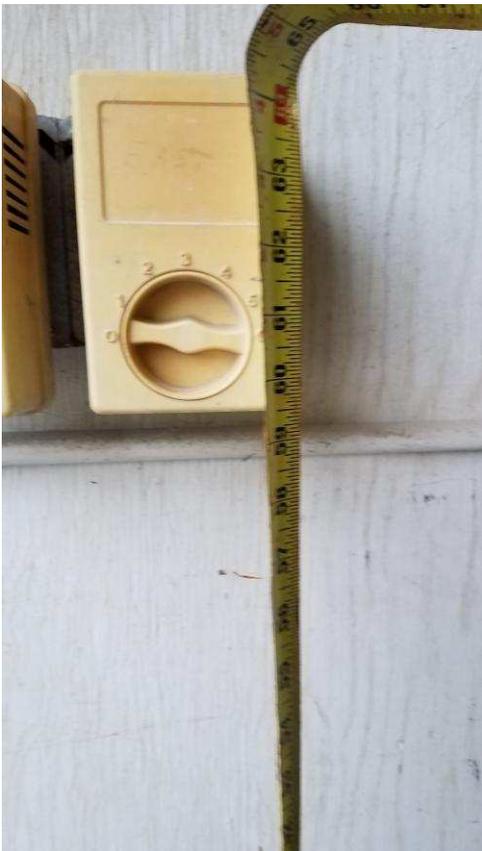
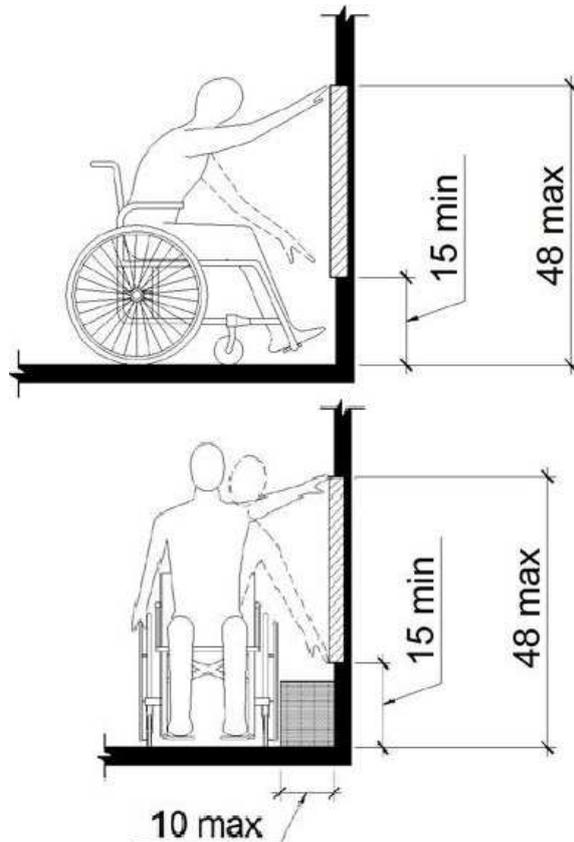
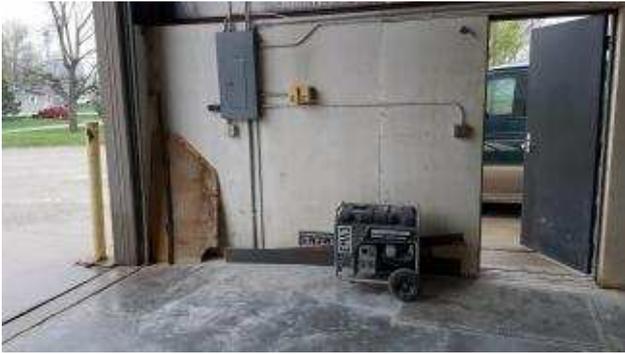
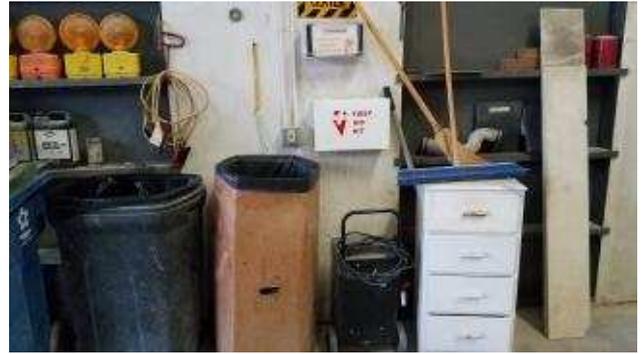
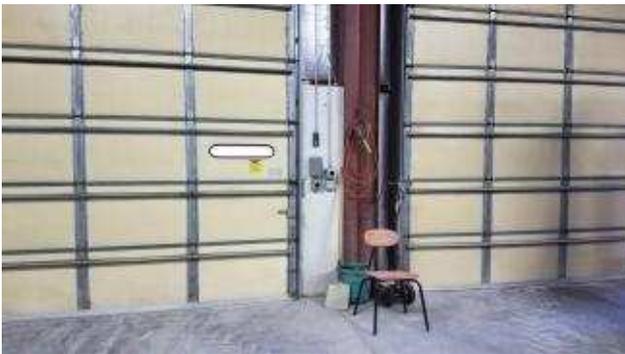
### Finding: 7

The controls and lockout tags are positioned too high for either a side or front approach.

controls high, lockout tags high

For deficit, leave as is, employee work area pursuant to 2010 Standards 106.5 Defined Terms, until an employee with a disability works here

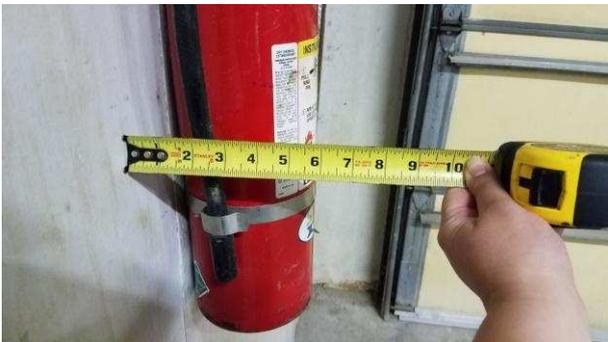
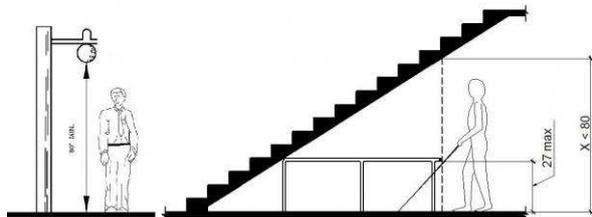
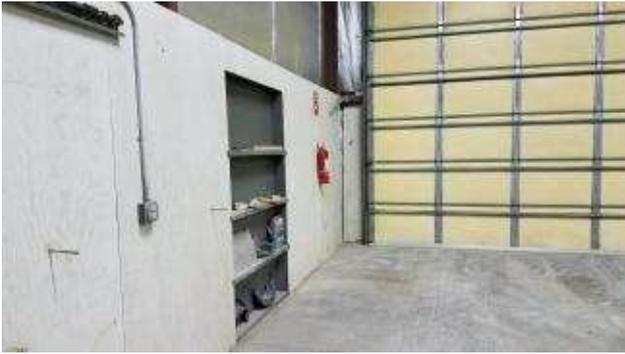
### Finding: 8

The fire extinguisher projects more than 4 inches into the circulation path.

fire extinguisher in shop 6"

For deficit, leave as is, employee work area pursuant to 2010 Standards 106.5 Defined Terms, until an employee with a disability works here

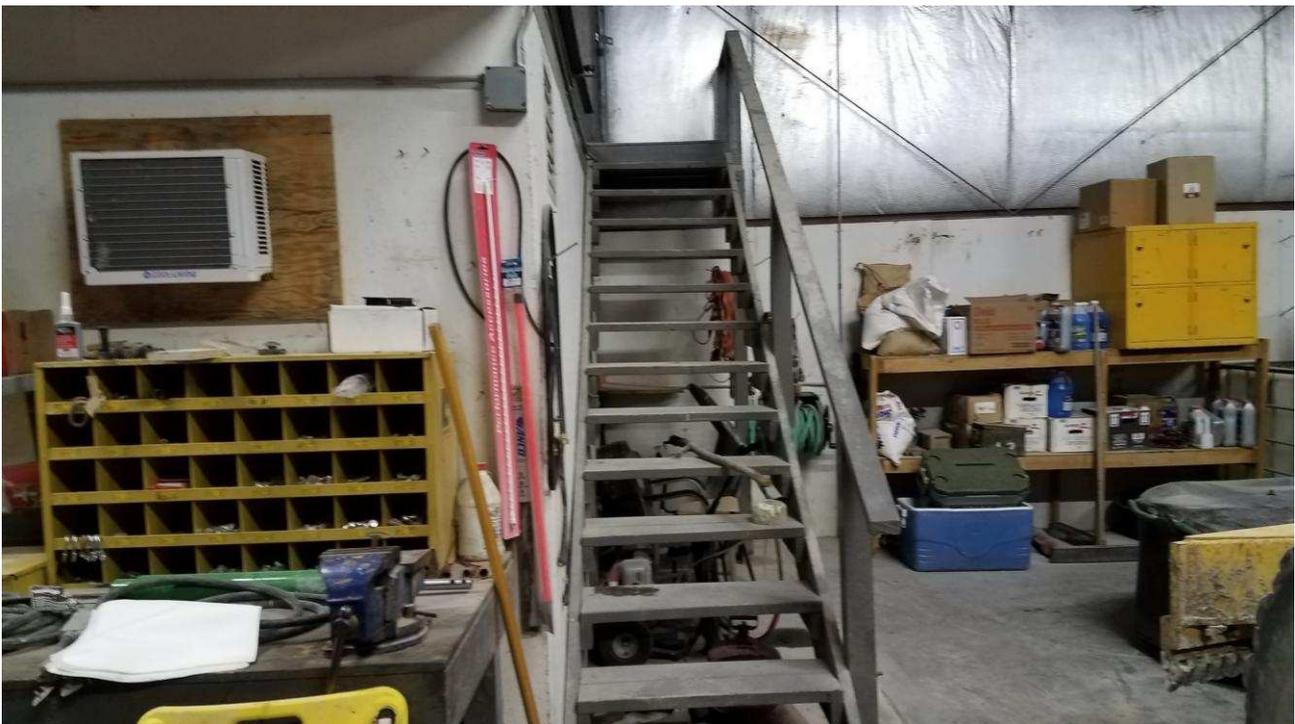
### Finding: 9

There is no accessible route between the main room and the mezzanine

stairs to storage  
mezzanine

No AR to upper level employee area, leave as is, and reassign duties if an employee with disabilities requires access here

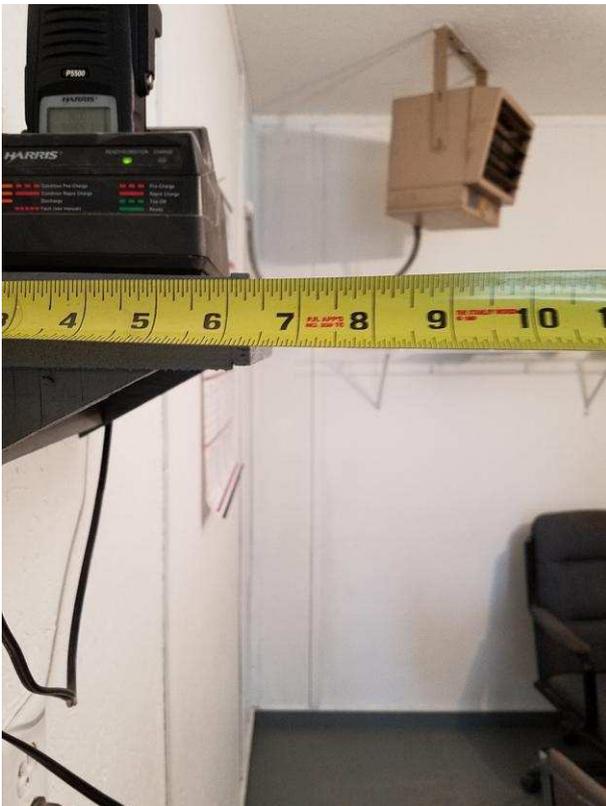
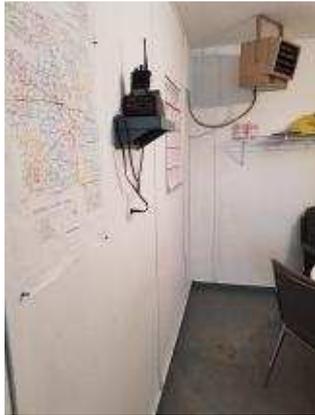
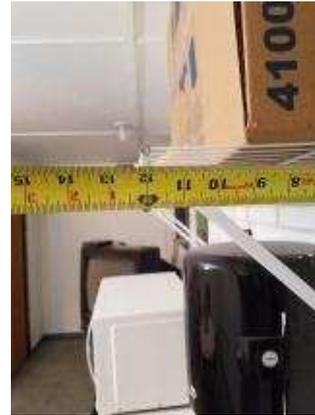
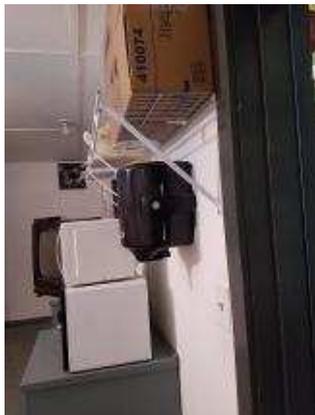
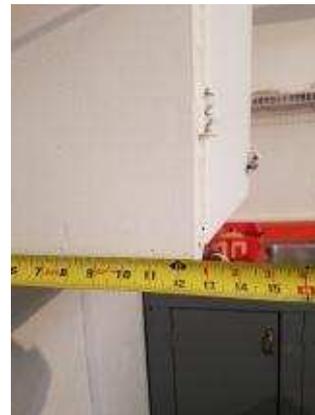
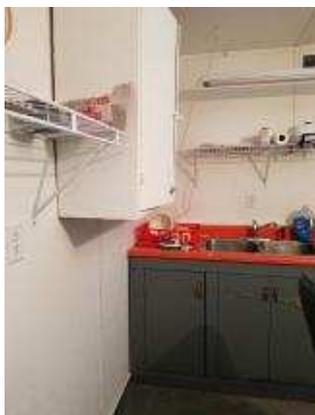
### Finding: 10

The shelves and cabinet projects more than 4 inches into the circulation path.

shelves protrude  
6.25" and 12", cabinet  
12.5"

For deficit, leave as is, employee work area pursuant to 2010 Standards 106.5 Defined Terms, until an employee with a disability works here

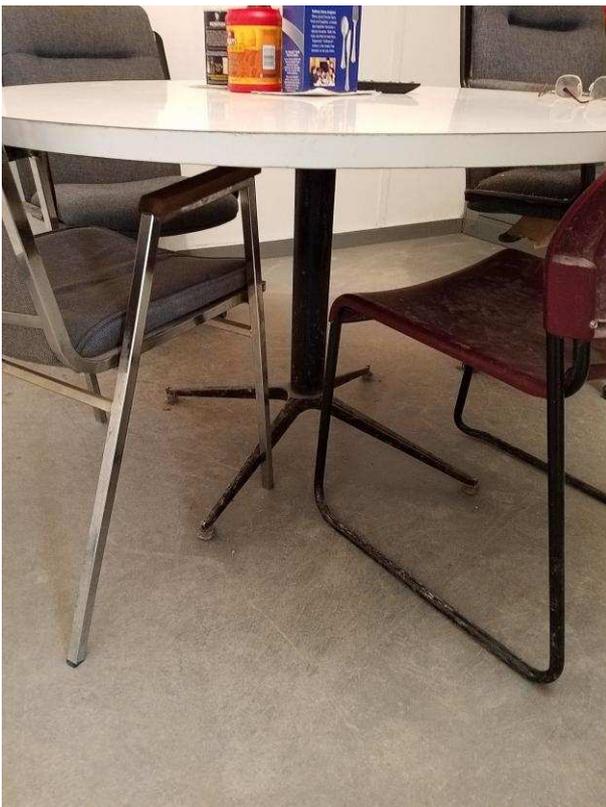
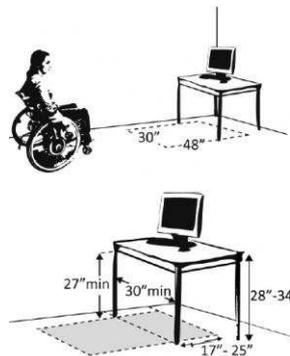
### Finding: 11

Compliant knee and toe clearance is not provided at the accessible table.

break area table lacks  
toe clearance

Replace the table with one providing required knee and toe clearances

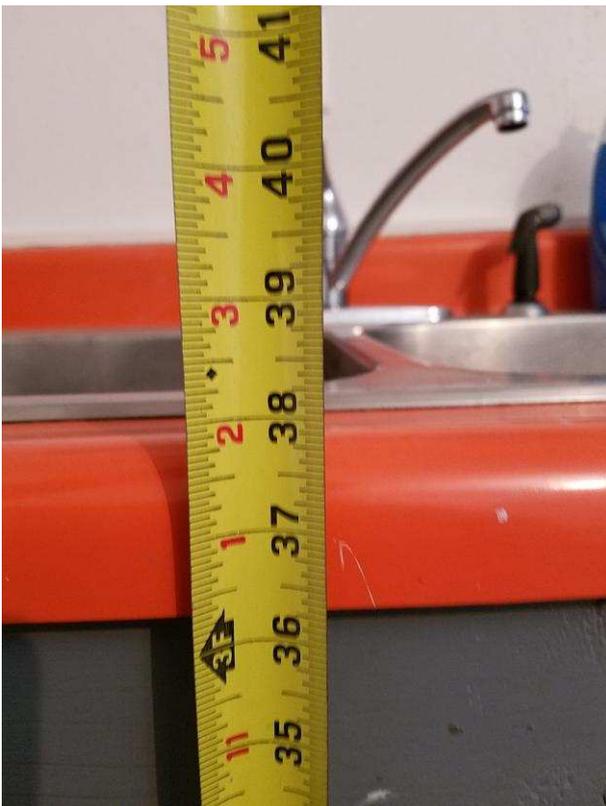
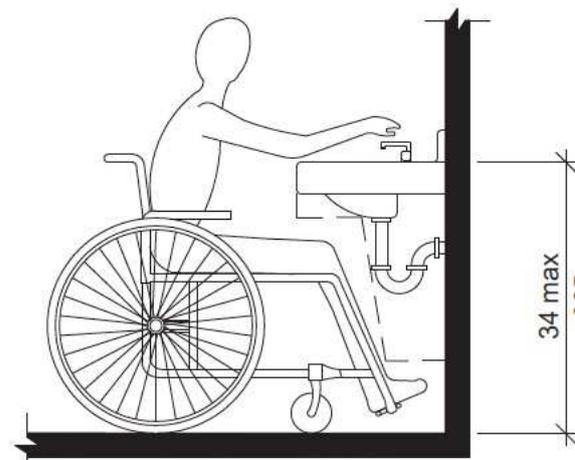
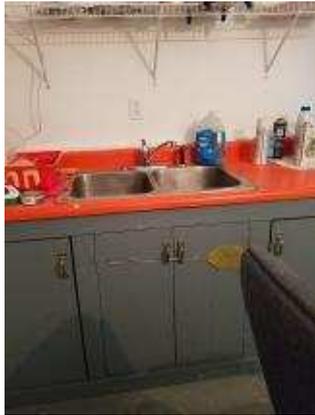
### Finding: 12

The sink is not accessible.

break area sink height  
38"

Lower sinks to max 34" aff to front of rim

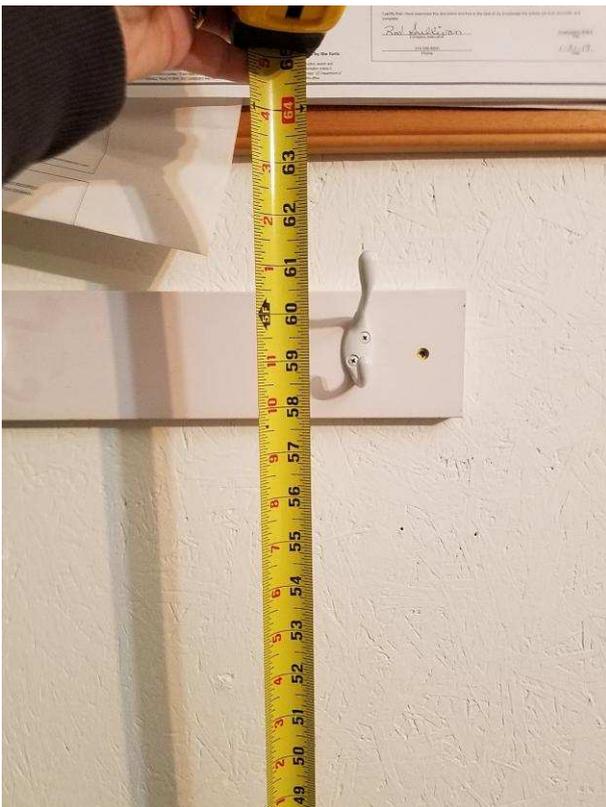
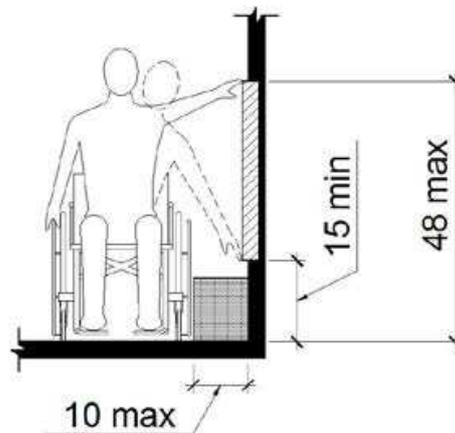
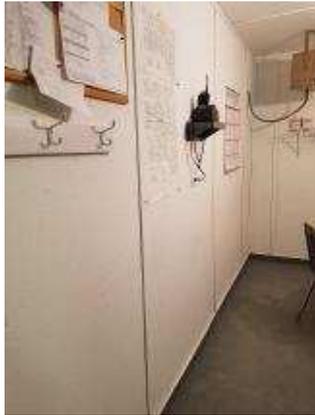
### Finding: 13

The phone shelf is too high and is out of the maximum reach range for a side approach.

phone shelf too high,  
hooks high at 59 in

Lower operating mechanisms to max 48" aff to highest operable part; leave as is if employee only operated

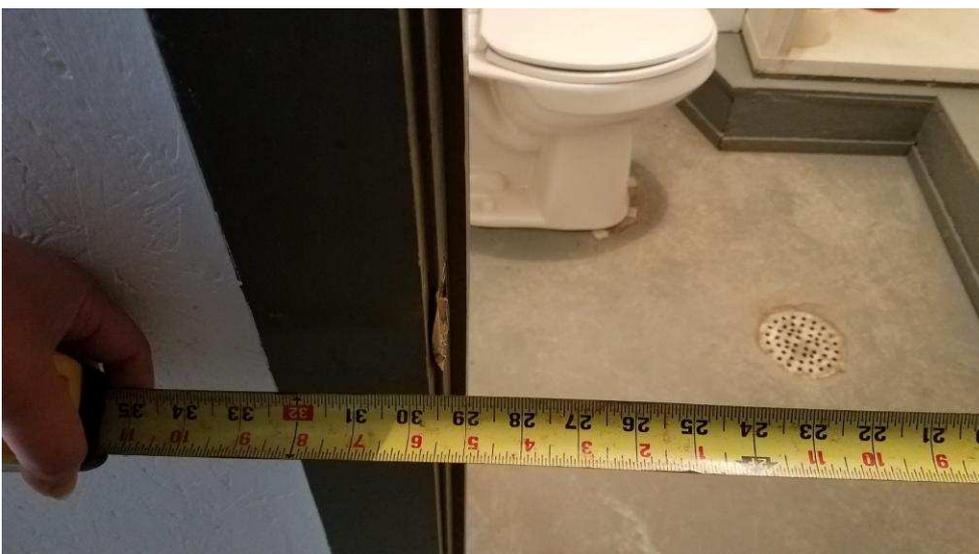
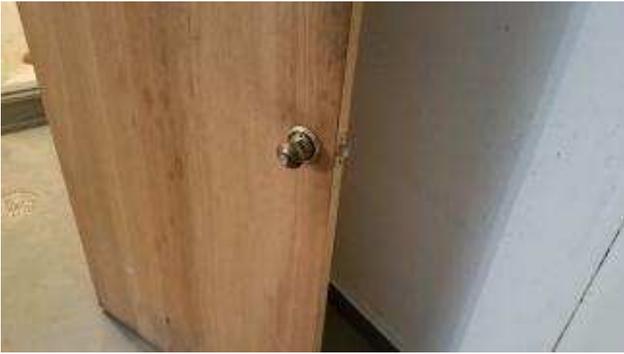
### Finding: 14

restroom- knob, 29"  
wide

For all doors along the public circulation route, replace doors with doors having 80" overhead clearance and 32" clear width

For all doors along the public circulation route, replace hardware with lever hardware or hardware operable without a tight pinch or grasp

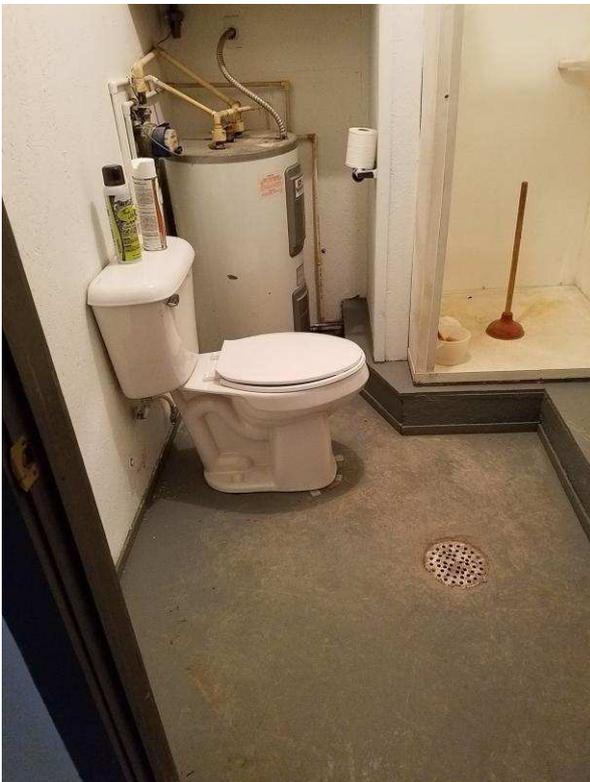
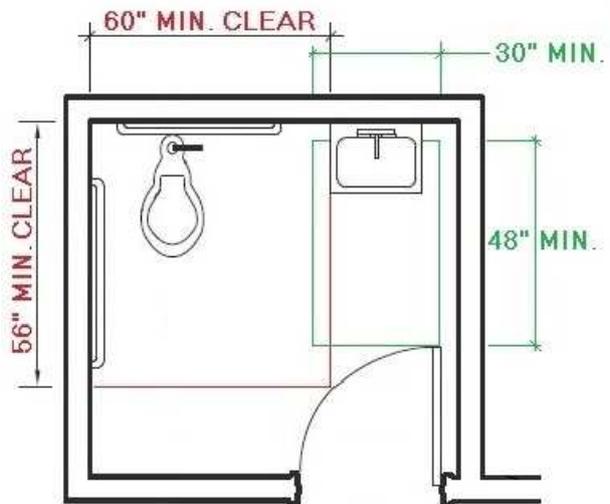
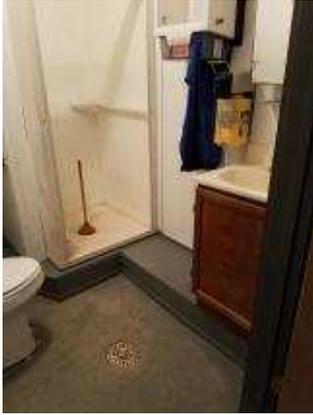
### Finding: 15

The restroom is not nearly compliant.

The restroom does not have the required minimum clear floor space or maneuvering clearances for the toilet, The restroom does not have the required minimum clear floor space or maneuvering clearances for the lavatory, The entry door does not contain the required minimum maneuvering spaces on the pull/push sides, The entry door encroach into the required clear floor space for fixtures, Grab bars are missing and/or incorrectly installed, Accessories, such as toilet seat covers, paper towel holders, garbage cans, hand dryers, and mirrors are either too high or without clear floor space or both, The restroom contain floor level changes greater than a 1/2 inch of the floor drains and is slope (XX) - (XX), the shower is too small and missing numerous accessible elements.

restroom lacks  
accessible features

Create a compliant wheelchair accessible restroom and correct all features to be accessible
