Site Accessibility Evaluation

Oxford Shed

**1910 Lower Old Hwy 6 Rd
NW
Oxford, IA 52322**

***Inspection Date: 04/24/2019
Inspector: Shelley Zuniga***

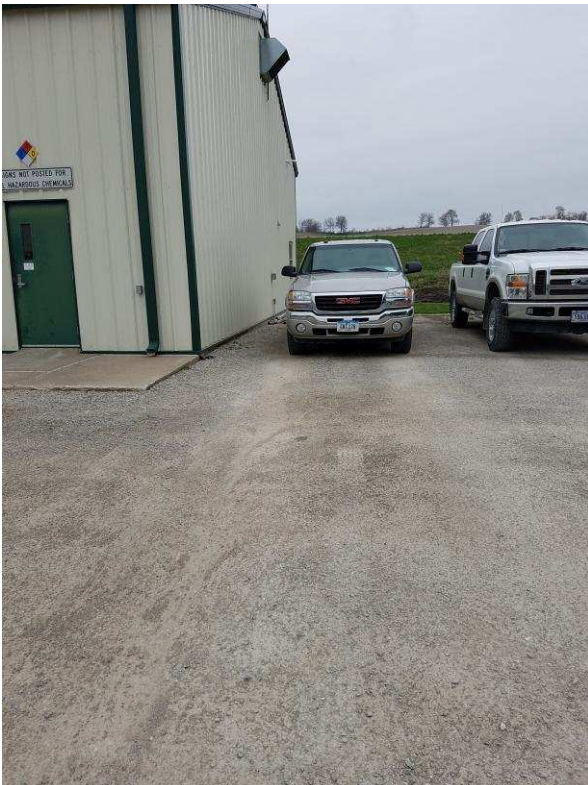
Finding: 1

There are no accessible parking stalls.

There are an unknown number of parking stalls in the parking lot that could be reasonably associated with this facility. There should be a minimum of one accessible stall with a minimum of one being designed as van accessible.

gravel lot lacks
designated stalls

Create one or more 8' accessible parking stalls, with one 5' adjacent access aisle, with proper signage and striping based on the total number of stalls

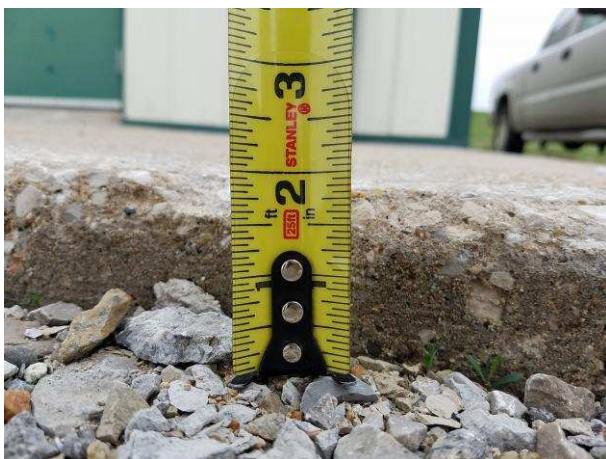
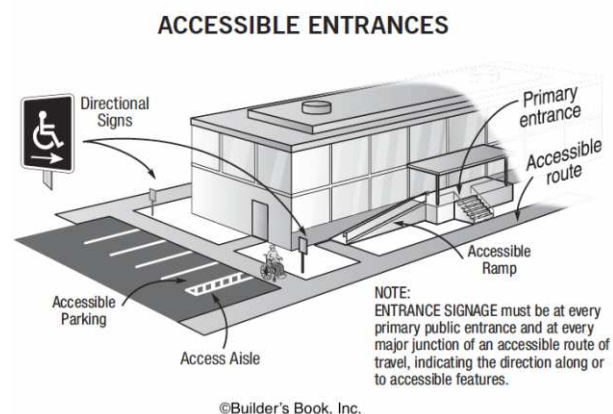
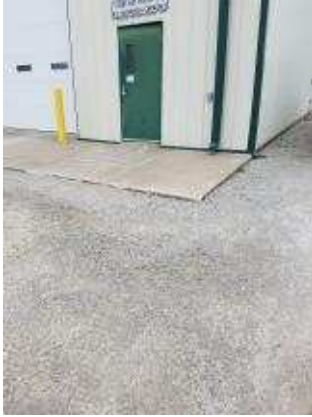
Finding: 2

There is no accessible route between the buildings.

gravel route through
parking lot, 2" change
in level 2 main entry

Create AR with crushed and compacted stone or similar outdoor material from building to building within the site

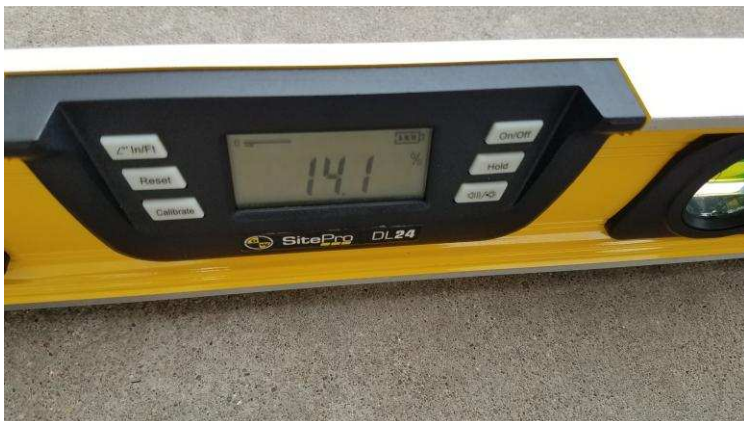
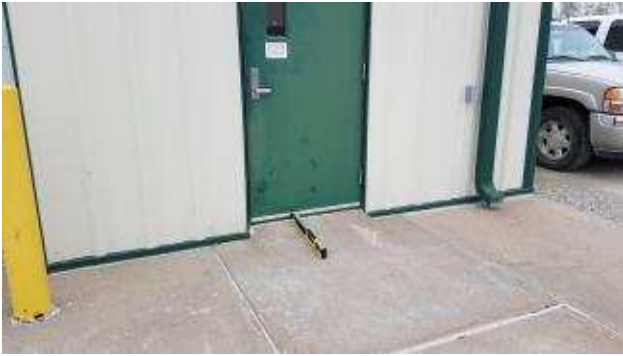
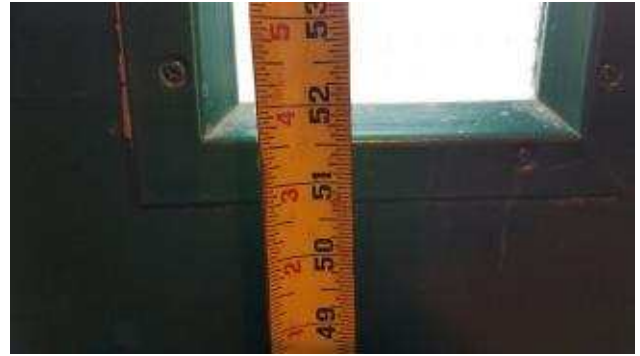
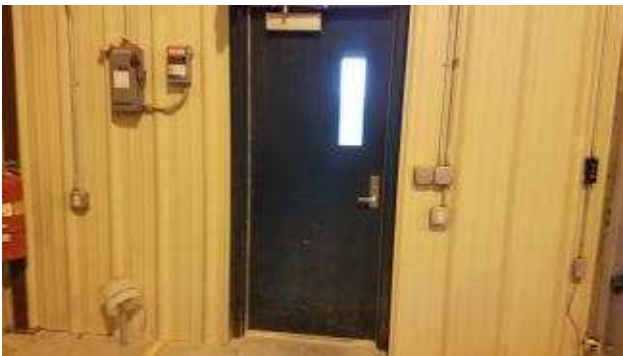
Finding: 3

entry- 14.1%, 10#,
window 52"

For all doors along the public circulation route, provide required maneuvering clearance on push and pull side of doors

For all doors along the public circulation route, inspect, adjust, and maintain 8.5 lbf to open exterior doors as a smart practice

or all doors along the public circulation route, replace doors with ones having sidelight viewing windows max 43" aff

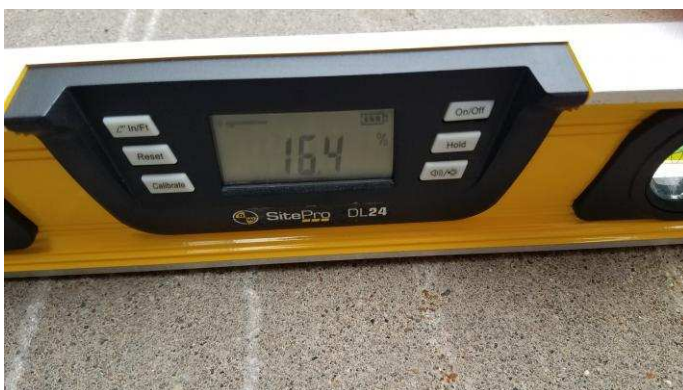
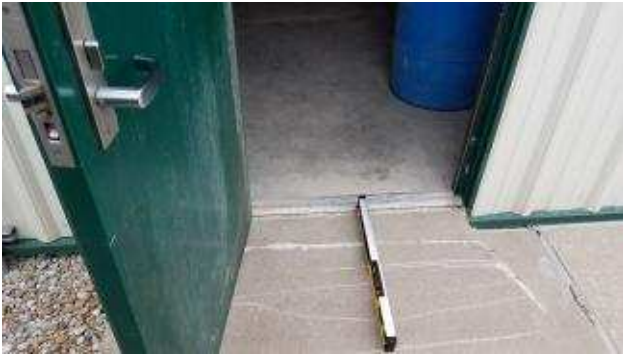
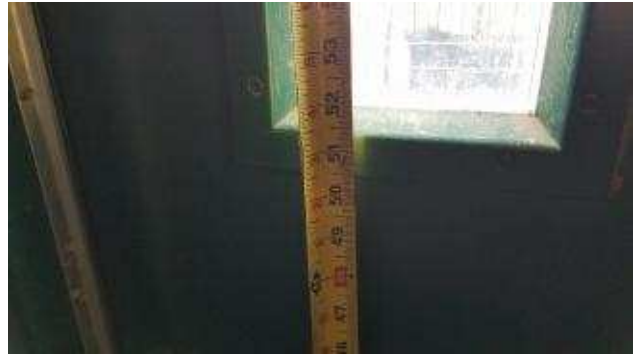
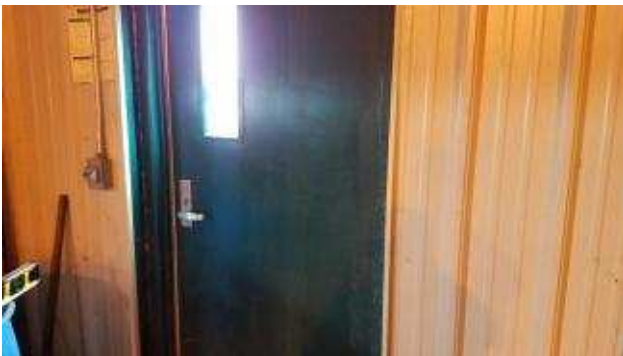
Finding: 4

side entry- 16.4%,
closes fast, window
52"

For all doors along the public circulation route, provide required maneuvering clearance on push and pull side of doors

For all doors along the public circulation route, inspect, adjust, and maintain closing speed on door closers

For all doors along the public circulation route, replace doors with ones having sidelight viewing windows max 43" aff

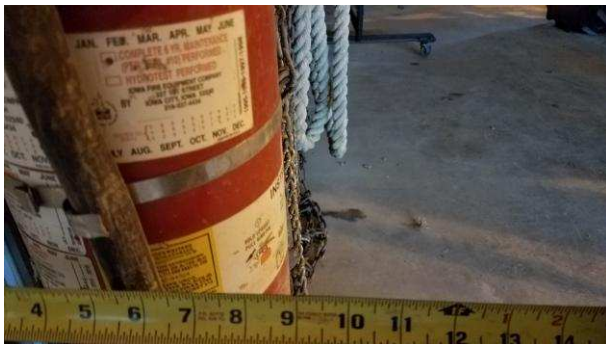
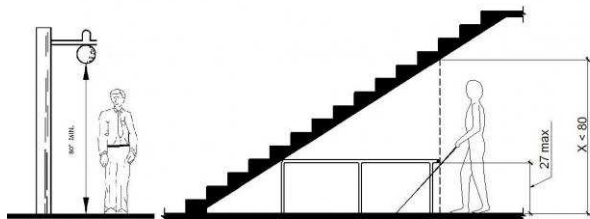
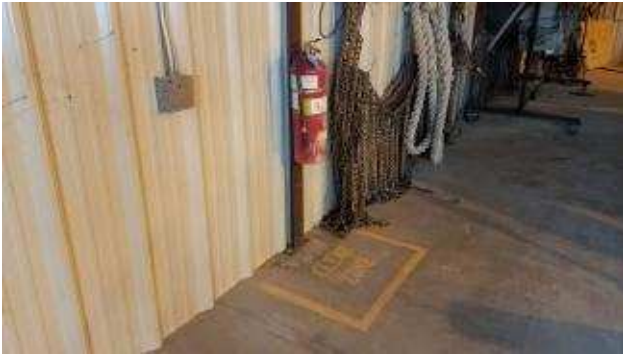
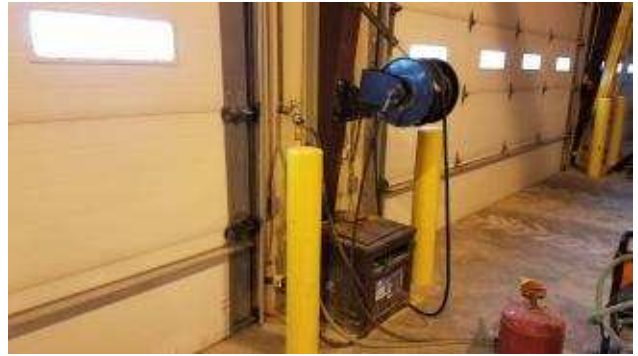
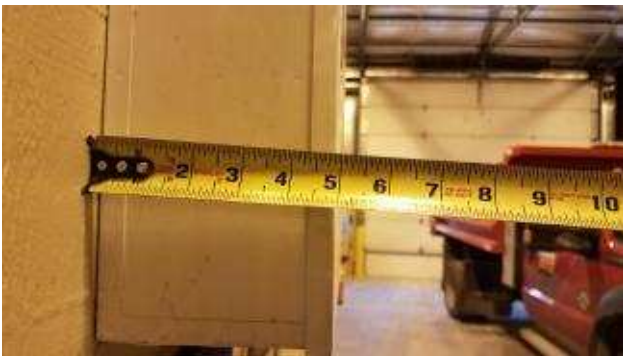
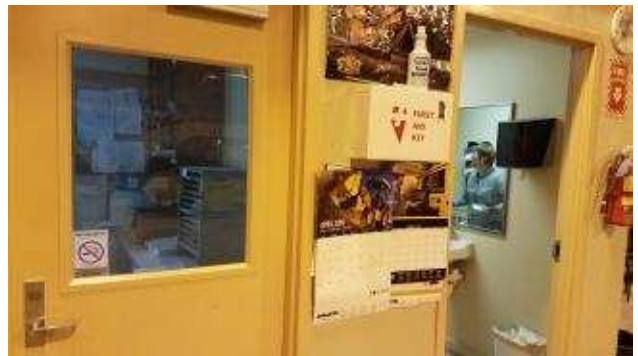
Finding: 5

Multiple objects project more than 4 inches into the circulation path.

fire extinguisher in
bays 9", hose reel,
first aid 4"

For deficit, leave as is, employee work area pursuant to 2010 Standards 106.5 Defined Terms, until an employee with a disability works here

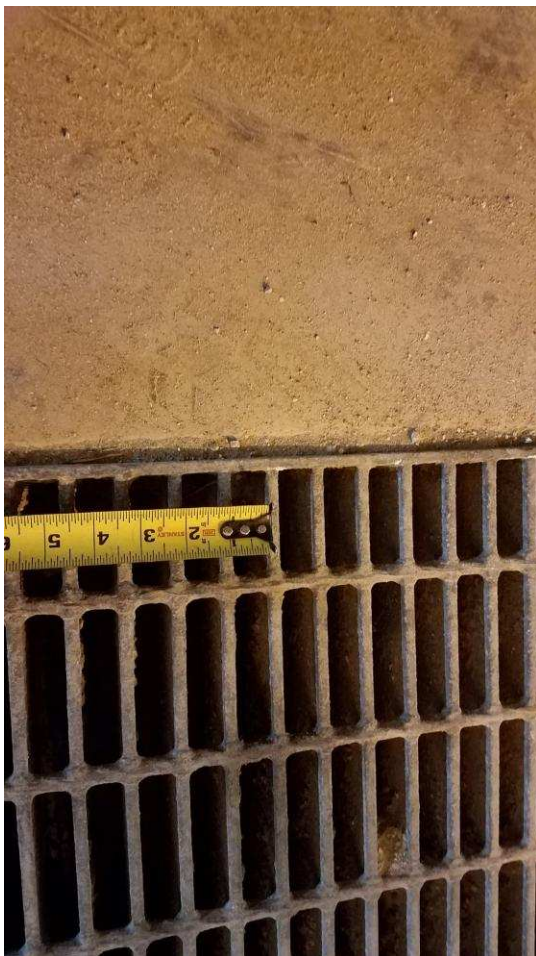
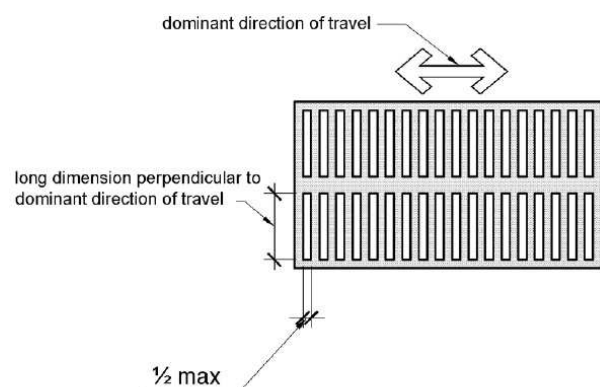
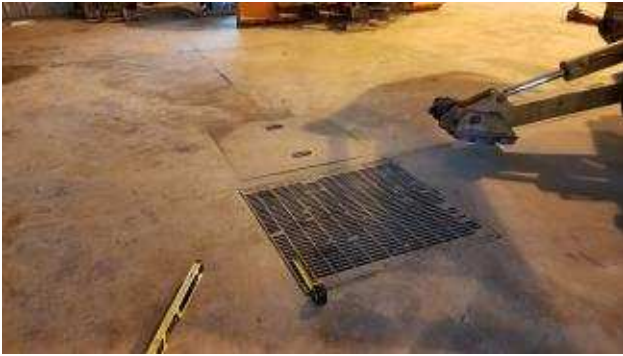
Finding: 6

Gratings are spaced greater than a 1/2 inches in the direction of traffic flow.

1" in bays

Leave as is, grating, integral to the use of the site.

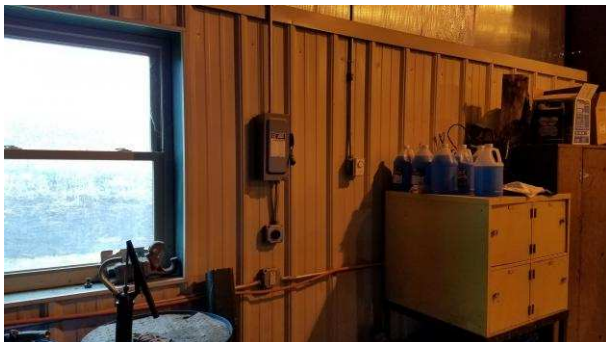
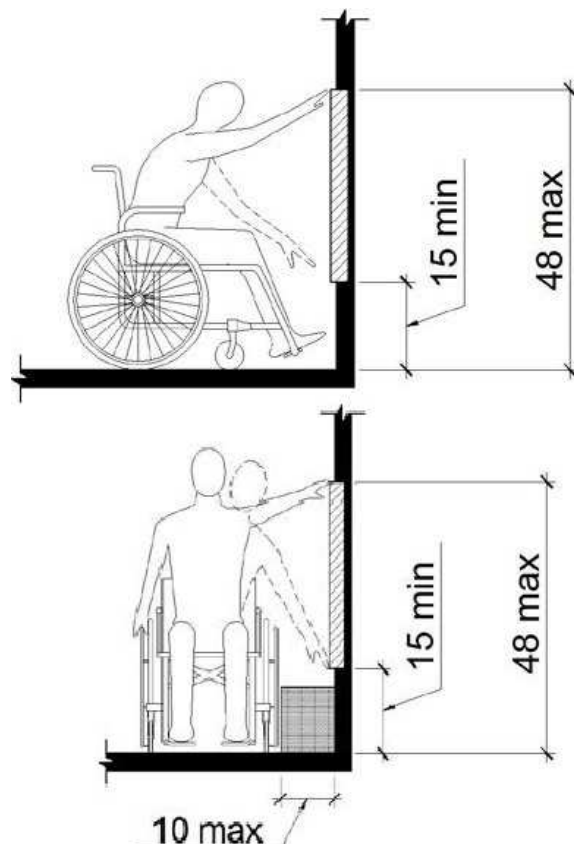
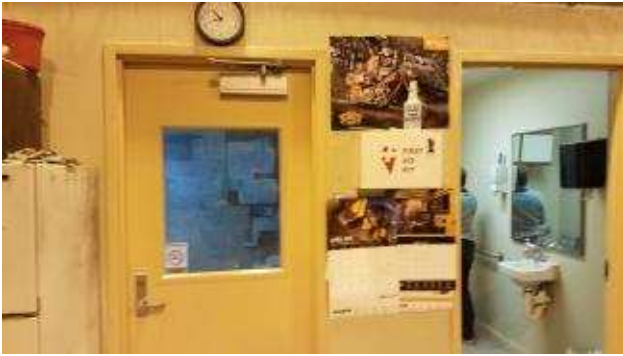
Finding: 7

The thermostat and first aid is positioned too high for either a side or front approach.

thermostat in bays,
first aid

For deficit, leave as is, employee work area pursuant to 2010 Standards 106.5 Defined Terms, until an employee with a disability works here

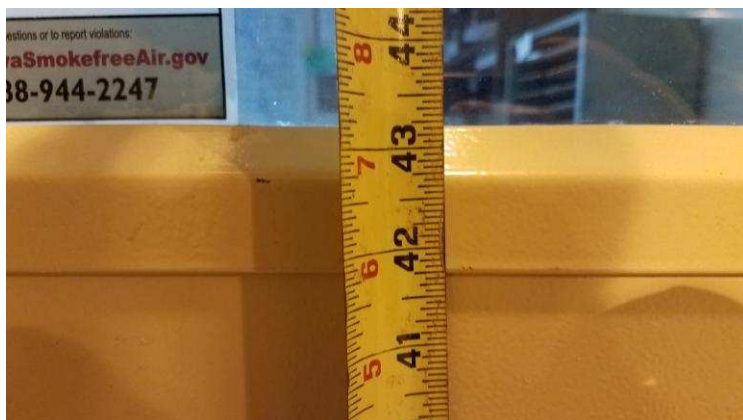
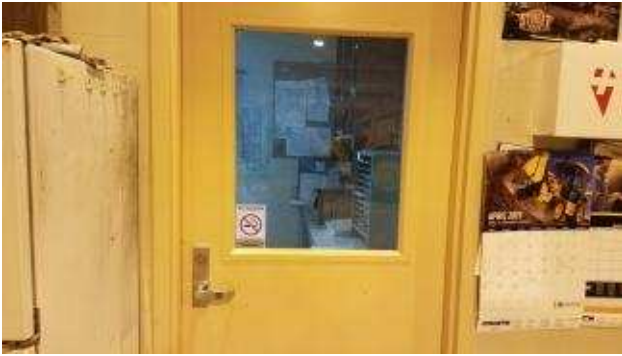
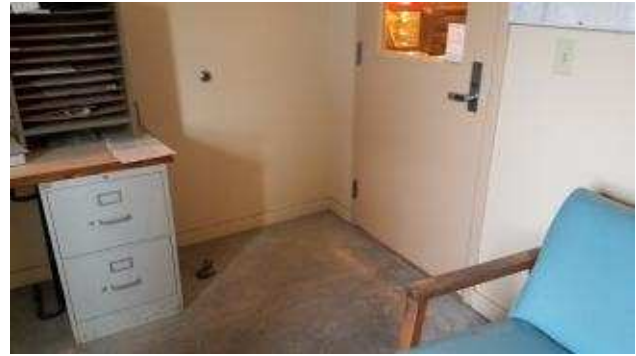
Finding: 8

office- 10#, window
43.25", cabinet back
pull side

For all doors along the public circulation route, provide required maneuvering clearance on push and pull side of doors

For all doors along the public circulation route, inspect, adjust, and maintain 5 lbf to open interior doors

For all doors along the public circulation route, replace doors with ones having sidelight viewing windows max 43" aff

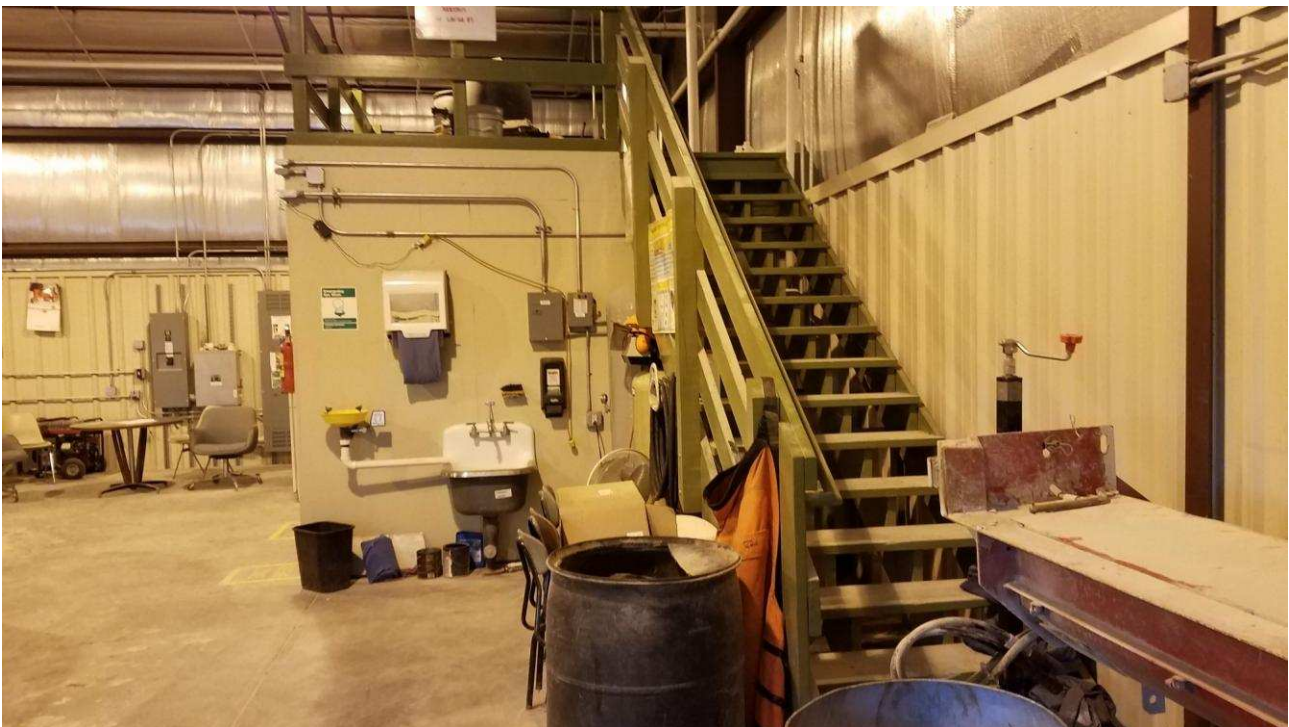
Finding: 9

There is no accessible route between the main floor and the mezzanine

stairs to
loft/mezzanine

No AR to upper level employee area, leave as is, and reassign duties if an employee with disabilities requires access here

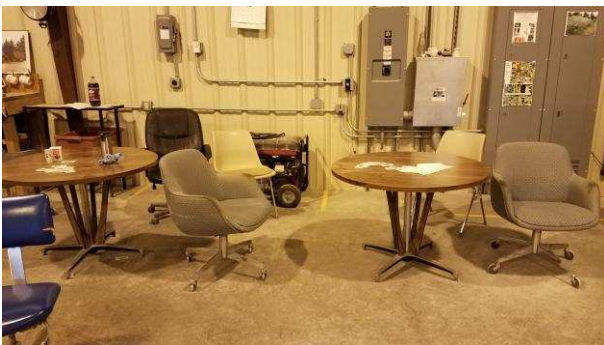
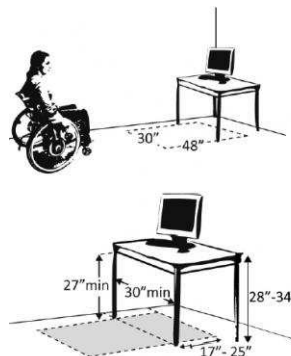
Finding: 10

Compliant knee and toe clearance is not provided at the accessible table.

break area tables lack
knee clearance

Replace one of the tables with ones providing required knee and toe clearances

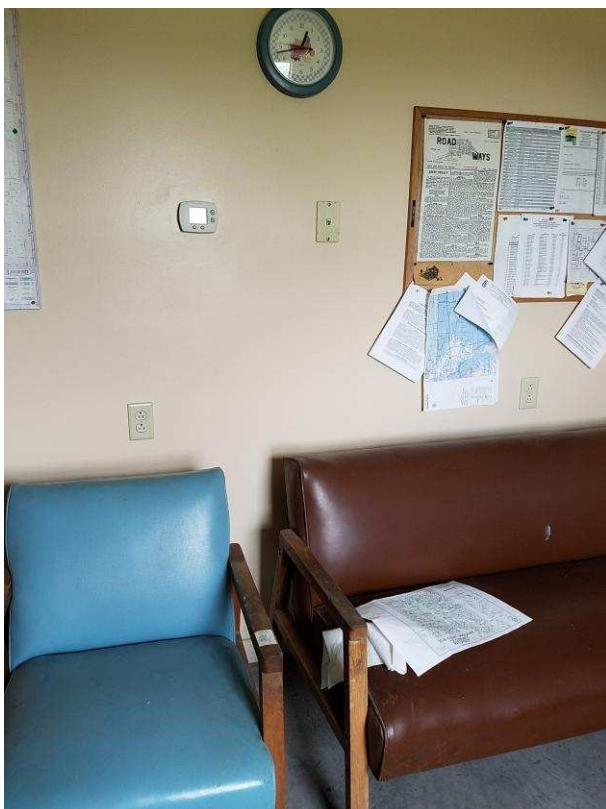
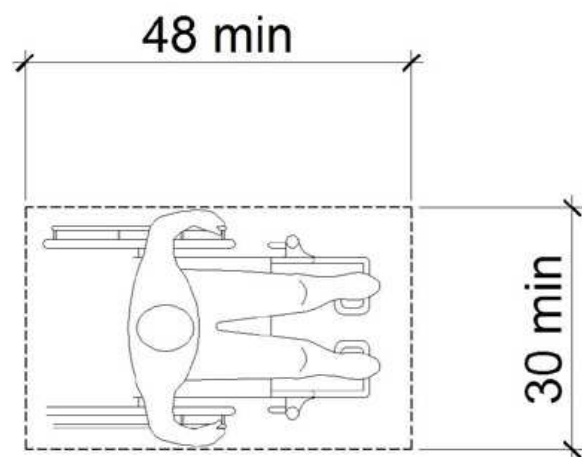
Finding: 11

The operable part is not accessible because there is not adequate clear floor space for either a forward or side approach.

thermostat and
outlets lack clear floor
space in office

For deficit, leave as is, employee work area pursuant to 2010 Standards 106.5 Defined Terms, until an employee with a disability works here

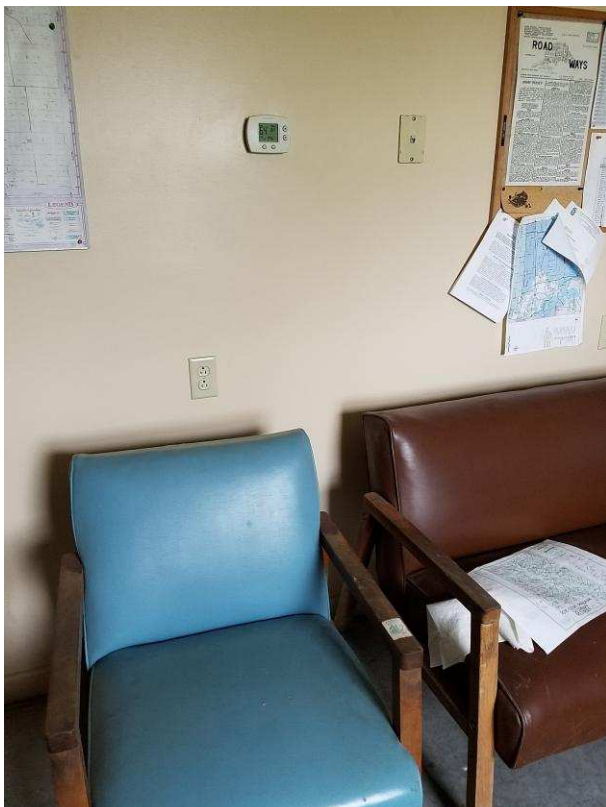
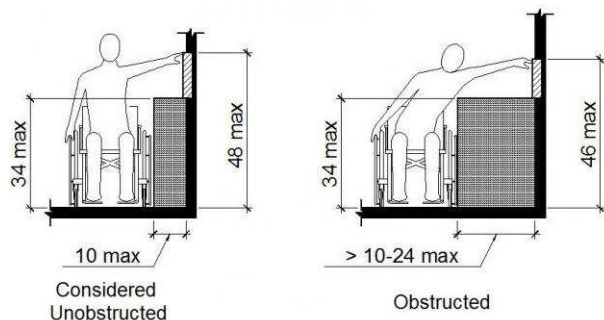
Finding: 12

The operable part is too high and is out of the maximum reach range for a side approach.

thermostat too high
behind chair in office

For deficit, leave as is, employee work area pursuant to 2010 Standards 106.5 Defined Terms, until an employee with a disability works here

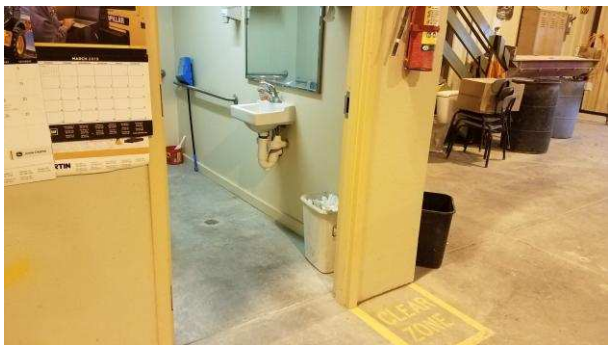
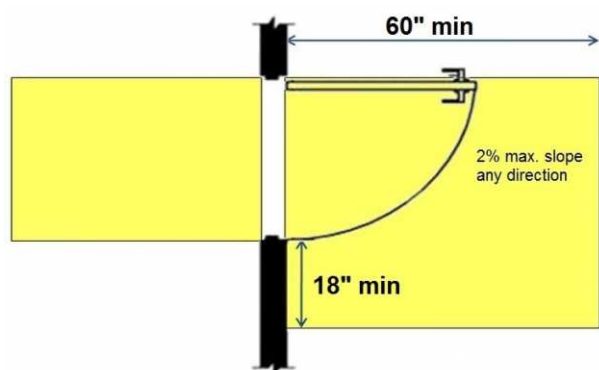
Finding: 14

The maneuvering space on the pull side of the door does not adequately extend beyond the latch side of the door.

restroom- wall and
sink pull side

For all doors along the public circulation route, provide required maneuvering clearance on push and pull side of doors

For all doors along the public circulation route, relocate storage, furniture, and other obstacles to create 60" maneuvering space around doors

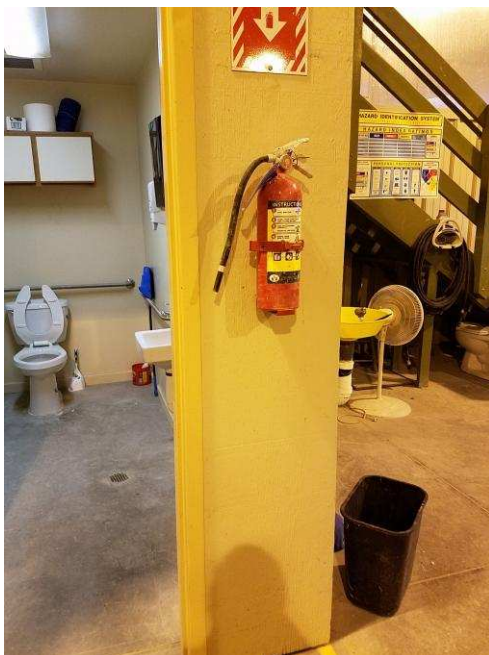
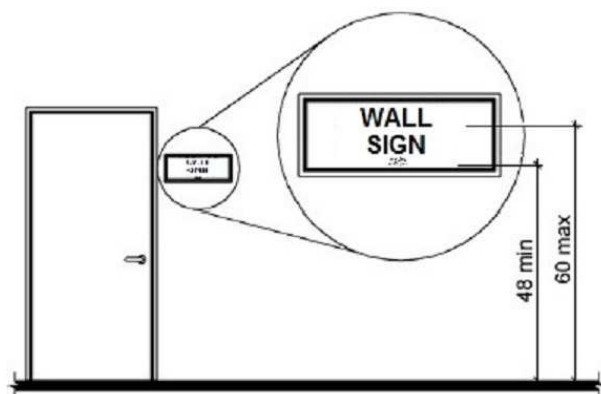
Finding: 15

Compliant room identification signs are missing on the strike side of the door.

restroom lacks
signage

Acquire and mount signage, including Braille and access symbol mounted on wall, latch side of door, 48" to baseline of lowest character and 60" to baseline of highest character

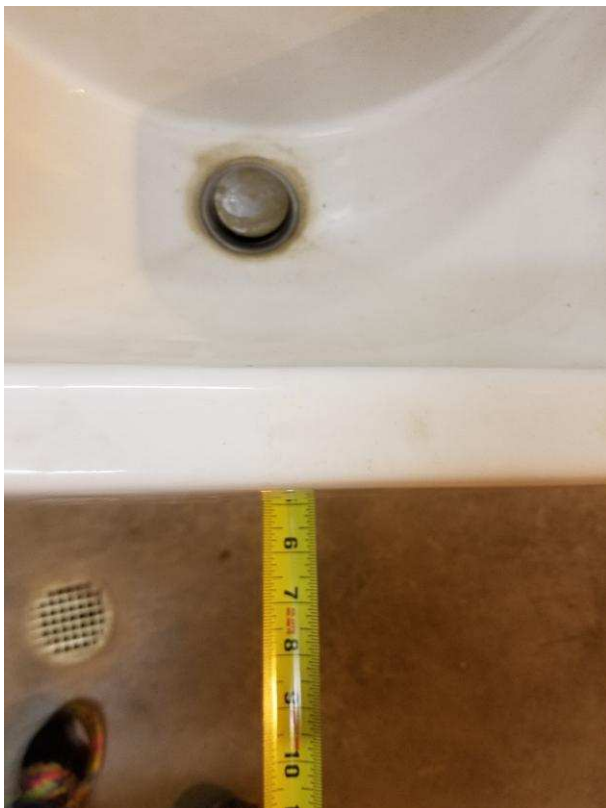
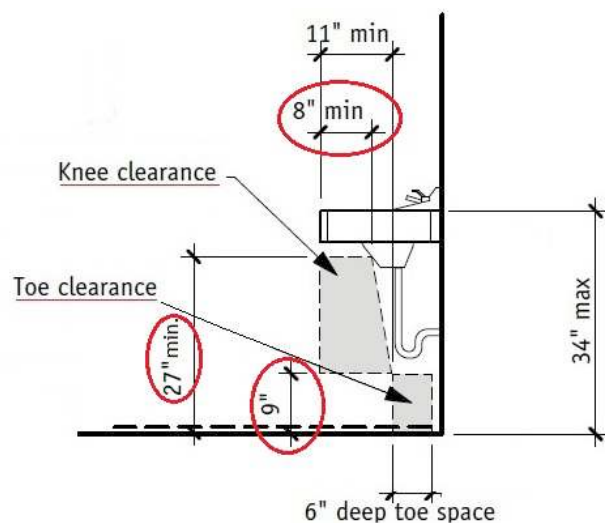
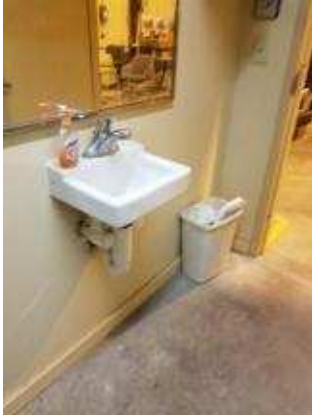
Finding: 16

Knee clearance at 27 inches off the floor is not 8 inches minimum deep.

sink lacks depth for
knee clearance

Replace sink with one providing 27" knee clearance that is a min 8" deep

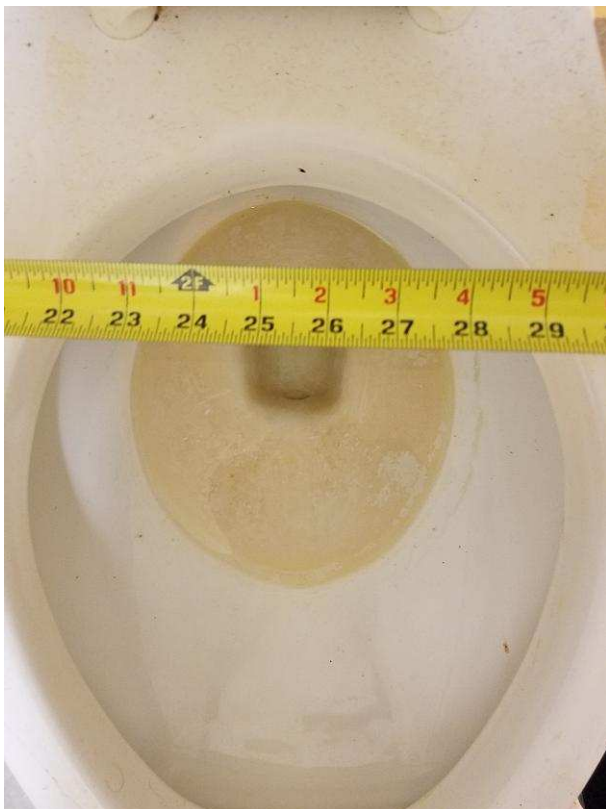
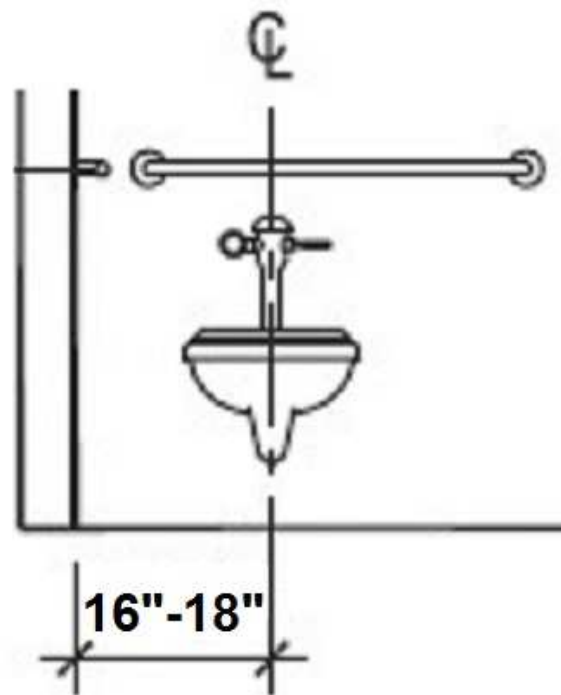
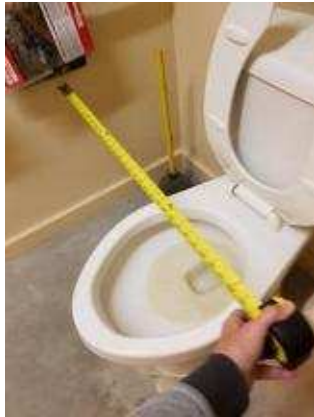
Finding: 17

The toilet is not located within the range allowed from the side wall or partition.

centerline 25.5"

Remount toilet to 16" to 18" from the side wall to centerline

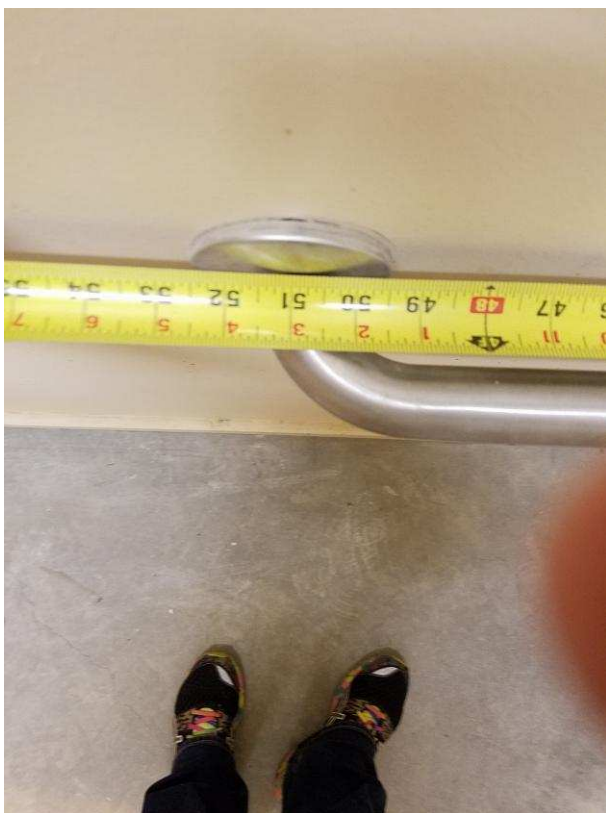
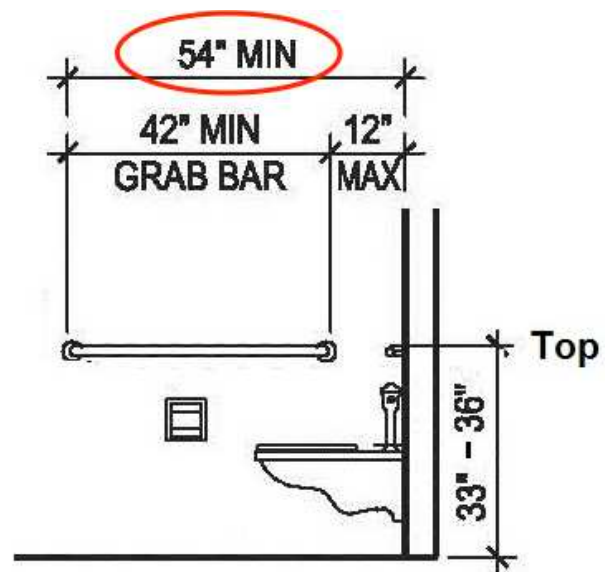
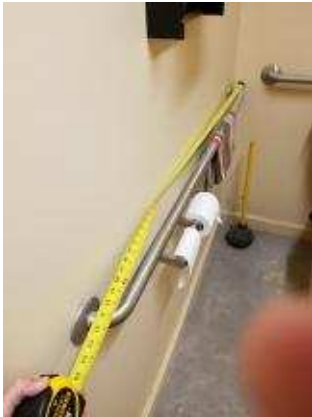
Finding: 18

The side grab bar does not extend far enough from the rear wall.

side grab bar fails,
extends to 51"

Remount side grab bar to max 12" from the rear wall at the close end and min 54" on the far end, and 33" to 36" aff

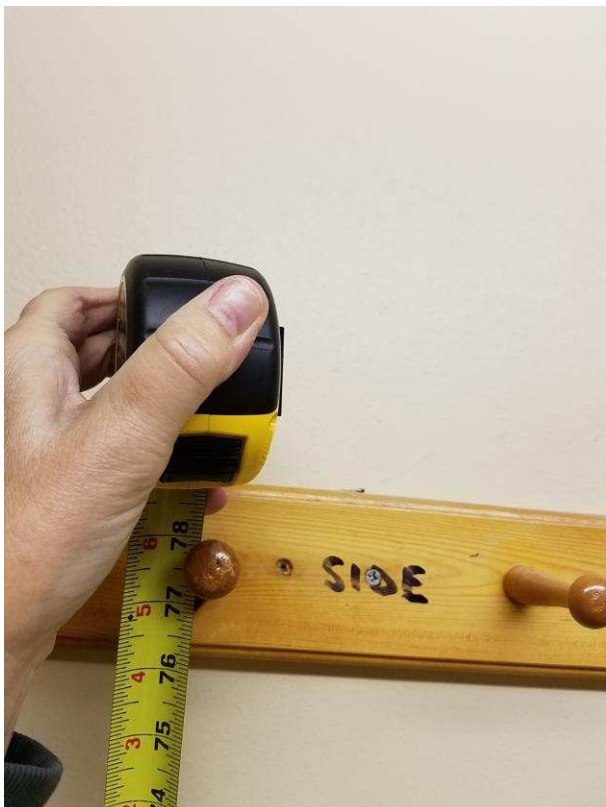
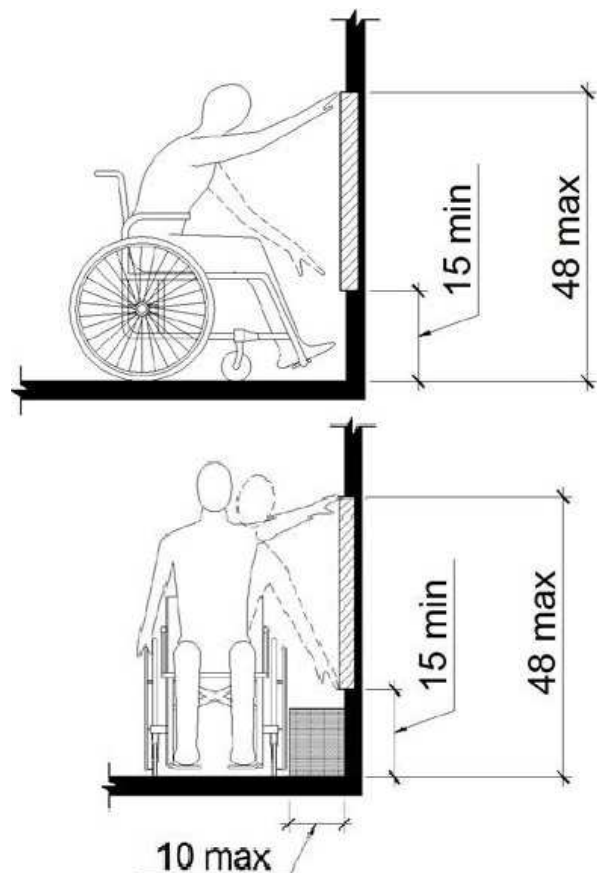
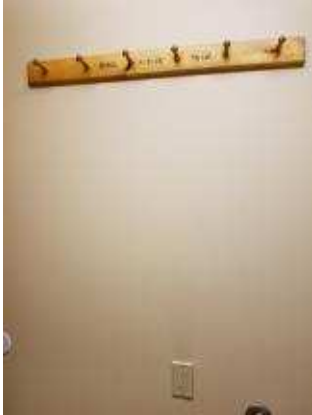
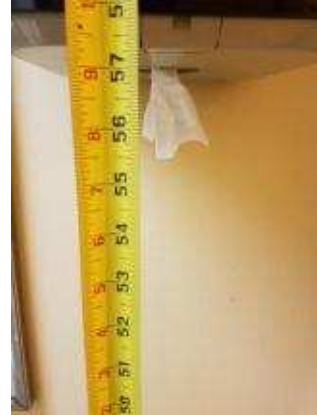
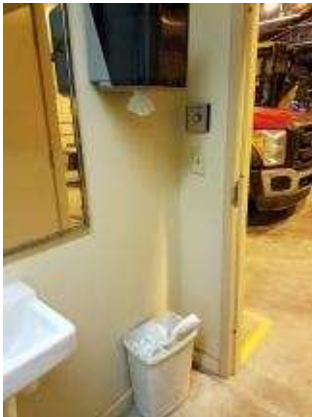
Finding: 19

The hooks and paper towels are positioned too high for either a side or front approach.

hooks at 77.5" and
paper towels at 56"

Remount operable parts to be in reach range of 15" min to 48" max

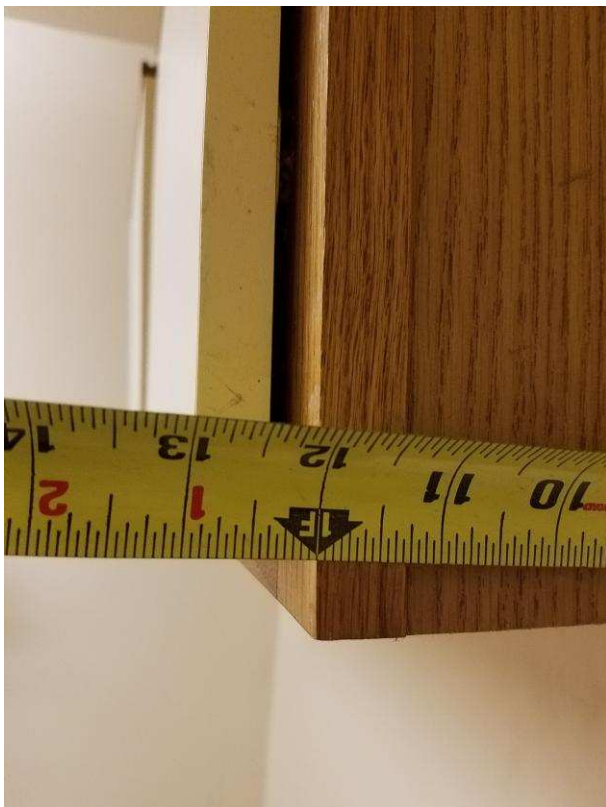
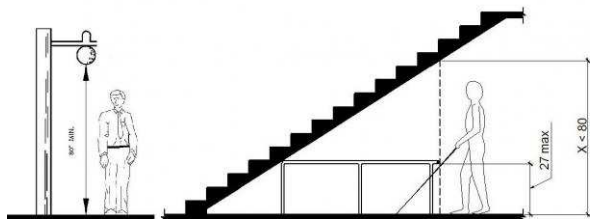
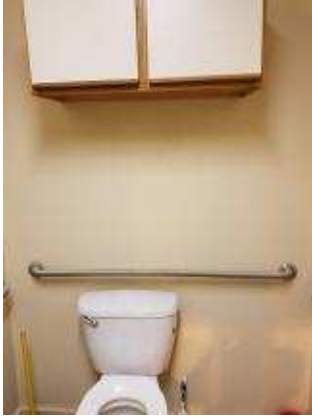
Finding: 20

The cabinet projects more than 4 inches into the circulation path.

cabinet protrudes 13"
over the toilet

Relocate protruding objects or place cane detectable warning or bollard at foot of item

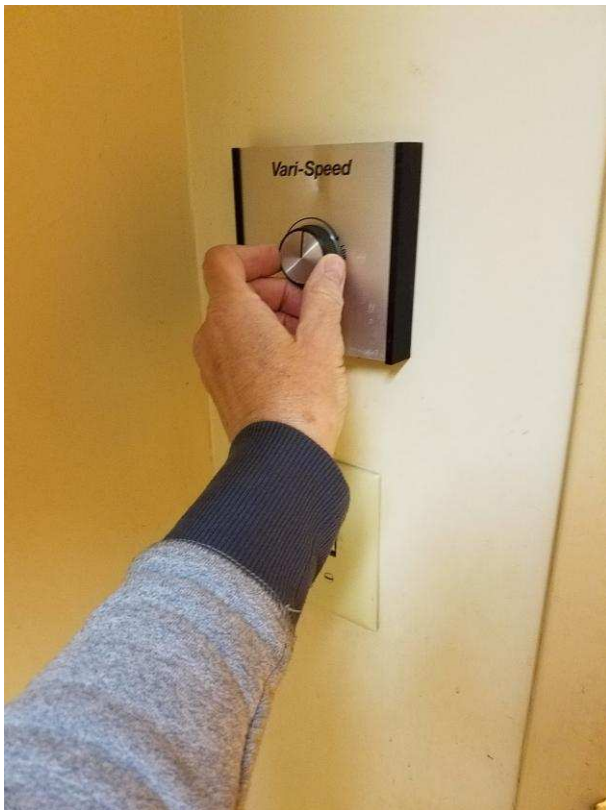
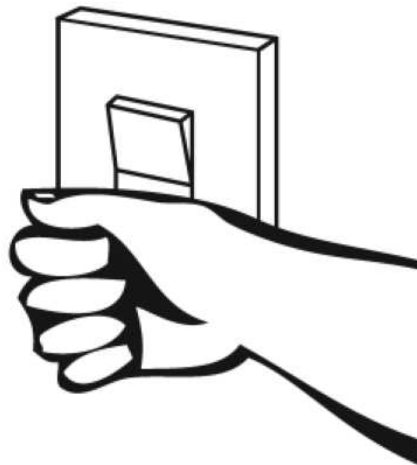
Finding: 21

The knob is not accessible because it requires tight grasping, pinching or twisting of the wrist.

knob in restroom

Replace knob with an operable part usable without a tight pinch or grasp; in the alternative, leave as is, employee use only
