# Site Accessibility Evaluation

## Walker Park

6078 Otter Creek Rd SE  
Lone Tree, IA 52755

*Inspection Date: 10/24/2018*

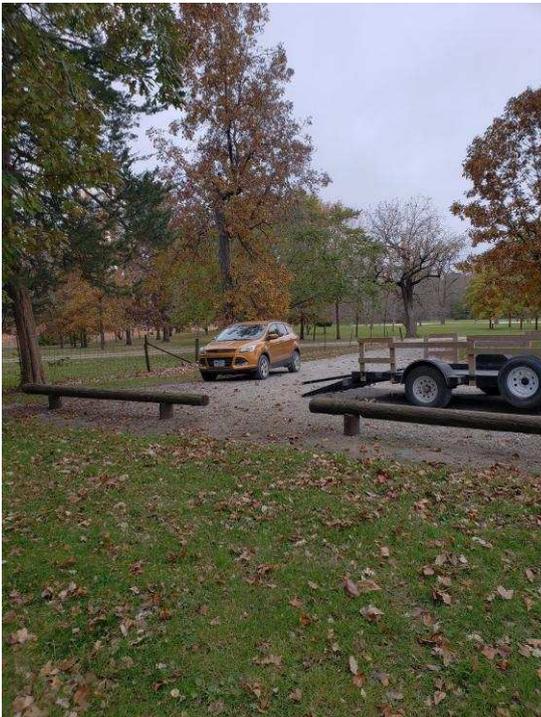
### Finding: 1

There are no accessible parking stalls.

There are a total of unknown parking stalls in the parking lot that could be reasonably associated with this facility. There should be a minimum of one accessible stall with a minimum of one being designed as van accessible.

no parking, gravel  
pull up lot

Create one or more 8' accessible parking stalls, with one 5' adjacent access aisle, with proper signage and striping based on the total number of stalls

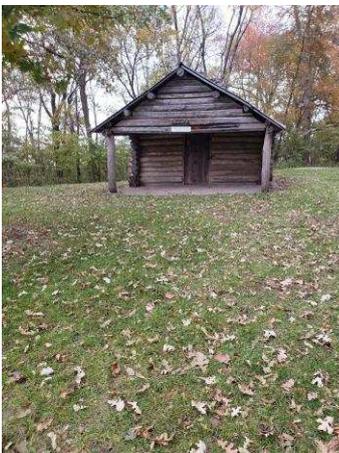
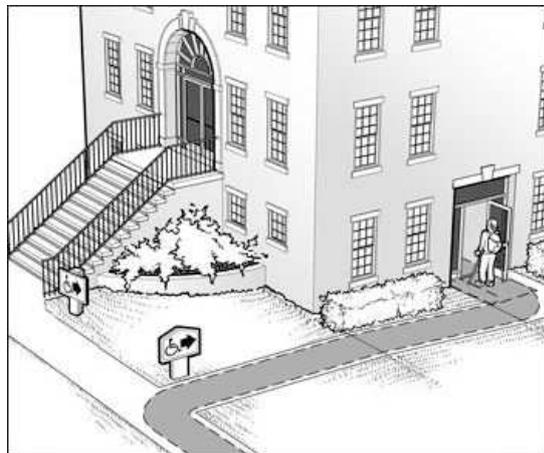
### Finding: 2

The building entrance is not located on an accessible route.

grass to cabin

Create AR with crushed and compacted stone or similar outdoor material from parking or sidewalk to building entrance

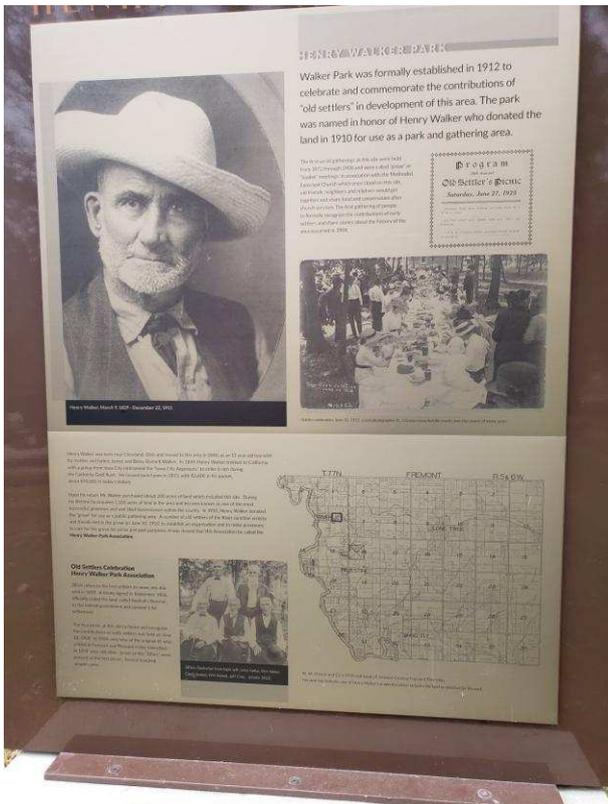
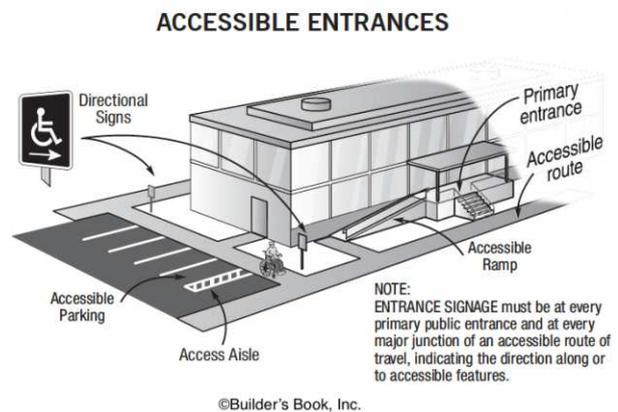
## Finding: 3

There is no accessible route to the park sign.

park sign- lacks AR,  
grass, text small in  
some spots

Create an accessible route with crushed stone or other outdoor material from parking to the sign and consider replacing with one having larger font

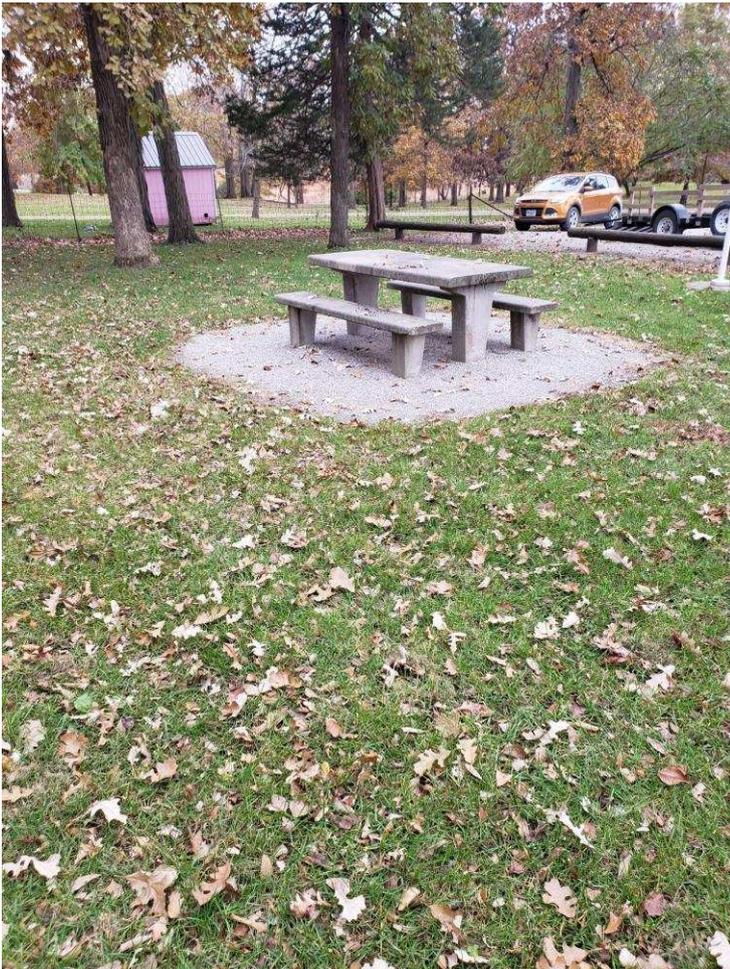
### Finding: 4

0 of 2 accessible,  
neither have route

Replace picnic table with one of an accessible design as a smart practice and place along an accessible route

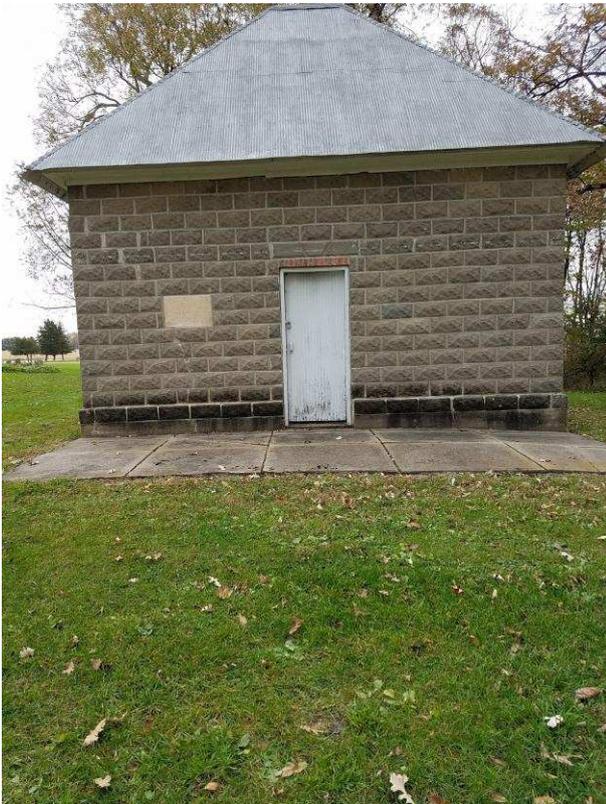
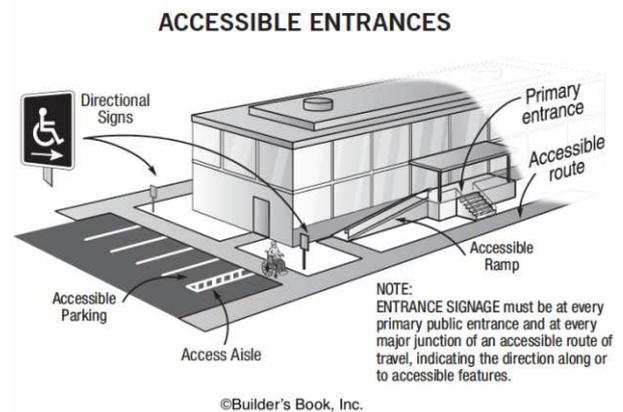
## Finding: 5

There is no accessible route to the memorial building

no route to memorial building, unable to access interior, change in level at door

Create an accessible route with crushed stone or other outdoor material from parking or walkway to memorial building

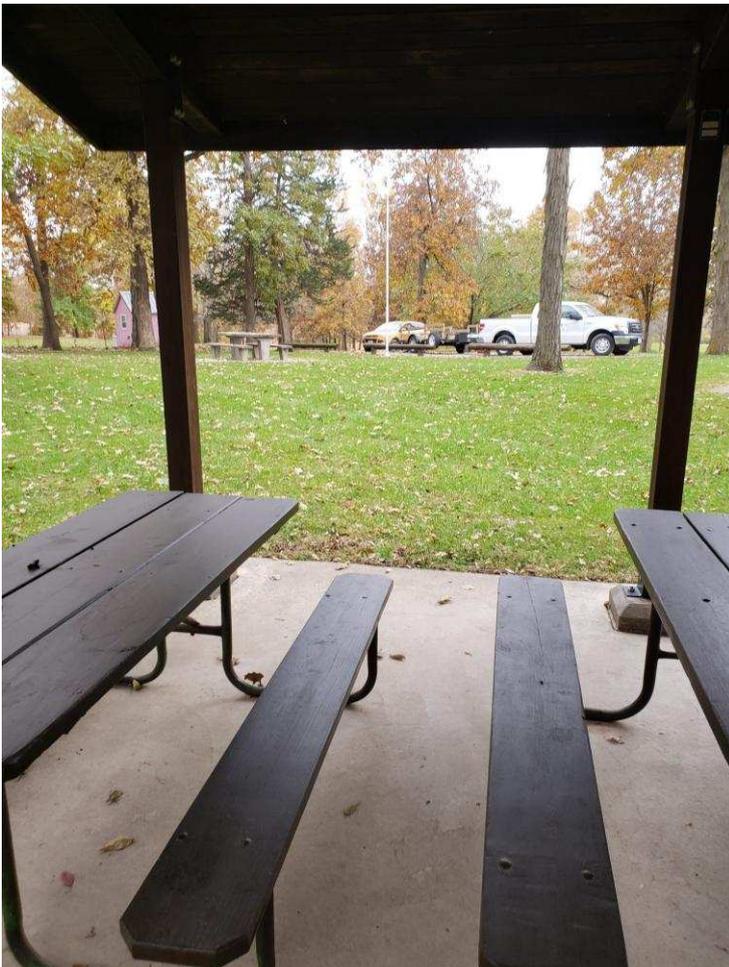
**Finding: 6**

lacks AR to shelter,  
grass

**Extend an AR to features and elements in the shelter or picnic area as a smart practice.**

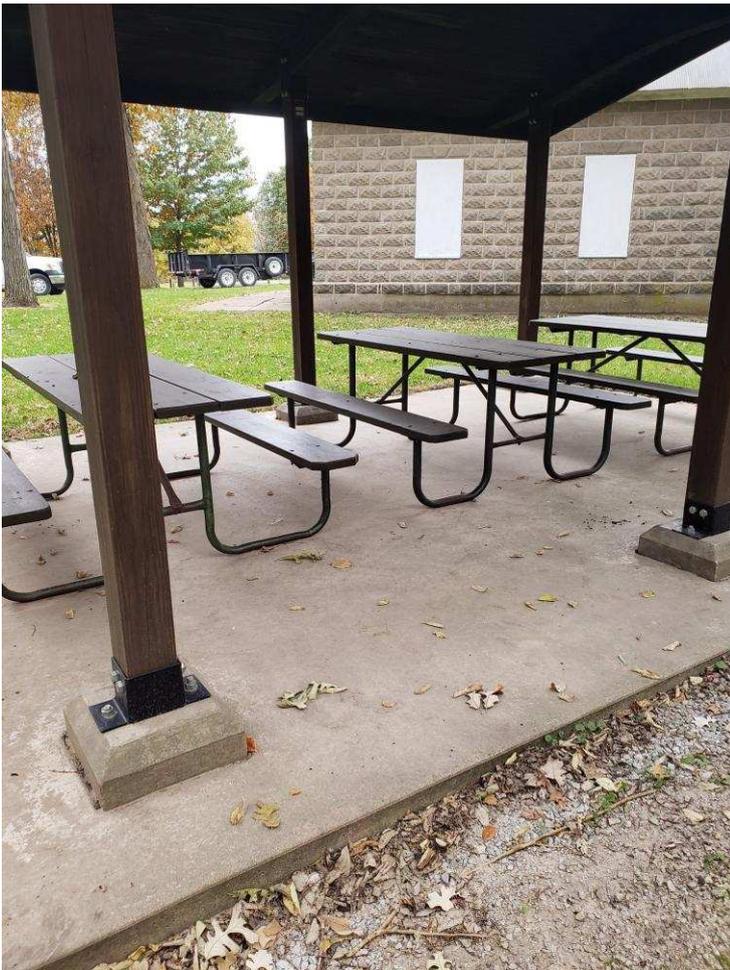
### Finding: 7

0 of 3 picnic tables  
are accessible

Replace one table with an accessible table and locate in an area providing access to the accessible end

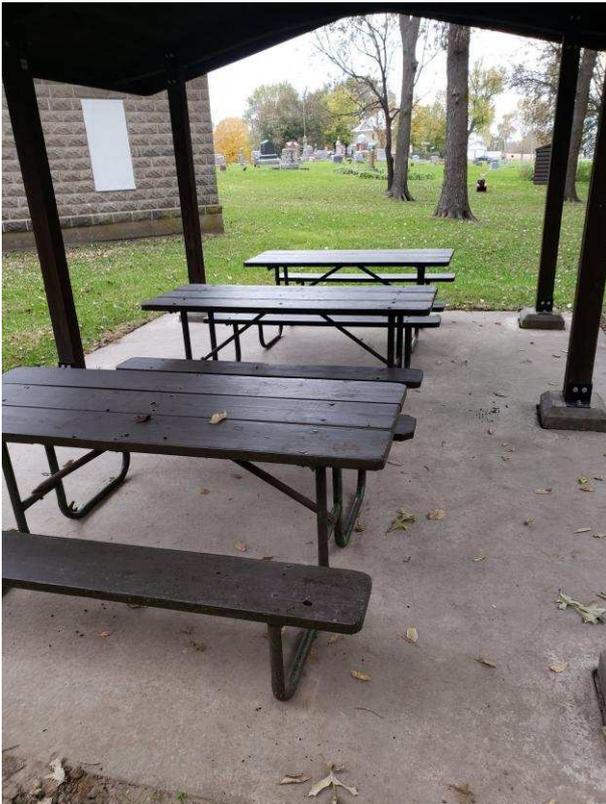
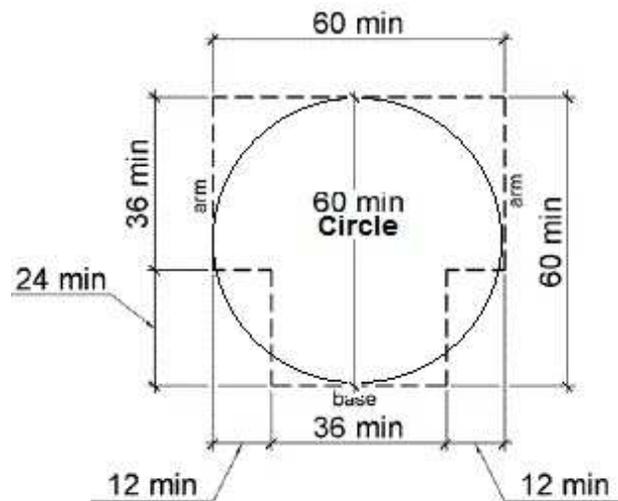
### Finding: 8

There is insufficient turning space within this room or space.

lacks turning space  
due to table  
configuration

Relocate obstacles to create turning space in shelter

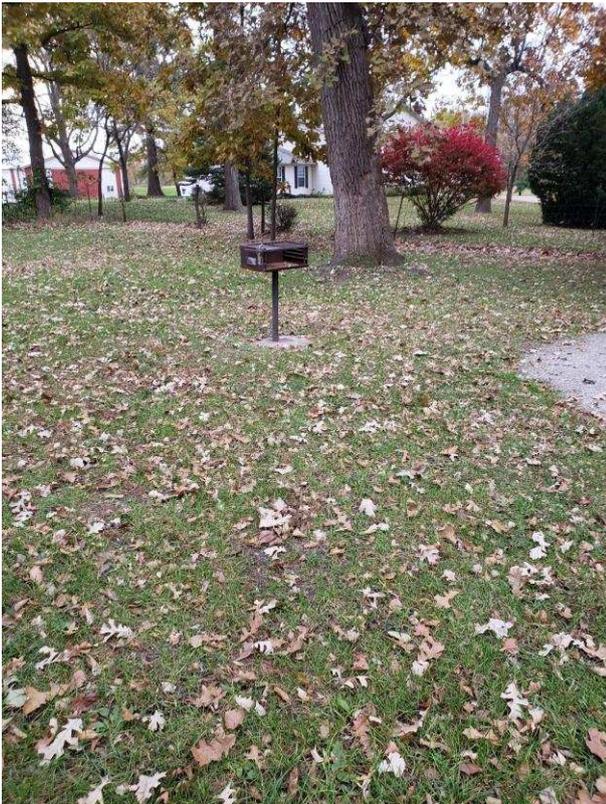
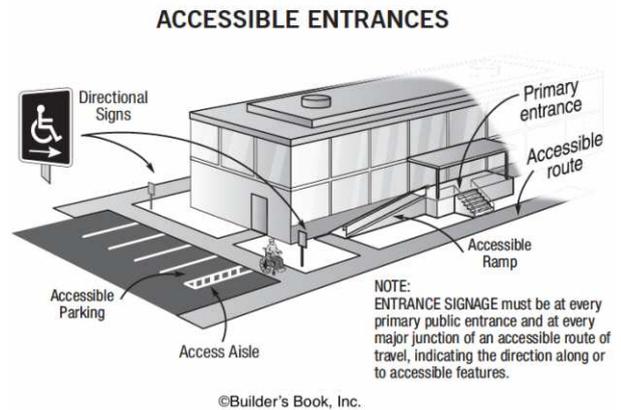
### Finding: 9

There is no accessible route to the grill..

lacks AR at grill

Create an accessible route with crushed stone or other outdoor material from parking to grill

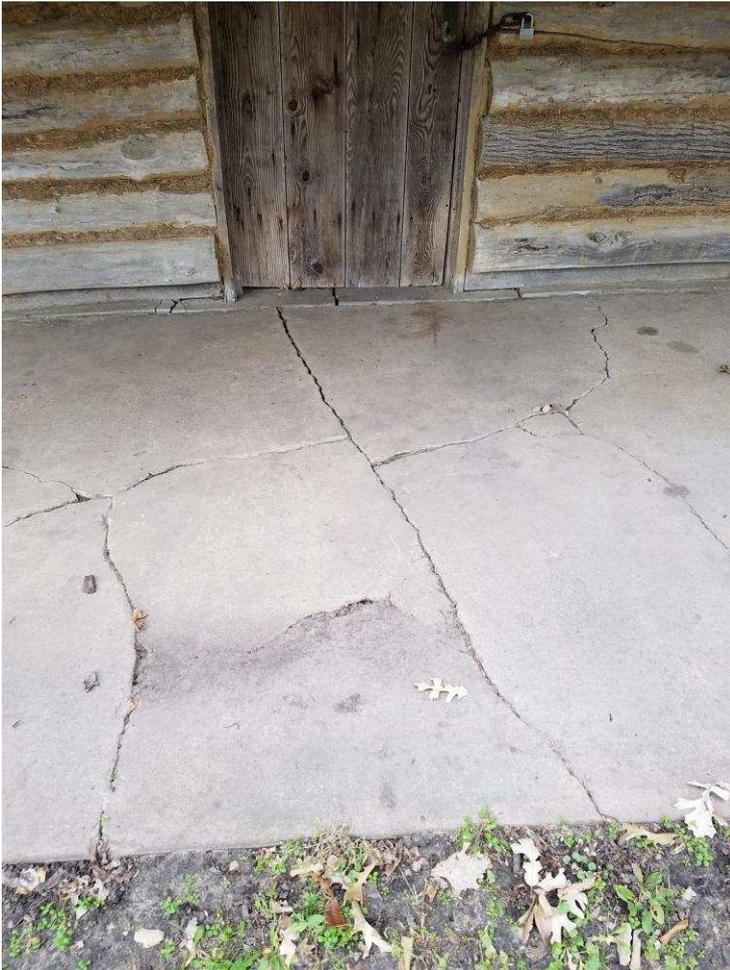
**Finding #10 Continued**

cracked cement in  
MC, no hardware,  
overhead clearance  
73"

For all doors along the public circulation route, provide required maneuvering clearance on push and pull side of doors

For all doors along the public circulation route, replace doors with doors having 80" overhead clearance and 32" clear width

Replace hardware with lever hardware or hardware operable without a tight pinch or grasp

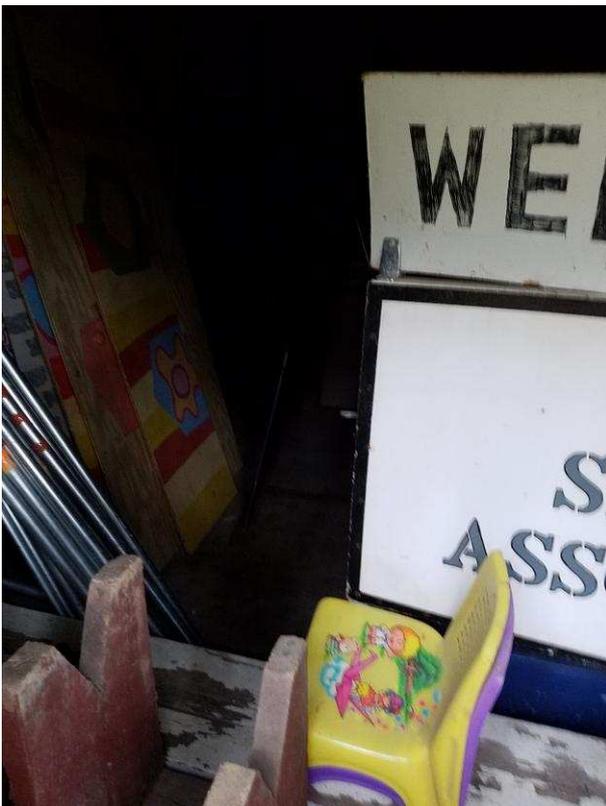
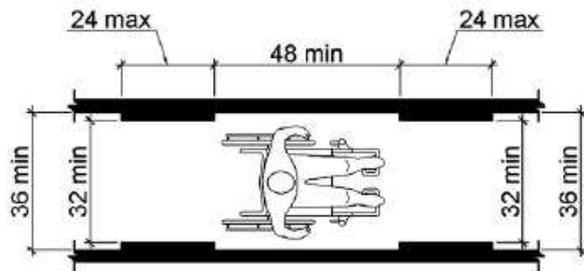
### Finding: 11

The route of travel at this location does not provide a minimum width of 36 inches.

interior full of storage

Widen AR to compliant 36" clear width by removing or relocating storage

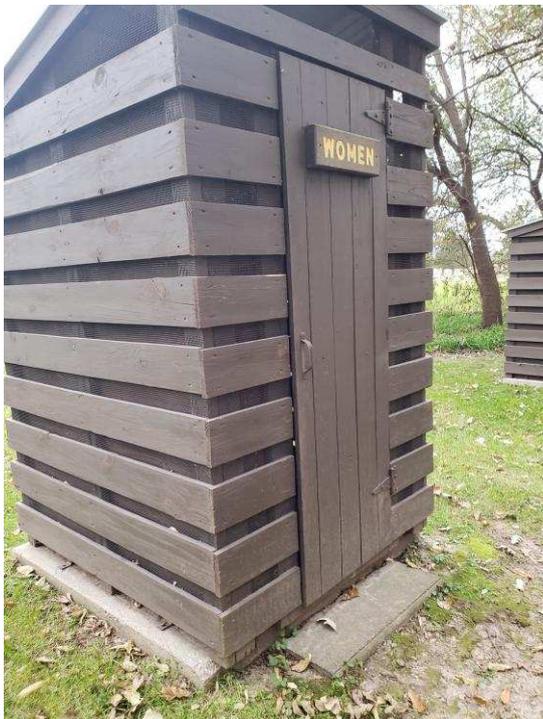
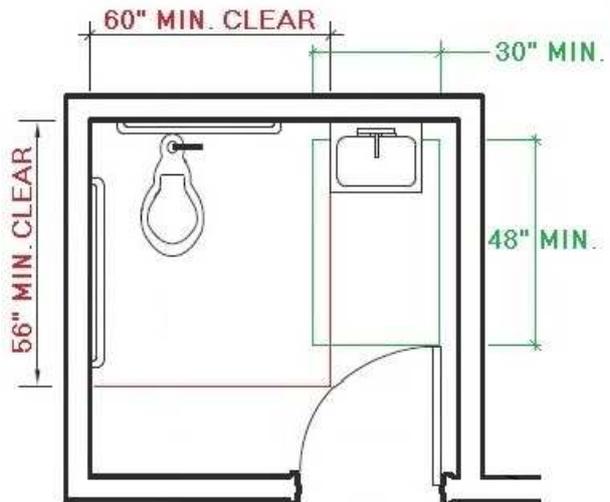
### Finding: 12

The restroom is not nearly compliant.

The restroom does not have the required minimum clear floor space or maneuvering clearances for the toilet, The restroom does not have the required minimum clear floor space or maneuvering clearances for the lavatory, The entry door does not contain the required minimum maneuvering spaces on the pull/push sides, The entry door encroach into the required clear floor space for fixtures, Grab bars are missing and/or incorrectly installed, Accessories, such as toilet seat covers, paper towel holders, garbage cans, hand dryers, and mirrors are either too high or without clear floor space or both, The restroom contain floor level changes greater than a 1/2 inch of the floor drains and is slope (XX) - (XX), the shower is too small and missing numerous accessible elements.

lacks accessible  
restrooms, 1 men and  
2 women

Create a compliant wheelchair accessible restroom and correct all features to be accessible

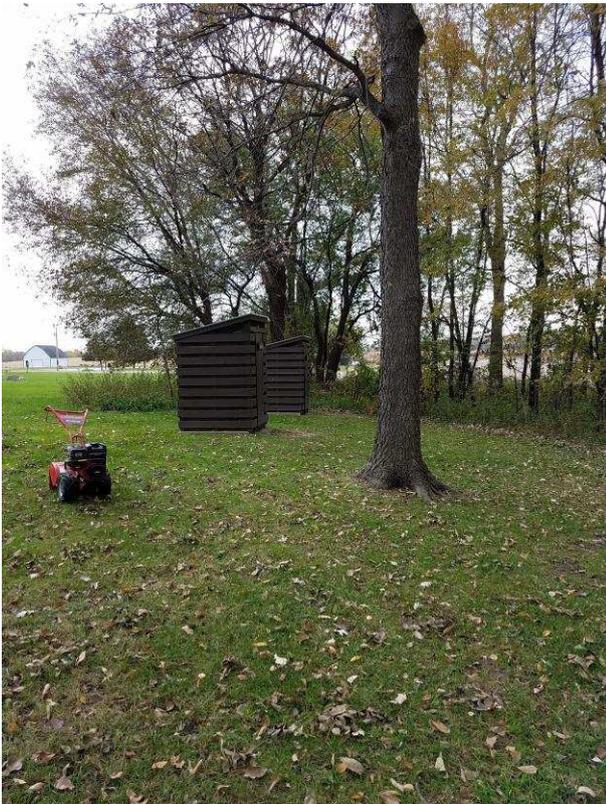
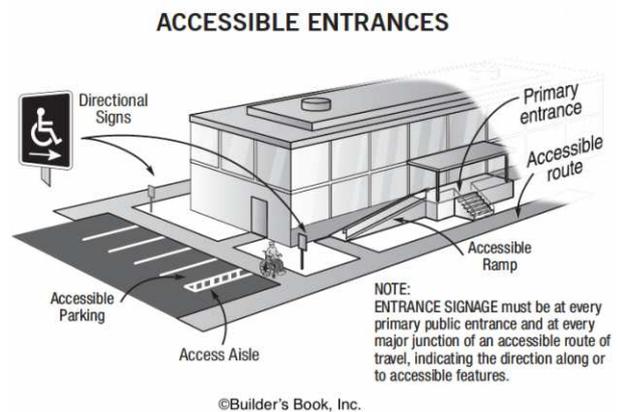
### Finding: 13

There is no accessible route to the restrooms.

lacks route

Create an accessible route with crushed stone or other outdoor material from parking or walkway to restrooms
