# Site Accessibility Evaluation

## Shueyville Shed

3341 120th St NE  
Solon, IA 52333

*Inspection Date: 04/24/2019*  
*Inspector: Shelley Zuniga*

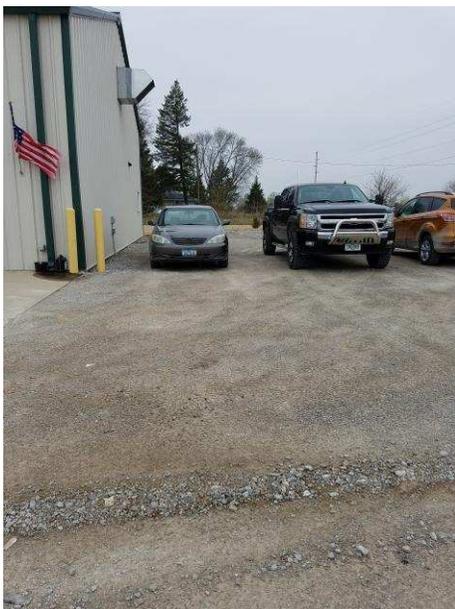
### Finding: 1

There are no accessible parking stalls.

There are an unknown number of parking stalls in the parking lot that could be reasonably associated with this facility. There should be a minimum of one accessible stall with a minimum of one being designed as van accessible.

parking lot lacks designated stalls

Create one or more 8' accessible parking stalls, with one 5' adjacent access aisle, with proper signage and striping based on the total number of stalls

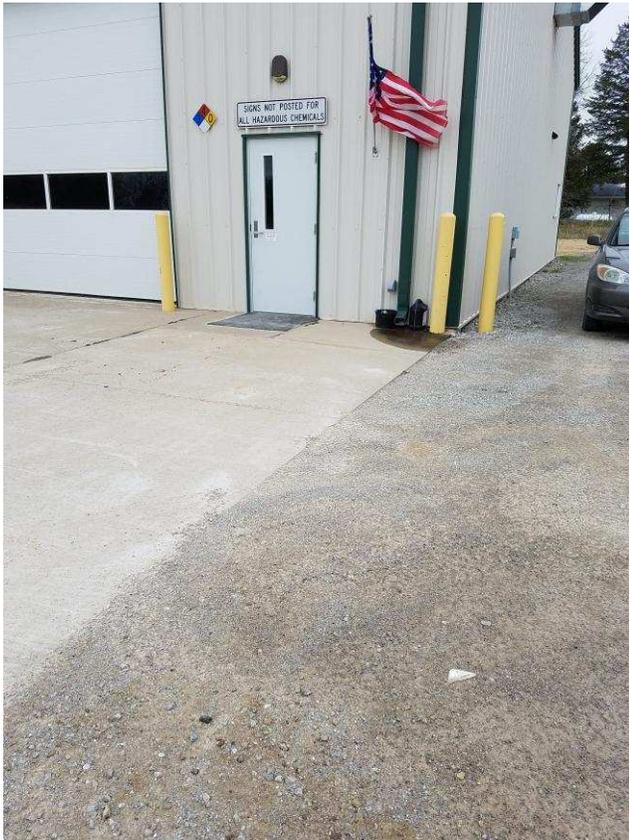
### Finding: 2

The accessible route contains loose gravel and/or surfaces that do not provide for a stable, firm slip resistant surface.

EAR would comply if parked next to a cement pad

Resurface AR where deterioration occurs, assure new accessible parking is adjacent to existing cement pad for access to entry

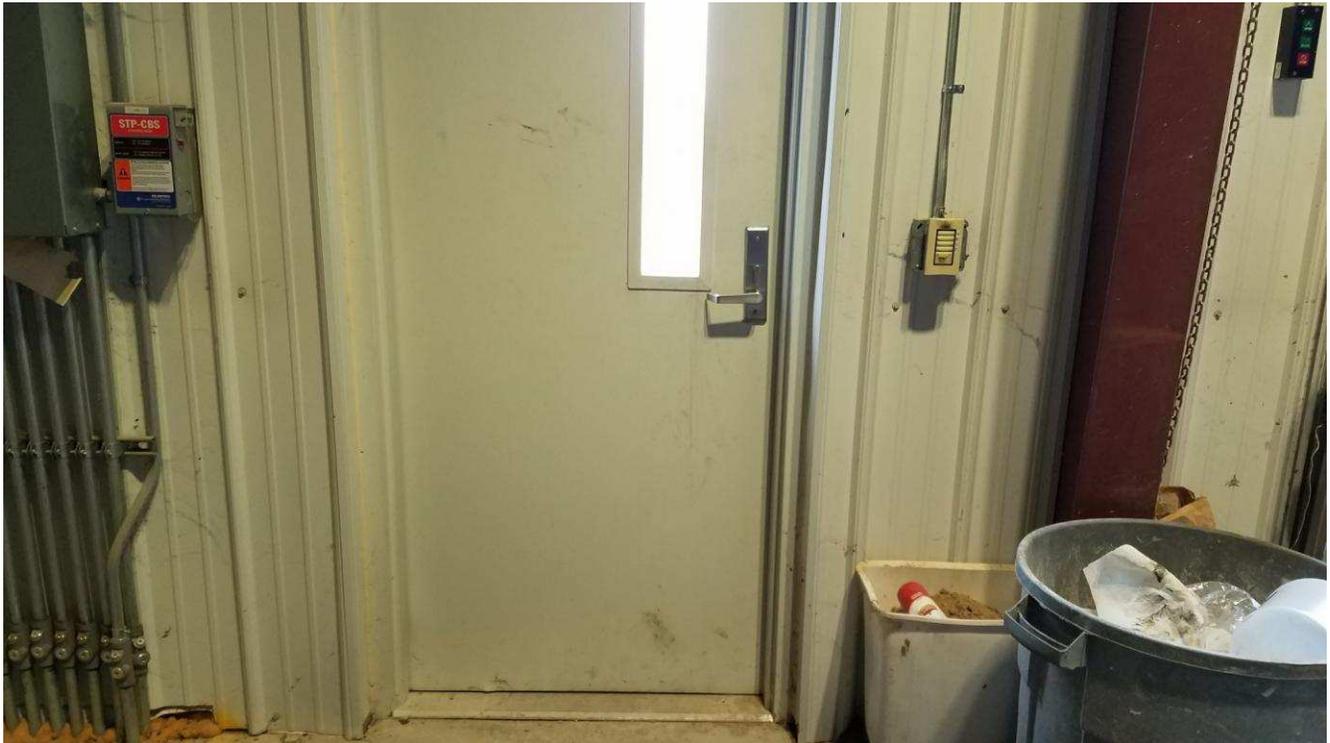
### Finding: 3

The door is equipped with a door closer and returns to a closed position too quickly.

entry- closes fast

Inspect, adjust, and maintain closing speed on door closers

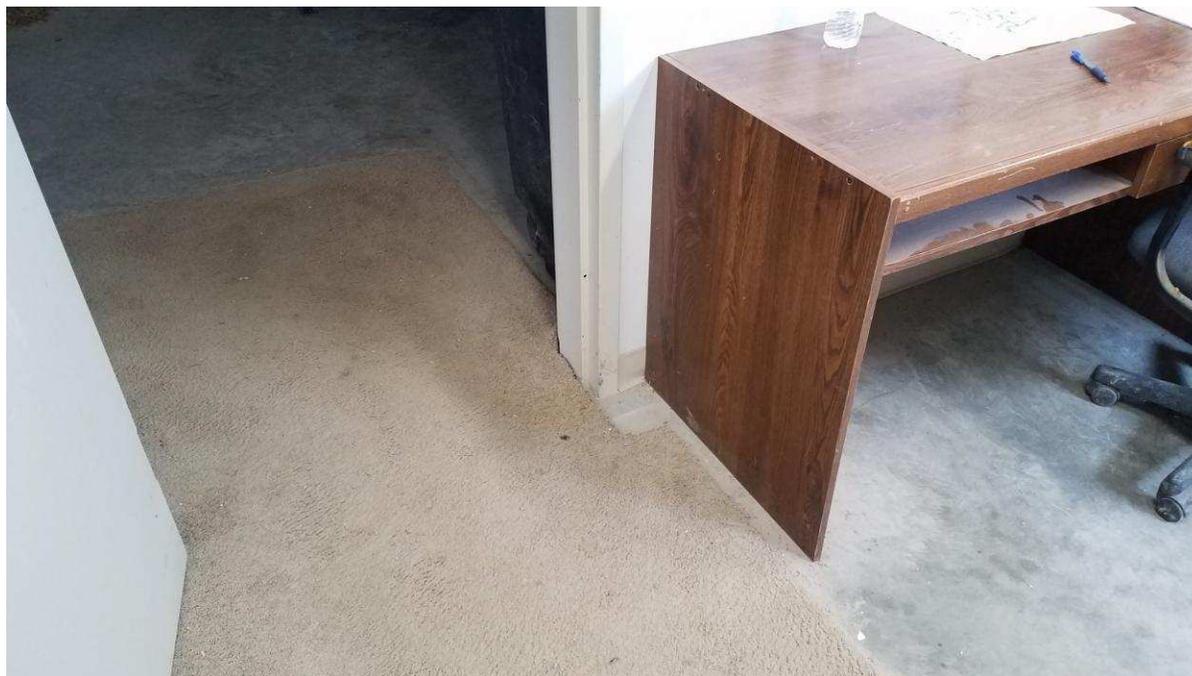
### Finding: 4

The maneuvering space on the pull side of the door does not adequately extend beyond the latch side of the door.

office- desk pull side

For all doors along the public circulation route, relocate storage, furniture, and other obstacles to create 60" maneuvering space around doors

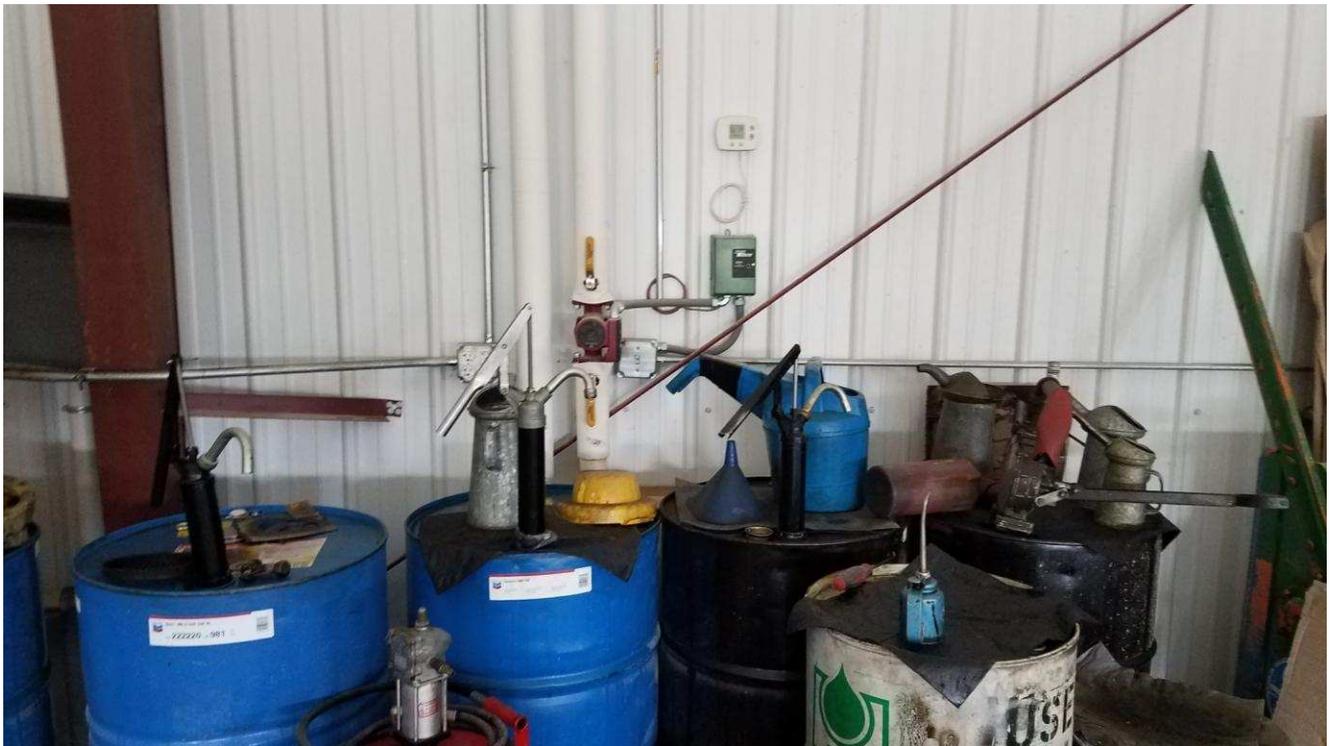
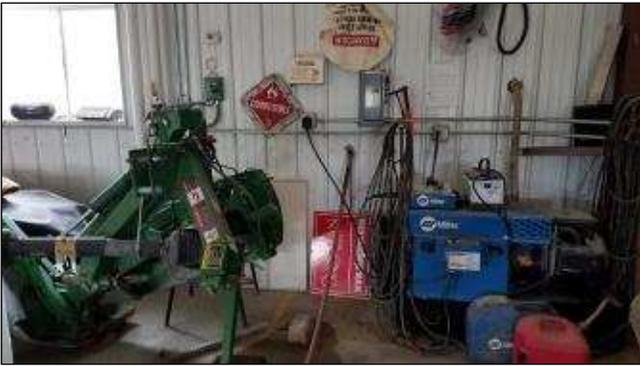
### Finding: 5

The operable part is not accessible because there is not adequate clear floor space for either a forward or side approach.

shop- thermostat,  
lockout tag box

For deficit, leave as is, employee work area pursuant to 2010 Standards 106.5 Defined Terms, until an employee with a disability works here

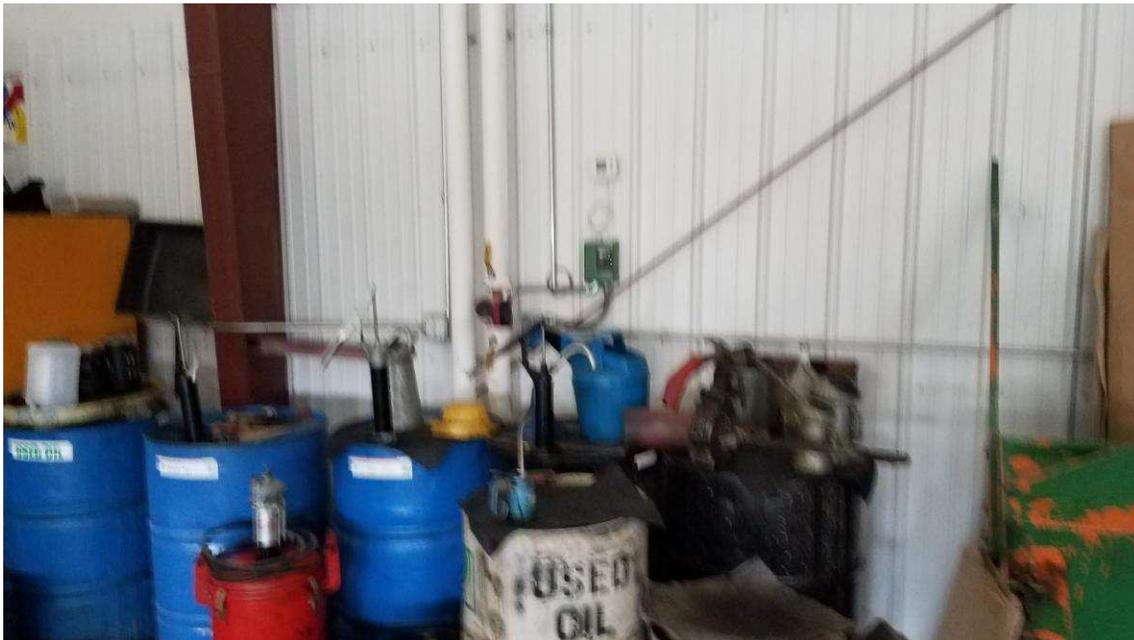
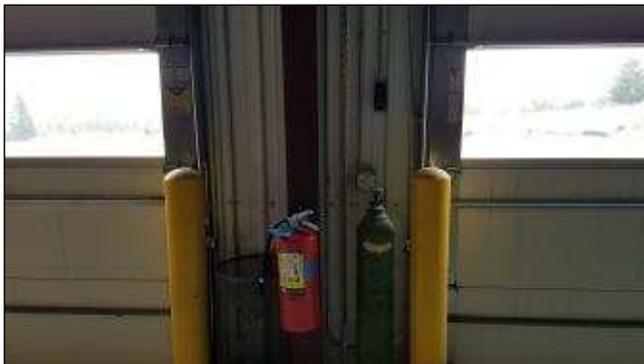
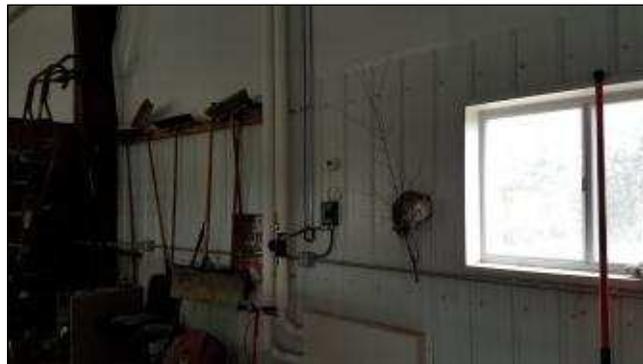
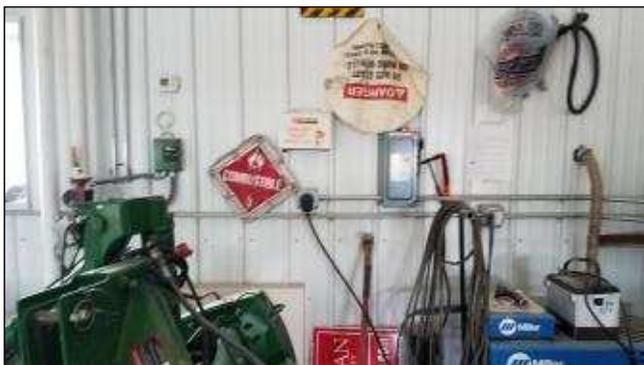
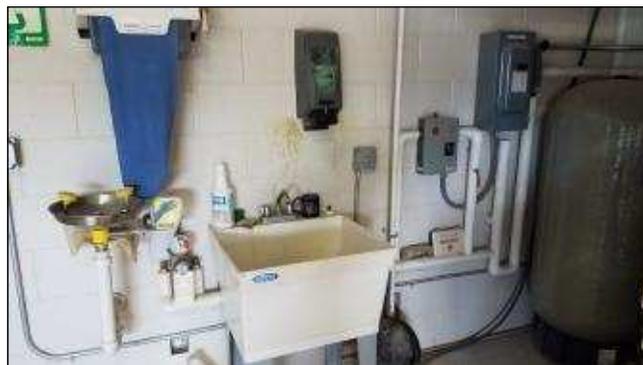
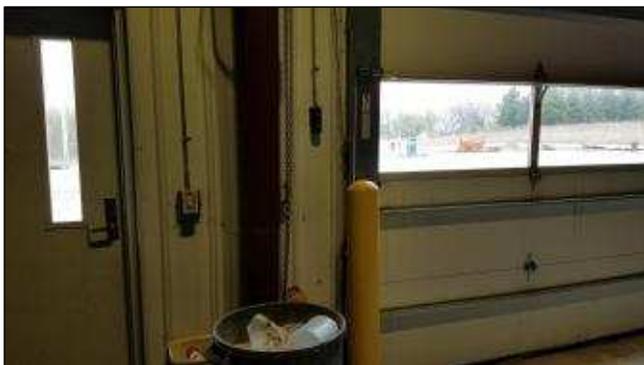
### Finding: 6

The thermostat and door controls are positioned too high for either a side or front approach.

shop- thermostat,  
overhead door  
controls, lockout tag  
box, soap at sink

For deficit, leave as is, employee work area pursuant to 2010 Standards 106.5 Defined Terms, until an employee with a disability works here

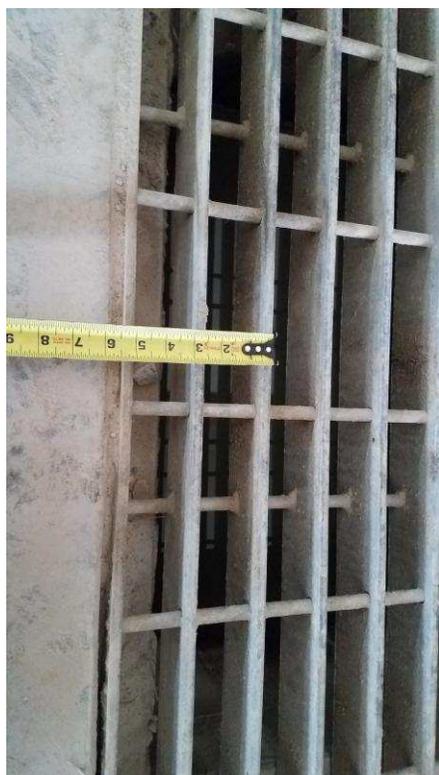
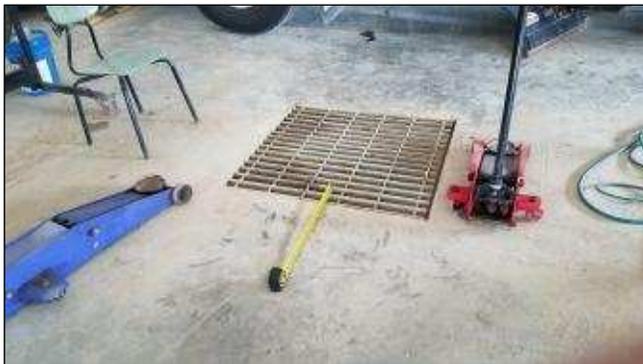
### Finding: 7

Gratings are spaced greater than a 1/2 inches in the direction of traffic flow.

shop- 1.5" grates

Leave as is, grating, integral to the use of the site.

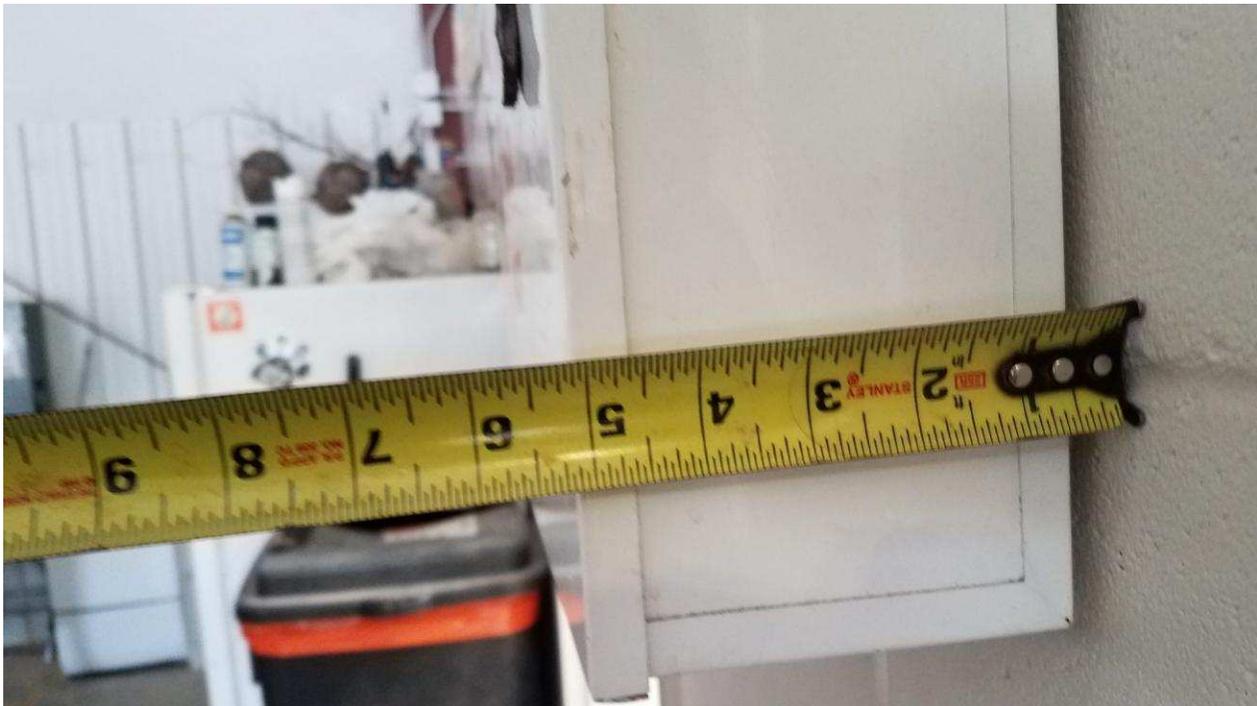
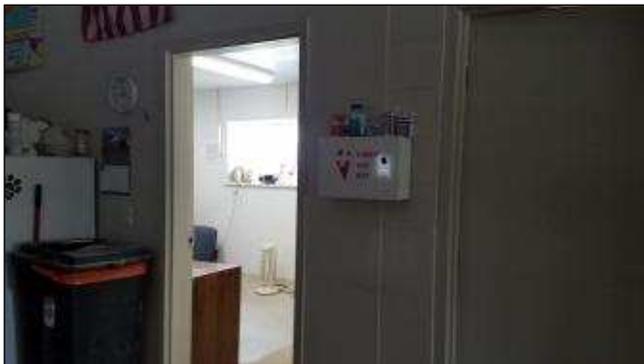
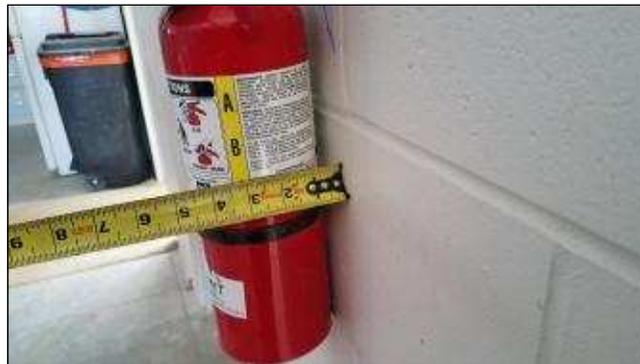
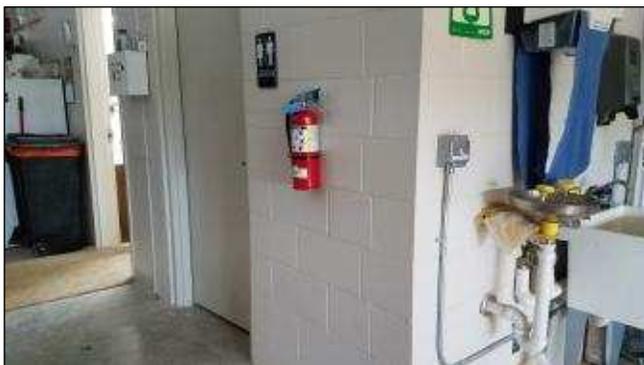
### Finding: 8

The first aid and fire ext. project more than 4 inches into the circulation path.

shop- first aid 5", fire  
extinguisher 4.5"

For deficit, leave as is, employee work area pursuant to 2010 Standards 106.5 Defined Terms, until an employee with a disability works here

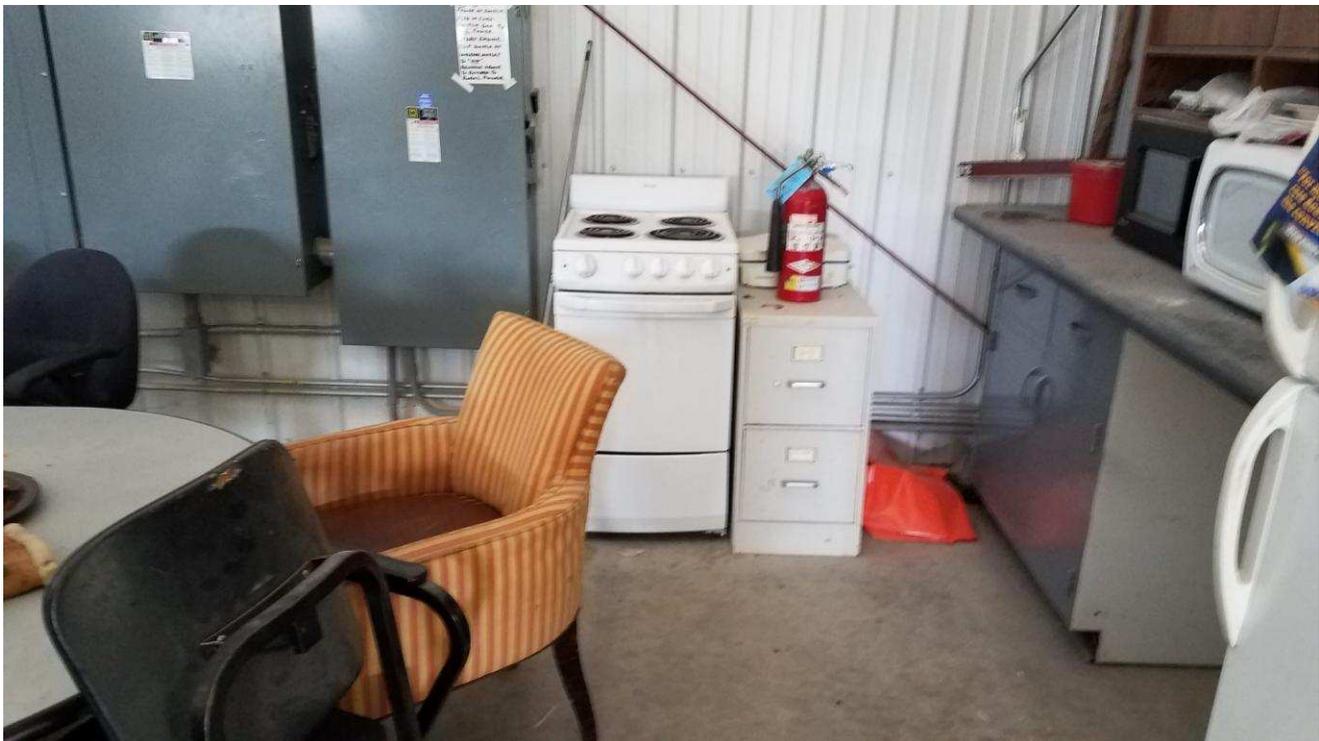
### Finding: 9

Clear floor space is not provided at the range or cooktop

shop- chair at oven in break area

Relocate chair for CFS at oven

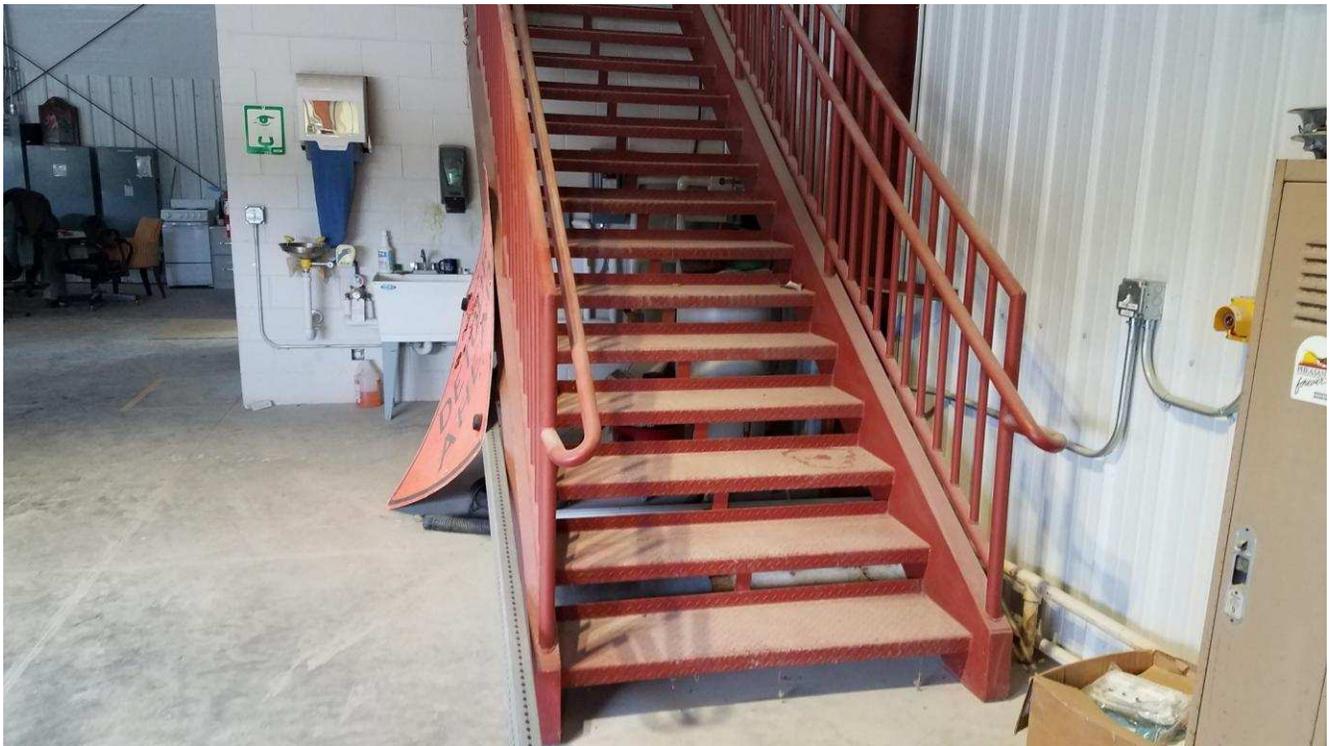
### Finding: 10

There is a change in level greater than 1/4 inch.

stairs to  
loft/mezzanine

Stairs only to upper level storage, leave as is, employee area only; reassign duties if an employee with a disability requires access here

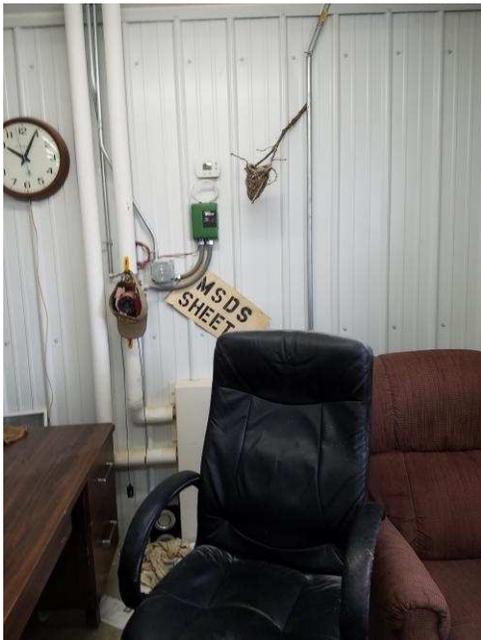
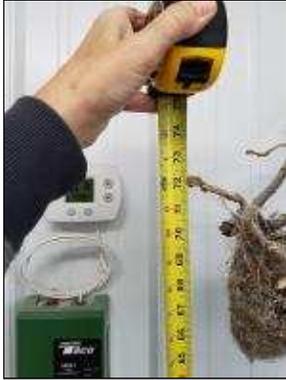
### Finding: 11

The thermostat is positioned too high for either a side or front approach.

office - thermostat too high and lacks clear floor space, lights lack clear floor space

For deficit, leave as is, employee work area pursuant to 2010 Standards 106.5 Defined Terms, until an employee with a disability works here

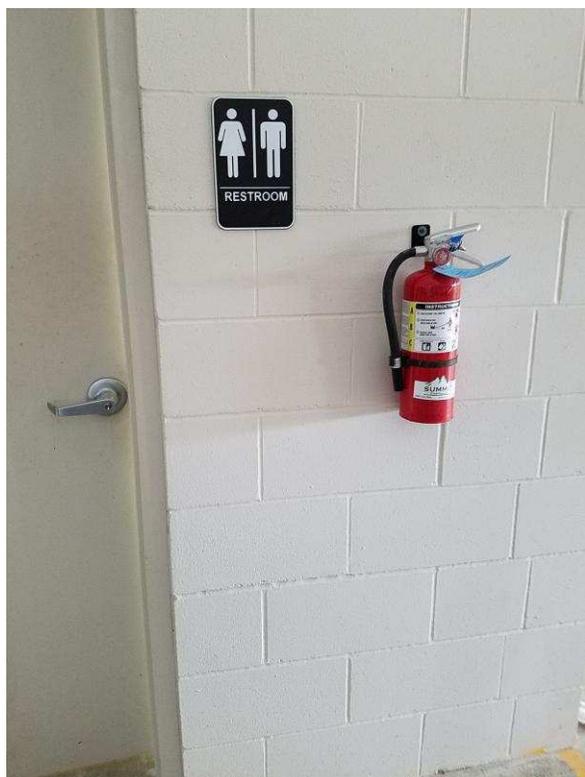
### Finding: 14

The tactile sign is incorrectly located.

restroom lacks symbol  
of access

Mount signage at all permanent rooms/spaces having Braille and the international symbol of accessibility, mounted 48" to baseline of lowest character and 60" to the baseline of the highest character sign and on the latch side of the door

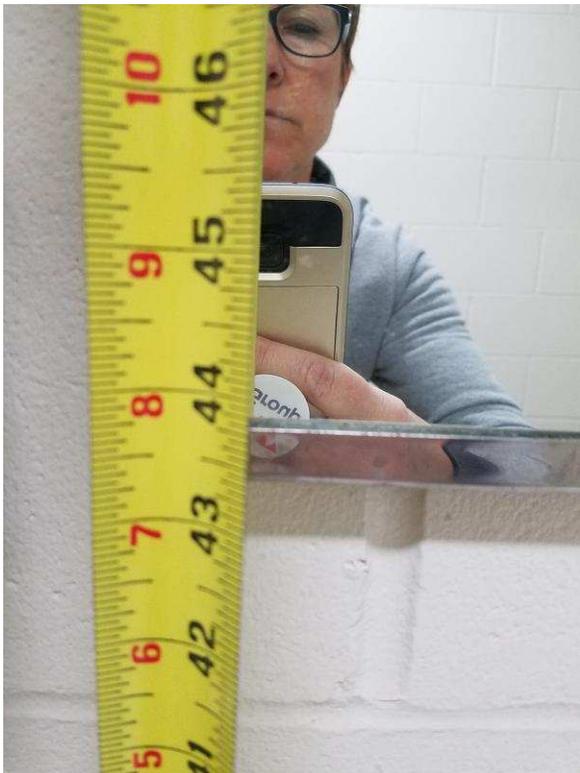
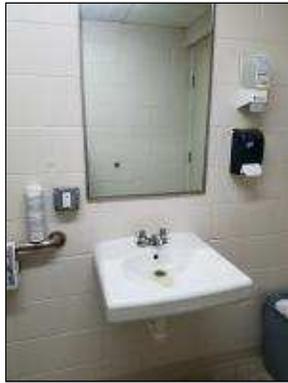
### Finding: 15

The mirror is mounted too high.

mirror 43.75"

Lower mirror so reflective surface is max 40" aff

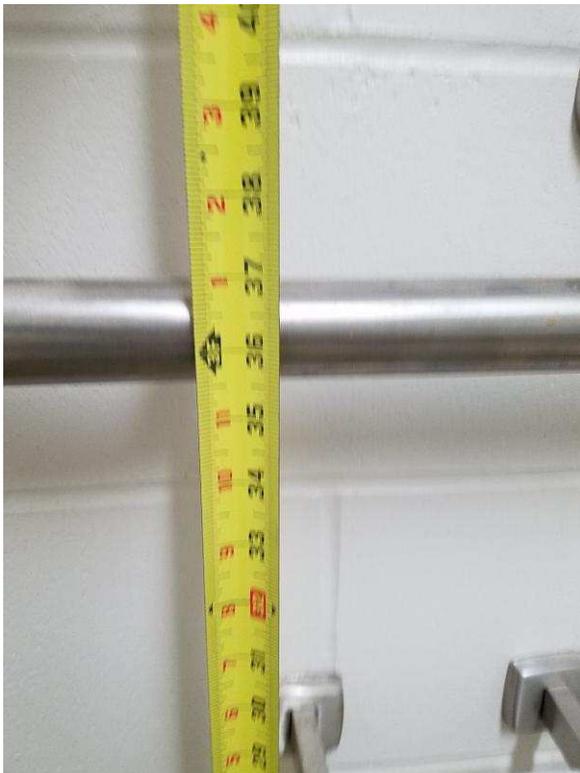
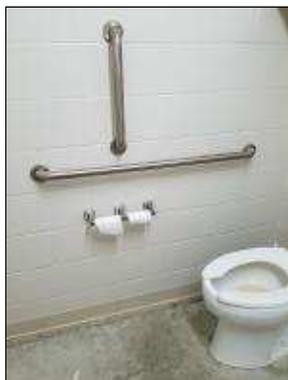
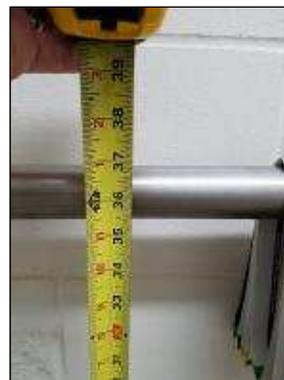
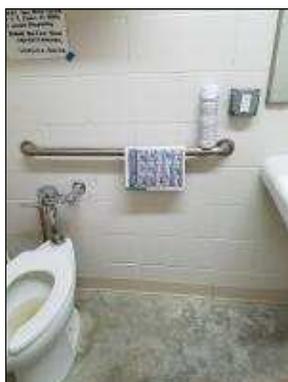
### Finding: 16

The grab bar mounting height fails.

grab bars 37" aff

Remount grab bars in to 33" to 36" aff

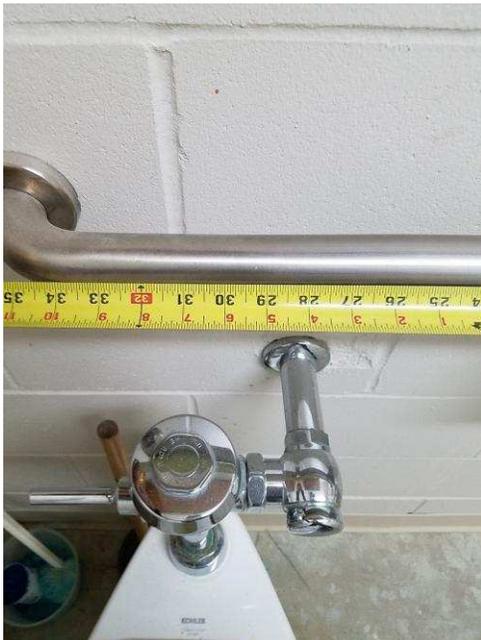
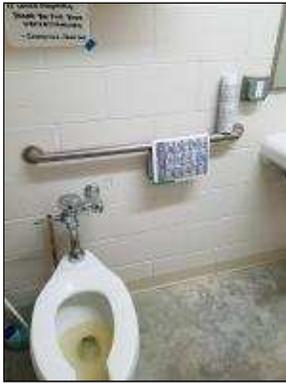
### Finding: 17

The rear grab bar does not extend adequately past the toilet on the wide side.

36 inch grab bar  
extends 31 in on open  
side

Remount rear grab bar to behind the toilet, 12" to one side of center and 24" to the other and 33" to 36" off

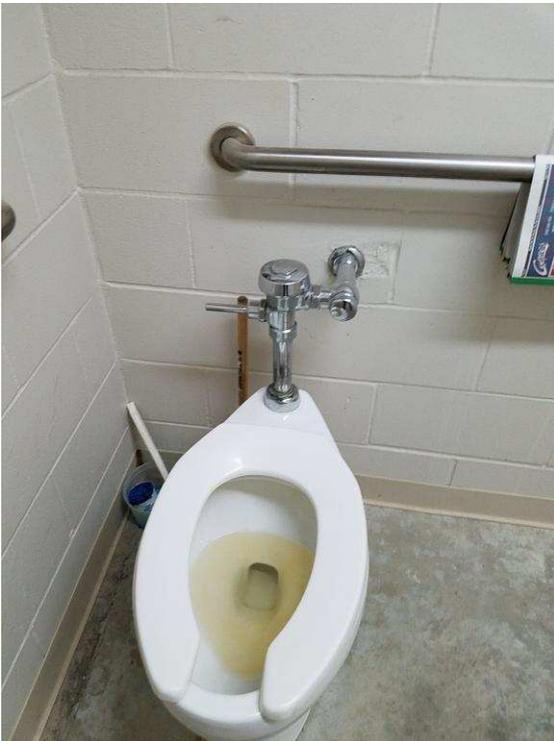
### Finding: 18

The flush handle is located on the wrong side of the toilet.

flush on close side

Replace toilet tank with one having flush mechanism on the open side, in the alternative, install an auto flush unit

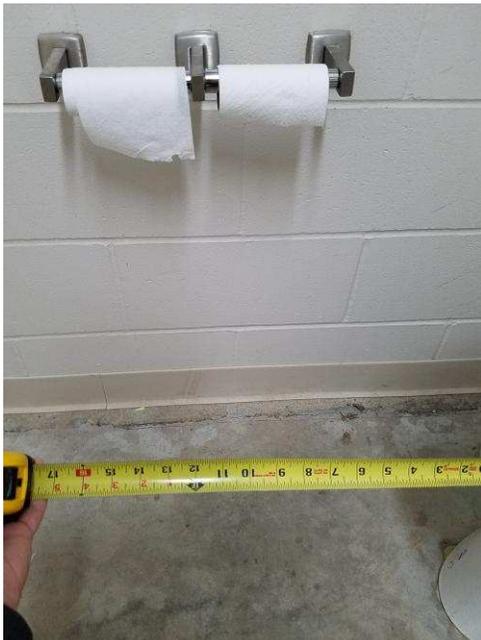
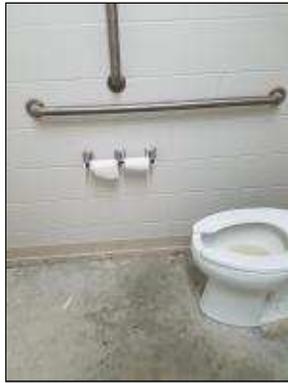
### Finding: 19

The toilet paper is not installed within the compliant range in front of the toilet.

toilet paper 11 in to center of dispenser

Remount toilet paper dispenser to 7 inches minimum and 9 inches maximum in front of the water closet measured to the centerline of the dispenser. The outlet of the dispenser shall be 15 inches minimum and 48 inches maximum above the finish floor

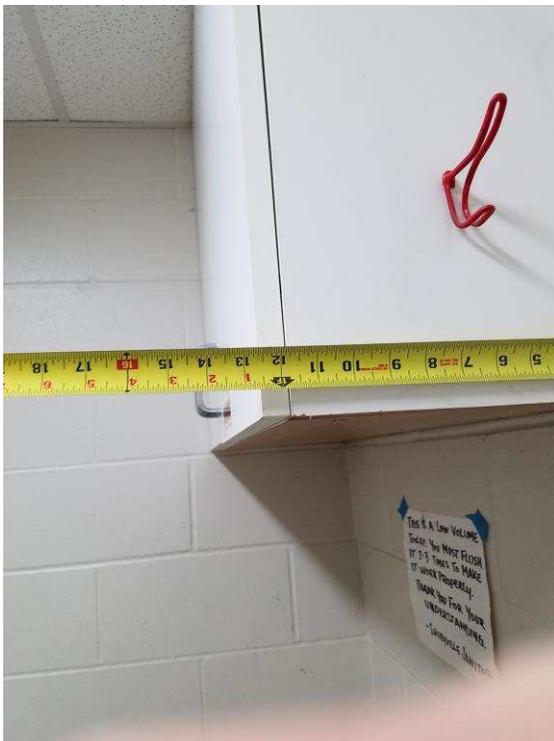
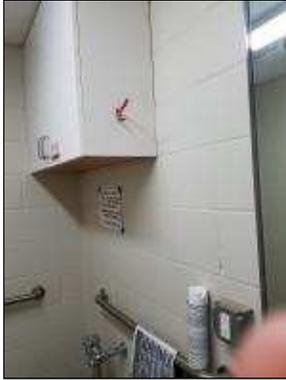
### Finding: 20

The cabinet projects more than 4 inches into the circulation path.

cabinet protrudes over  
toilet 12.5"

Relocate protruding objects or place cane detectable warning or bollard at foot of item

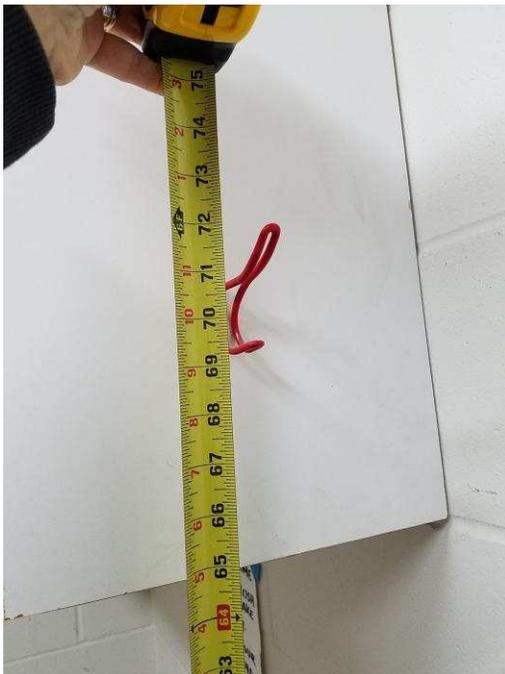
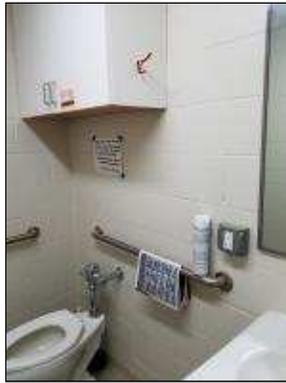
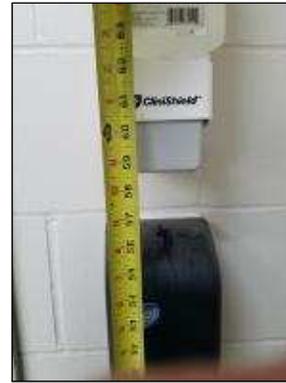
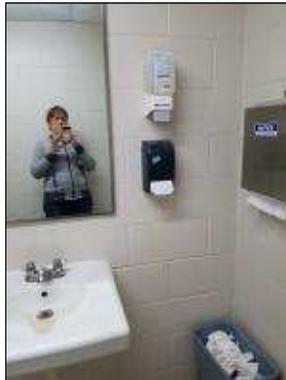
### Finding: 21

The hook and disinfectant is positioned too high for either a side or front approach.

reach range to hook  
69.5", disinfectant  
58.5"

Remount operable parts to be in reach range of 15" min to 48" max
