SHERIFF'S HQ/JAIL

STRUCTURAL CONDITION ASSESSMENT
511 South Capitol Street

April 28th, 2023

PREPARED FOR:
Brad Kunkel – Johnson County Sheriff

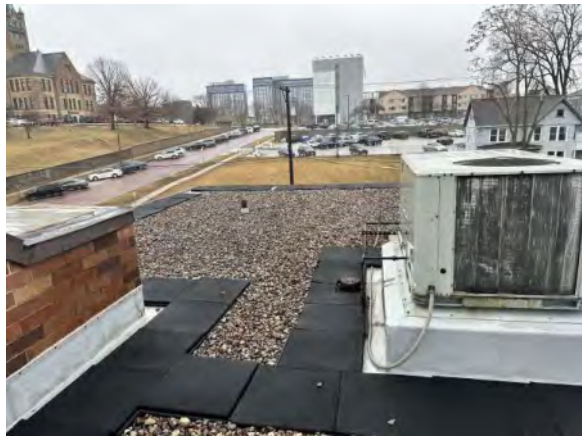
Ballasted membrane roof system – NE corner of building. Walkway pads present in foreground. Entire roof experiences multiple leaks in various locations due to age.
2	ARCH

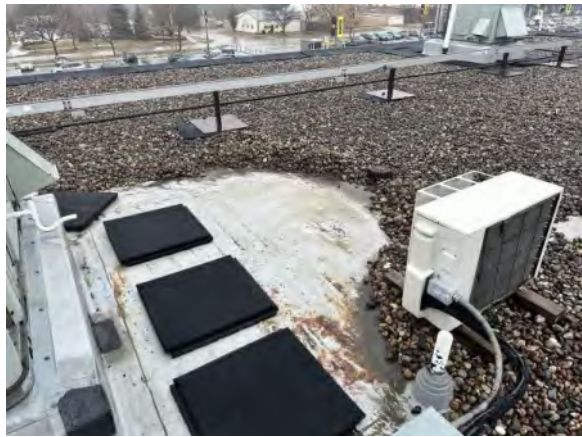
Exposed section of membrane roof near the center section of the building. Roof drain appears functional. Pads placed for access to mechanical RTU. Entire roof experiences multiple leaks in various locations due to age.
3	STR

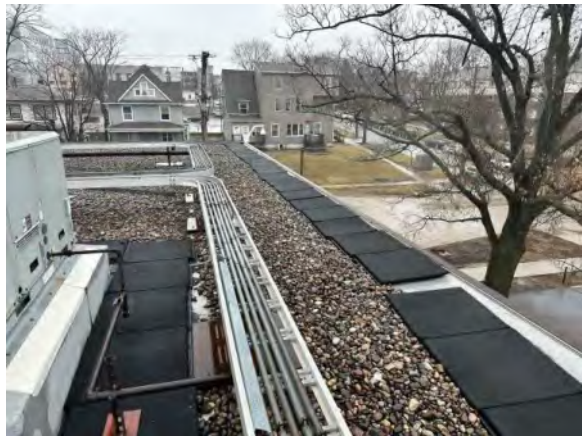
South edge of the roof. This area should be monitored periodically based on findings/issues on the second level exterior. (All exterior roof areas should.)

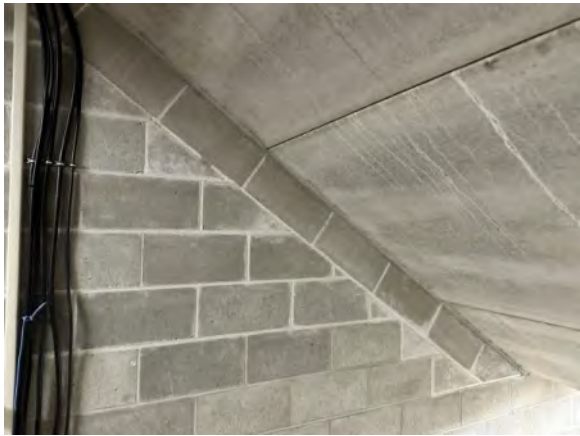
Hollow-core precast ceiling in the North Stairwell (top) showing signs of pull-out in the precast joint as well as potential moisture infiltration. Monitor for worsening condition(s.)
3	STR

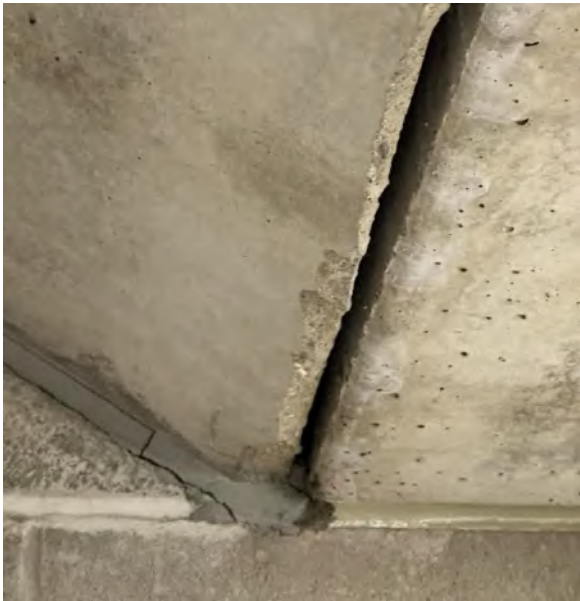
Close-up of a hollow-core precast ceiling joint in the North Stairwell (top) showing significant signs of pull-out in the precast joint. Monitor for worsening condition(s.)

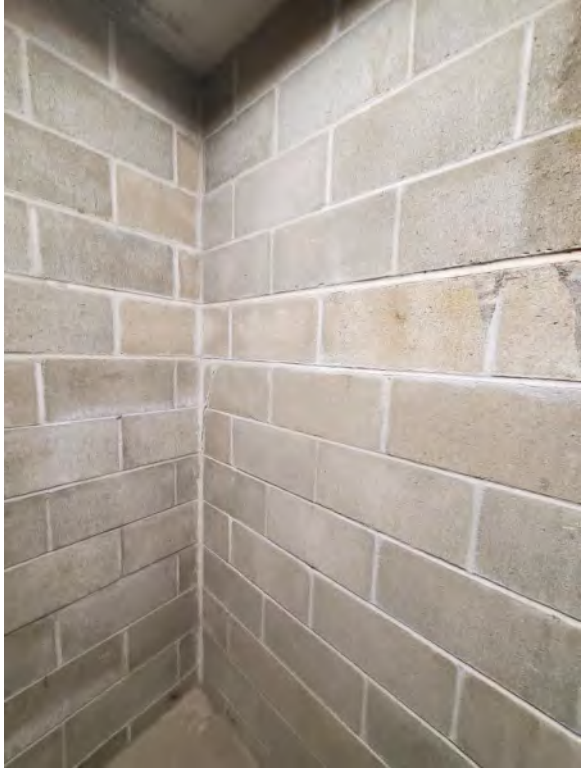
<p>Corner crack and spall in CMU corner within the North stairwell indicating additional stress/shifting. Monitor for worsening condition(s.)</p>
6	ARCH	 	<p>Exterior doorway threshold and jamb bases on the North edge of the building. Showing extreme water/salt damage and fatigue. Door assembly should be replaced when feasible.</p>

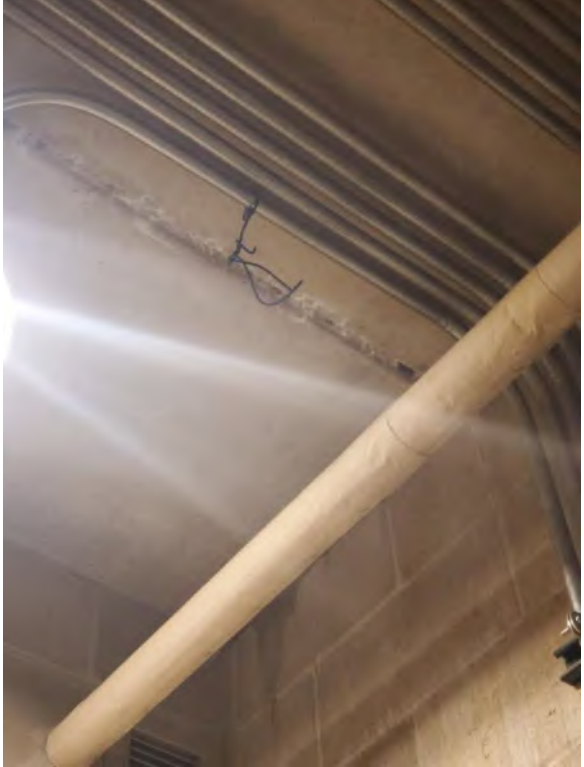
<p>Hollow-core ground level ceiling joint in maintenance area showing signs of moisture infiltration and efflorescence. Monitor situation for recurrence/worsening.</p>
11	STR

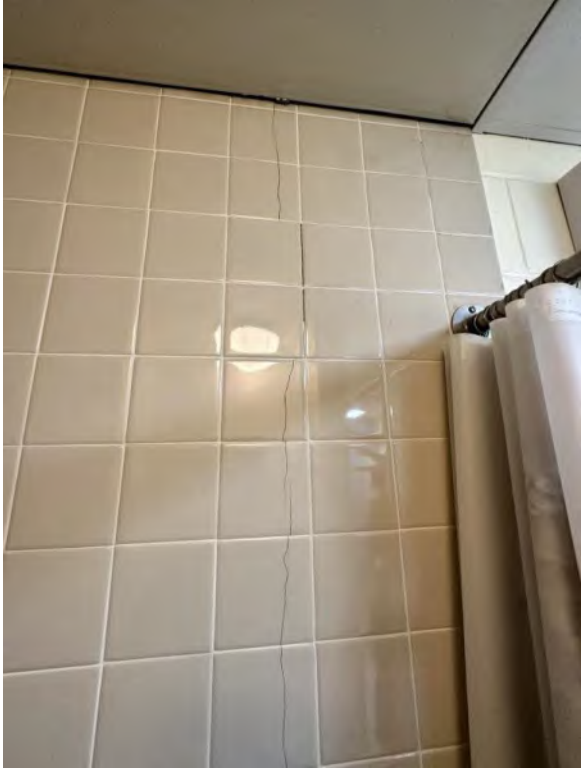
<p>Main level locker room. There are, however, some indications through the tile (reflective cracking) of structural movement behind the tile. The fact that the cracks are breaking through the tile itself and not along a joint indicate the issue is likely not simple building movement. This tile should be repaired when feasible and an examination made of the CMU behind it.</p>

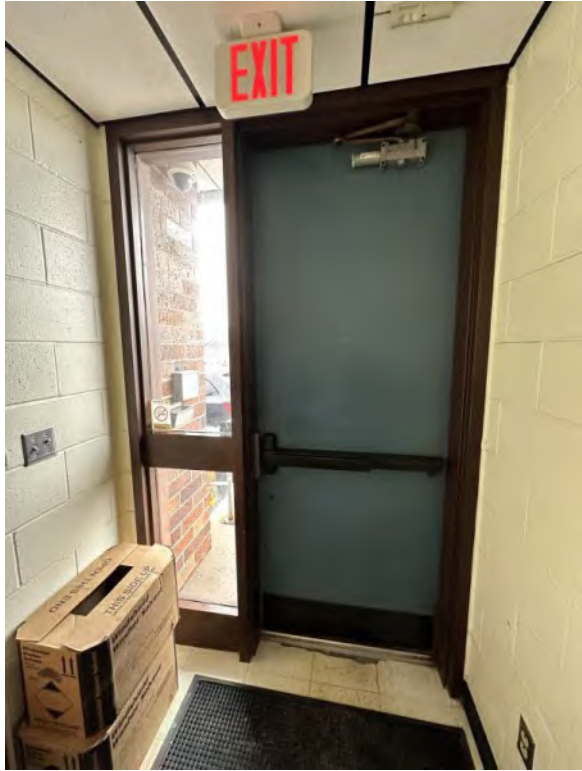
<p>Exterior door assembly and side light on the South side of the building. Showing extreme water/salt damage and fatigue. Door assembly should be replaced when feasible.</p>
19	STR

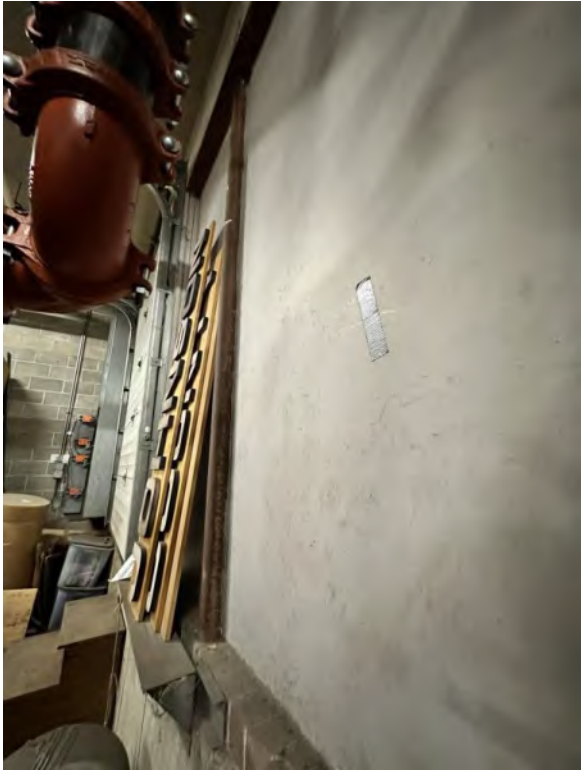
<p>Lally column in the sub-basement mechanical room. Column is showing signs of distress and should be replaced when feasible.</p>
22	STR

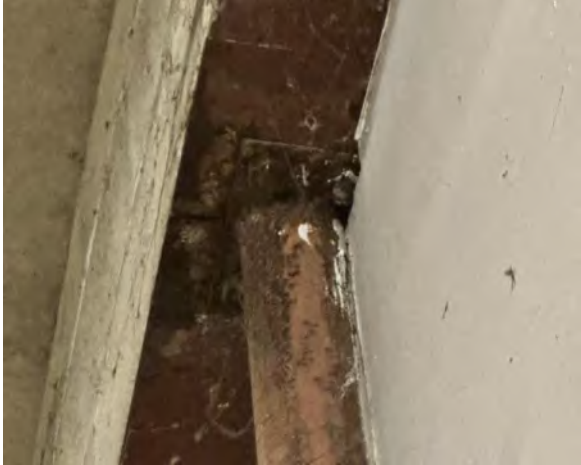
<p>Close-up of lally column fatigue.</p>

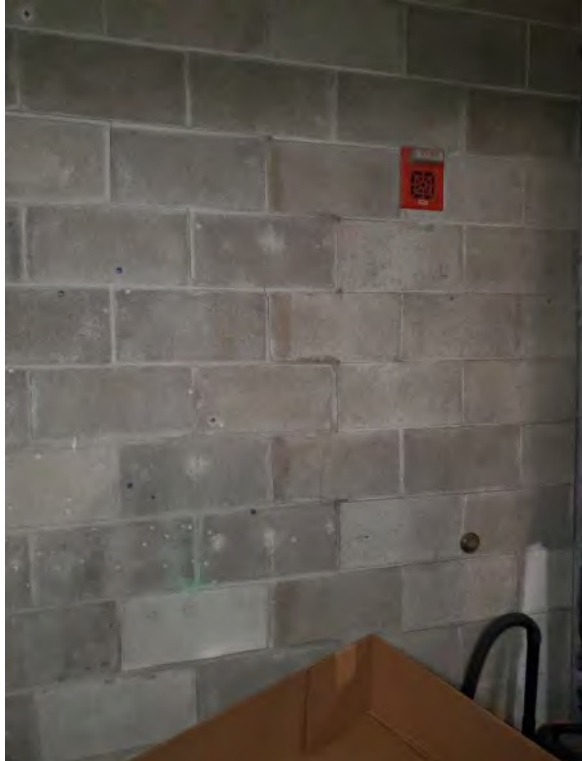
<p>Another area of the sally port showing wall shifting and pull from the areas above. Likely pulling on this CMU (via friction from above) and causing it to crack as the area moves out. Monitor for worsening of cracking/gaps.</p>

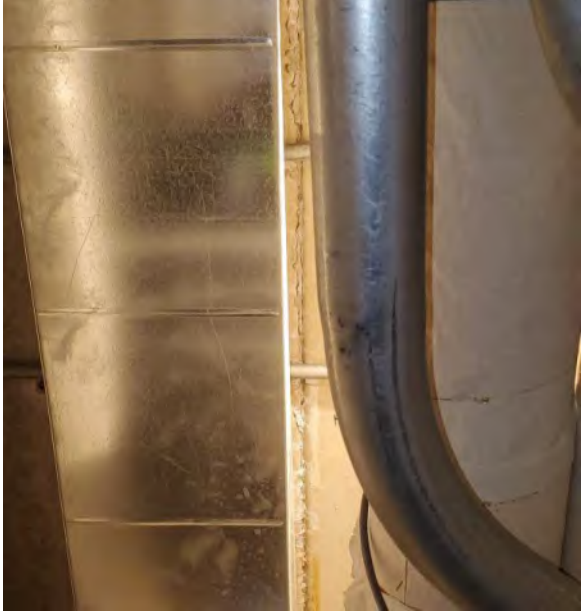
<p>Exposed hollow-core slab in ceiling near sally port showing a lot of moisture pass-through and efflorescence. Monitor this situation for worsening conditions.</p>
<p>31</p>	<p>STR</p>

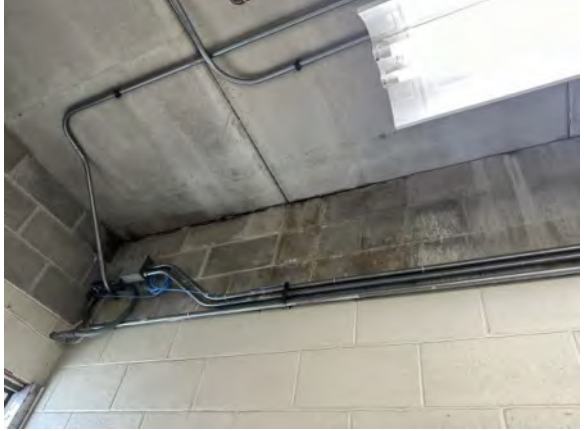
<p>Hallway ceiling near South exterior doorway showing split of hollow-core and buildup of moisture along the CMU/hollow-core seam coming in from outside. Monitor for worsening condition.</p>
<p>32</p>	<p>ARCH</p>

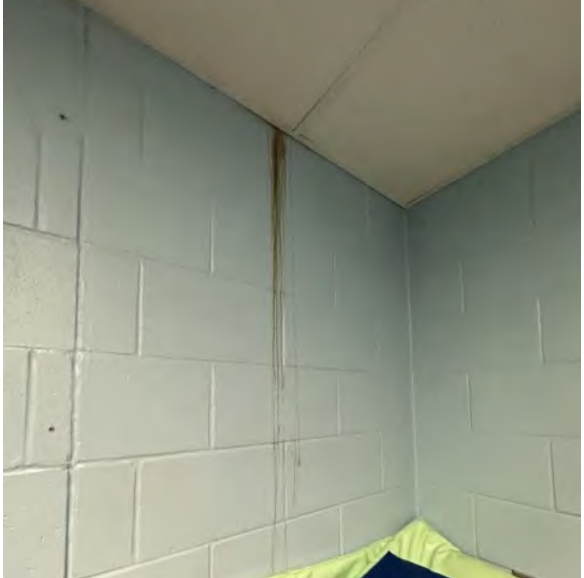
<p>Leaking from assumed plumbing blockage on upper floor. Monitor.</p>

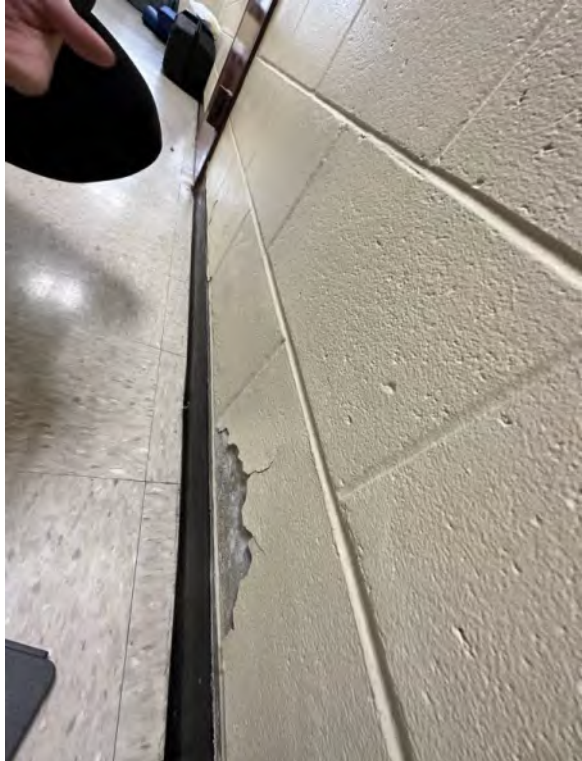
Central corridor CMU walls on upper level show consistent signs of paint failure at the base. This could be due to a number of reasons including movement. Monitor for ongoing issues and/or worsening conditions.

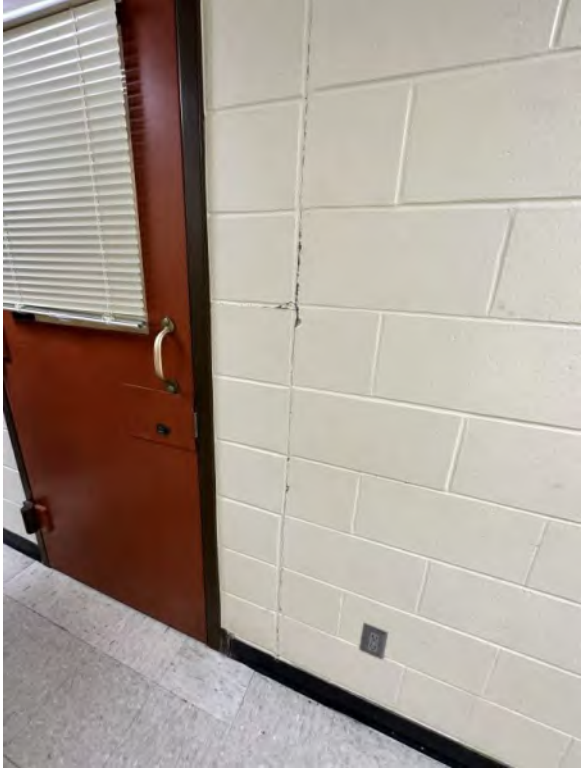
<p>Example of door (there are many) in the upper central hallway showing heavy fracturing of CMU adjacent to the door frame. Continuous vertical joint does not appear to be an expansion joint which would indicate that the door was retro-fitted into the opening. This tie-in doesn't look to be stable enough and the very heavy weight of the door is fracturing the adjacent block. These will need to be replaced/repaired at some point.</p>
6	STR

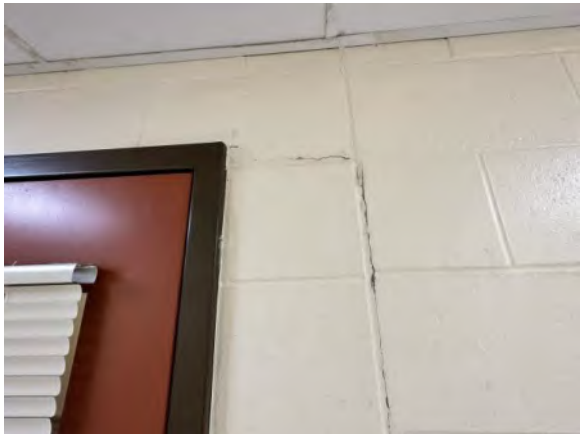
<p>Closeup of damage near door frame to the adjacent CMU.</p>

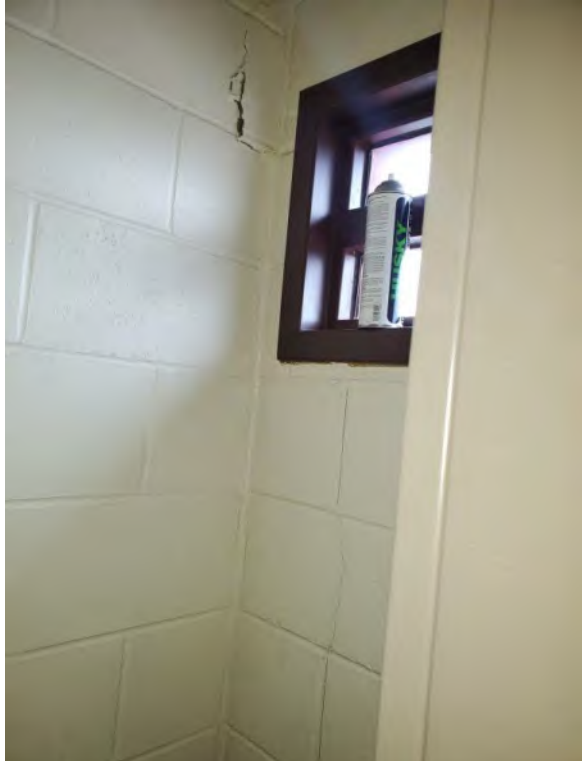
<p>Another exterior window in upper level North end accessory room (officers were working on PCs.) CMU movement and fracturing here is even worse. This should be repaired along with entire exterior wall repair/fascia repair at some point in the future.</p>

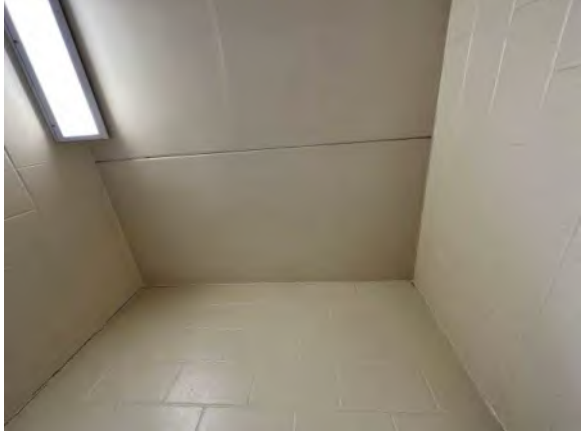
<p>Typical ceiling condition within a cell. Readily apparent pulling of the hollow-core and separating joint along with cracks at the exterior wall interface. This should be repaired along with entire exterior wall repair/fascia repair at some point in the future.</p>
12	STR

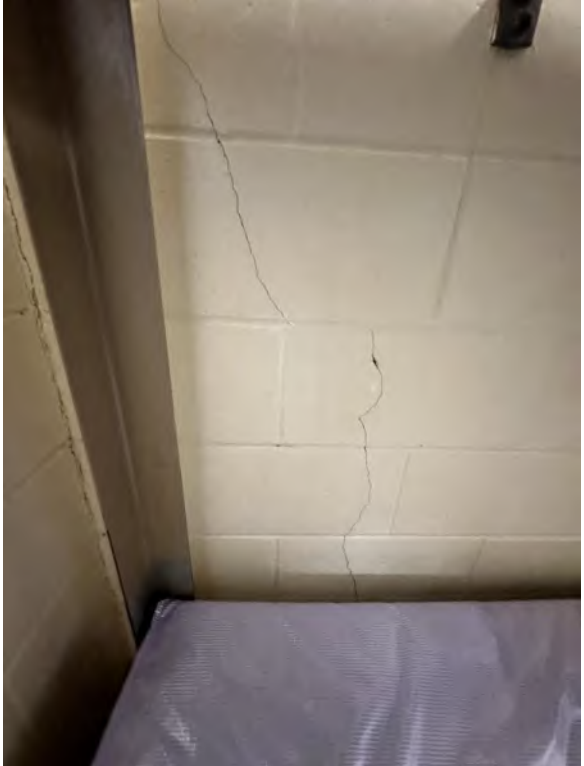
<p>Closeup of more typical exterior wall cell cracks under a window area.</p>
13	STR

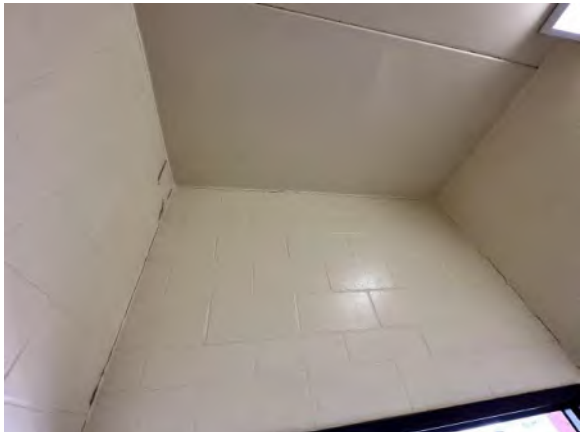
<p>Similar example of hollow-core ceiling and exterior wall cracking. In this example the top course of CMU is beginning to come loose.</p>

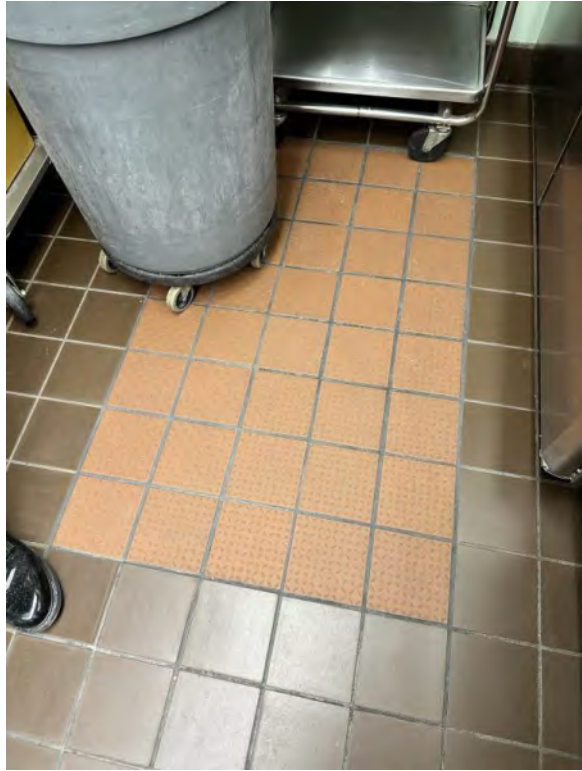
<p>Prior repair area of kitchen floor tile. This area and another one near the center of the kitchen have been repaired multiple times. The tile substrate is getting moisture in it and the tile is buckling up an inch or more. The area will eventually settle back down (partially) but needs to be pulled up and fully dried out to actually repair the damage. This ongoing issue is indicative of water infiltration and we believe it could be related to the exterior damage occurring across this floor. This should be repaired when possible but likely is best once exterior repairs are corrected.</p>
15	STR

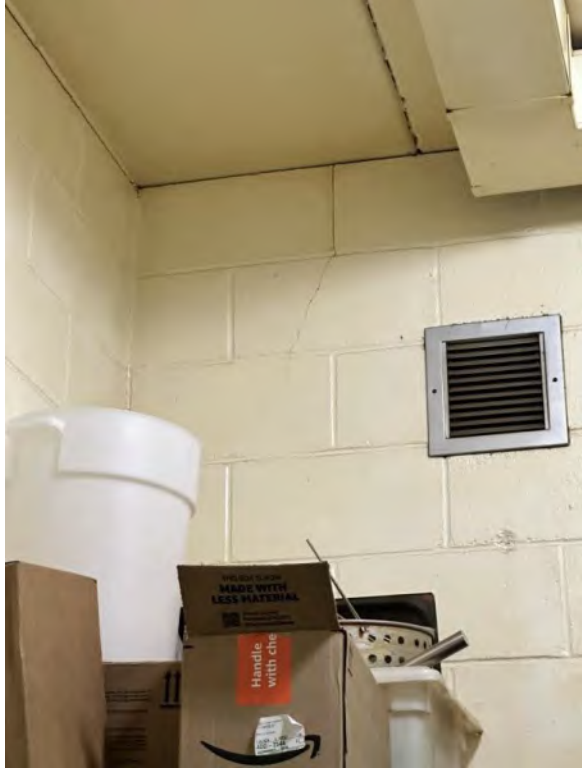
<p>Storage near kitchen. Wall cracks and significant pulling/splitting of hollow-core joints in the ceiling. Monitor for worsening condition(s.)</p>

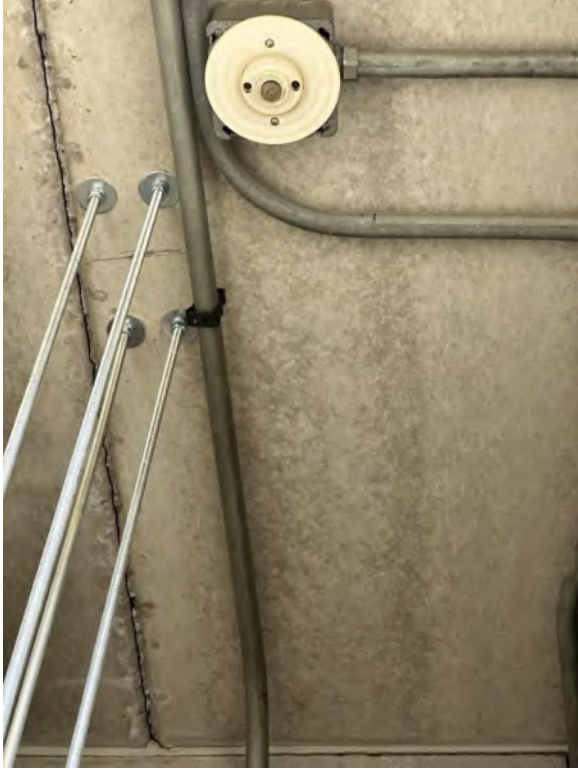
<p>Separation of ceiling hollow-core in storage area on the upper floor. Monitor for worsening condition(s.)</p>

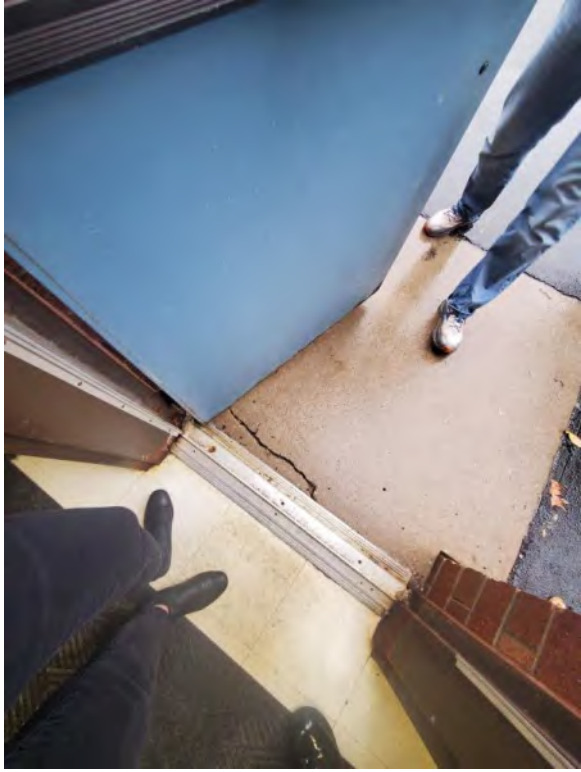
<p>South doorway stoop showing signs of settlement and breaking. Should be repaired or sealed (at a minimum) when time allows to keep stoop from heaving/settling and interfering with door operation.</p>
2	STR

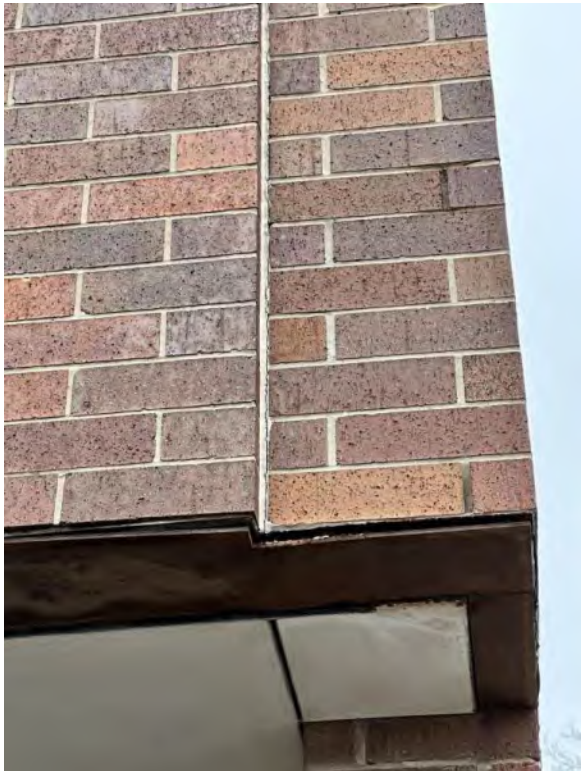
<p>Building corner at SW portion of exterior showing bearing plate separation from the building exterior and poor drainage condition. This area should be repaired soon.</p>

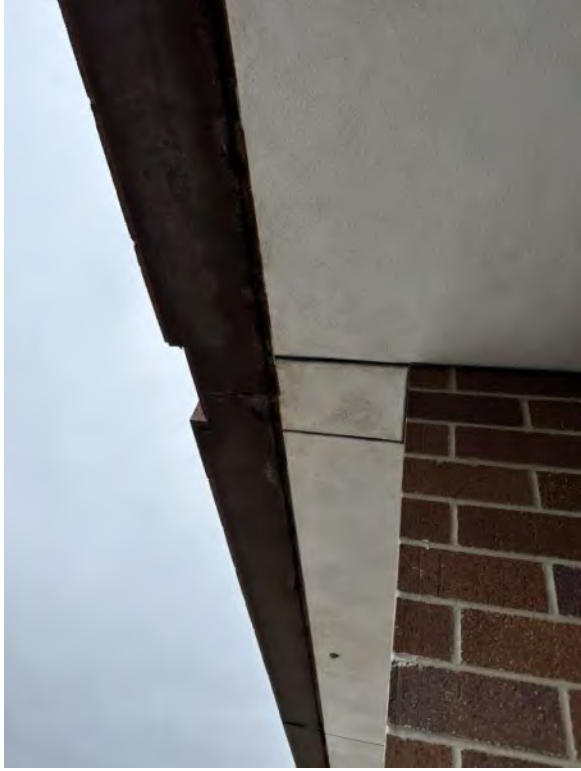
<p>Building edge on West side of exterior showing bearing plate corrosion from poor drainage condition. Joints failing in the masonry façade. This area should be repaired soon.</p>

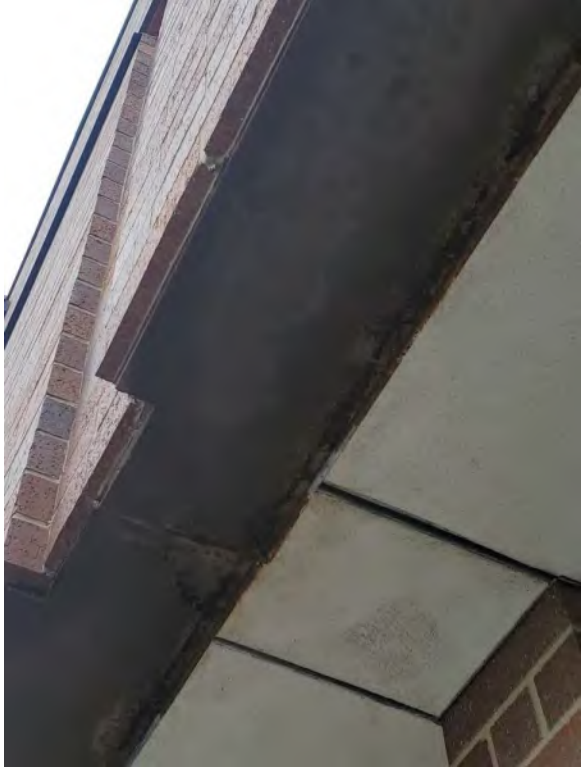
<p>Building edge on West side of exterior showing bearing plate corrosion from poor drainage condition. Welds starting to fail as well. Joints failing in the masonry façade. This area should be repaired soon.</p>
5	STR

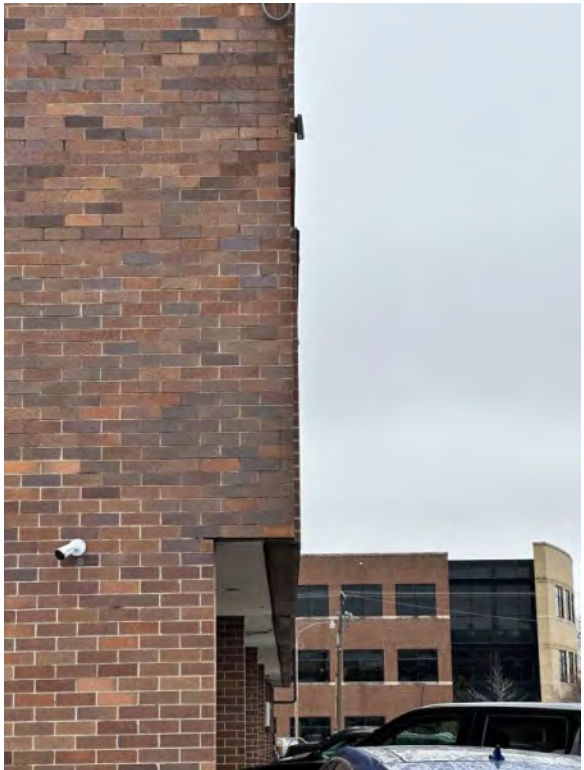
<p>Sighting down the West edge of the building to check pull-away of masonry façade N-S. Monitor this condition.</p>

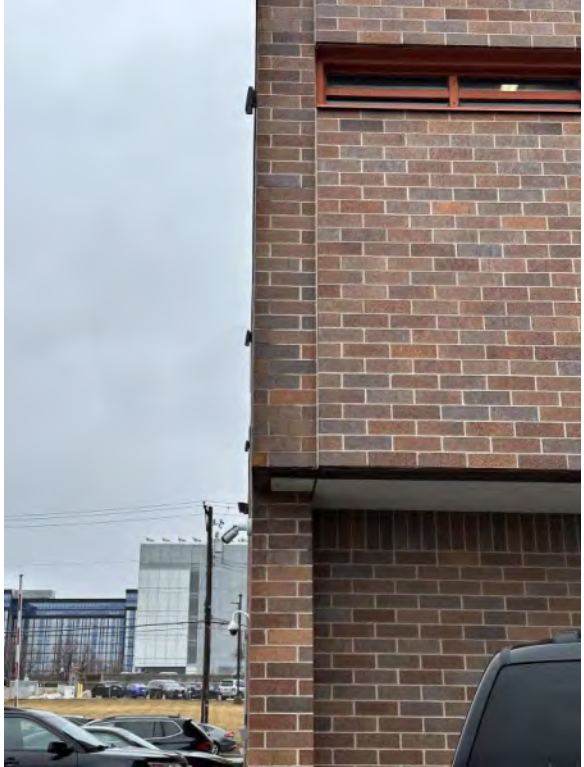
<p>Sighting down the North edge of the building to check pull-away of masonry façade N-S. Monitor this condition.</p>
7	STR

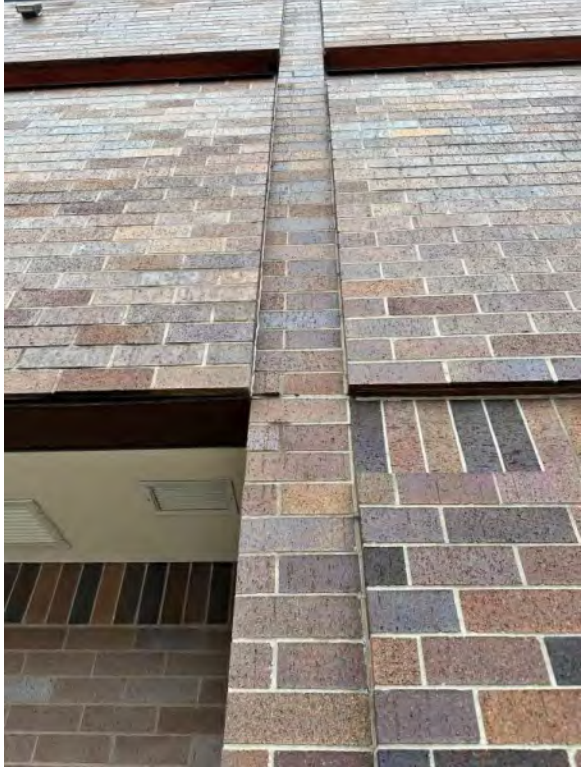
<p>Brick pop-out on fascia starting to occur indicating likely moisture issues as well as movement in the structure. This condition should be repaired soon.</p>

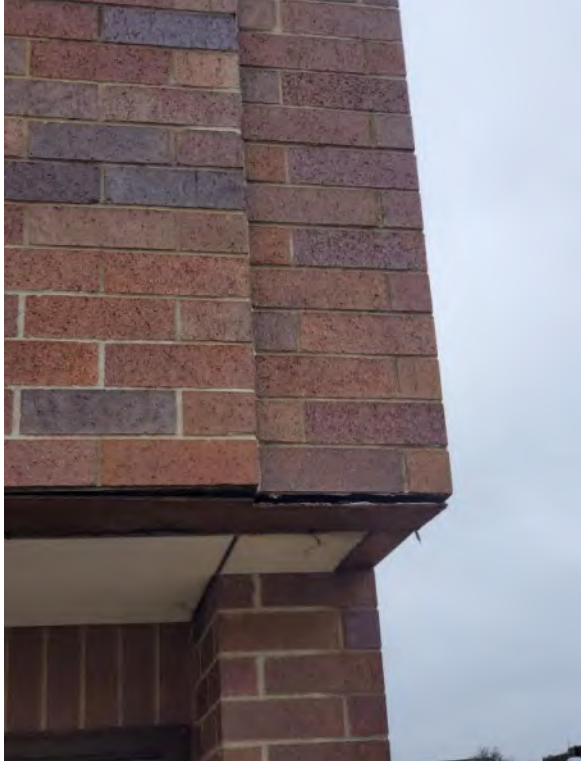
<p>Building edge on NE corner exterior showing bearing plate corrosion from poor drainage condition. Welds starting to fail as well. Joints failing in the masonry façade. This area should be repaired soon.</p>
9	STR

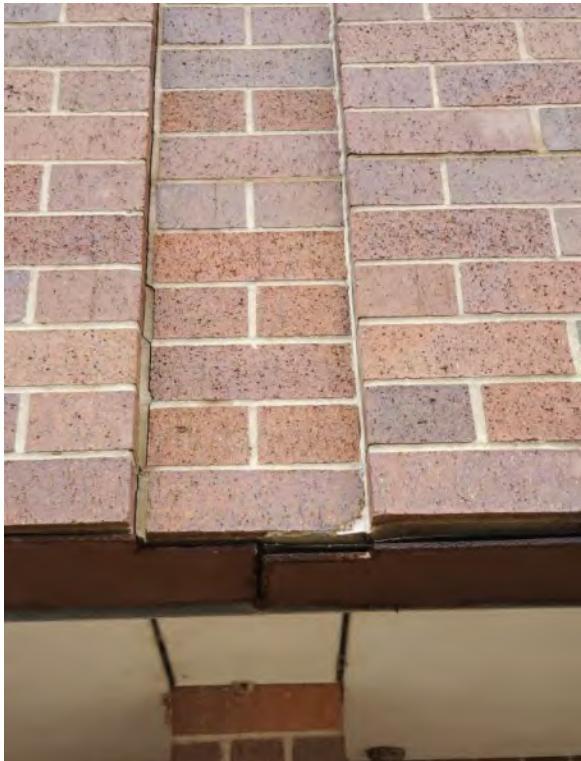
<p>Building edge on E side of structure. Showing similar conditions with the plate and failure of the masonry joints above. This area should be repaired soon.</p>

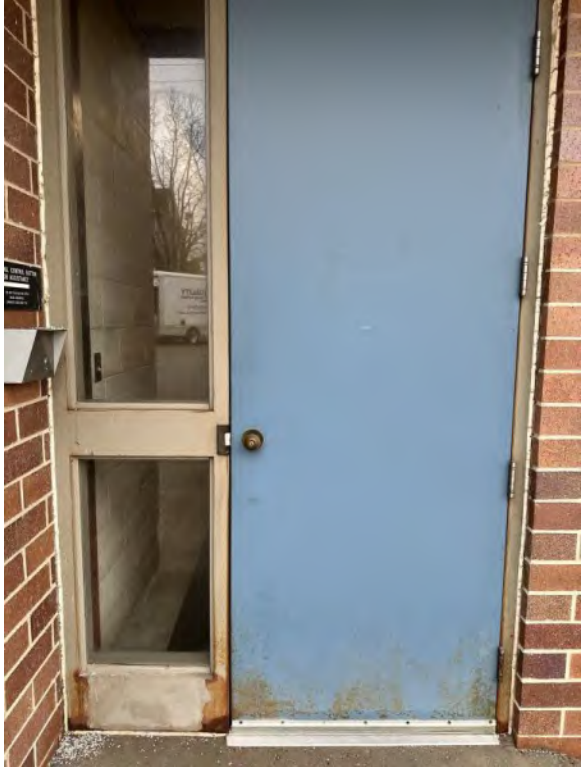
A photograph of a blue exterior door set in a brick wall. The door has a small window at the top and a handle. There is visible wear and discoloration at the bottom of the door and the surrounding brickwork.	<p>Exterior door on E side of building showing similar distress and wear to other doors. This door should be replaced when feasible.</p>
11	STR

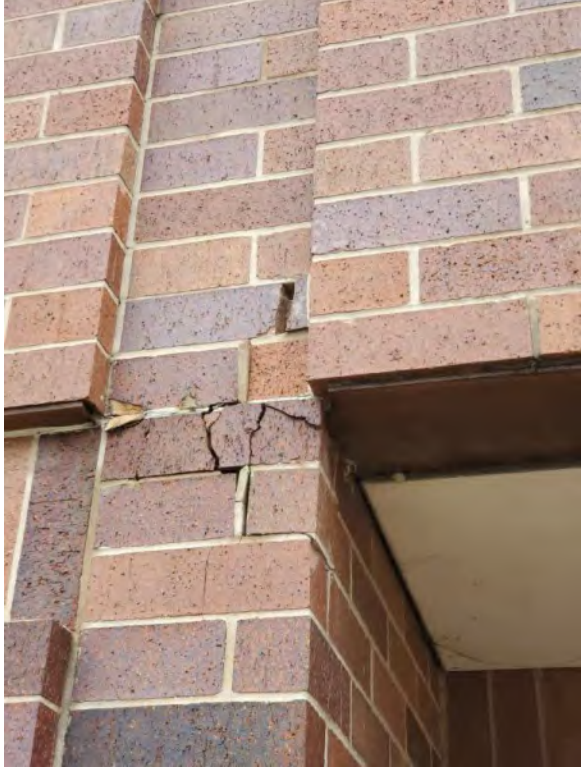
A close-up photograph of a brick wall corner. The bricks are reddish-brown with white mortar. There is significant cracking and crumbling of the bricks and mortar, particularly in a recessed area, indicating structural failure.	<p>Building edge on E side exterior near the sally port. Brick movement and failure are very bad here indicating movement and moisture issues at the recess in particular. This area should be repaired soon.</p>

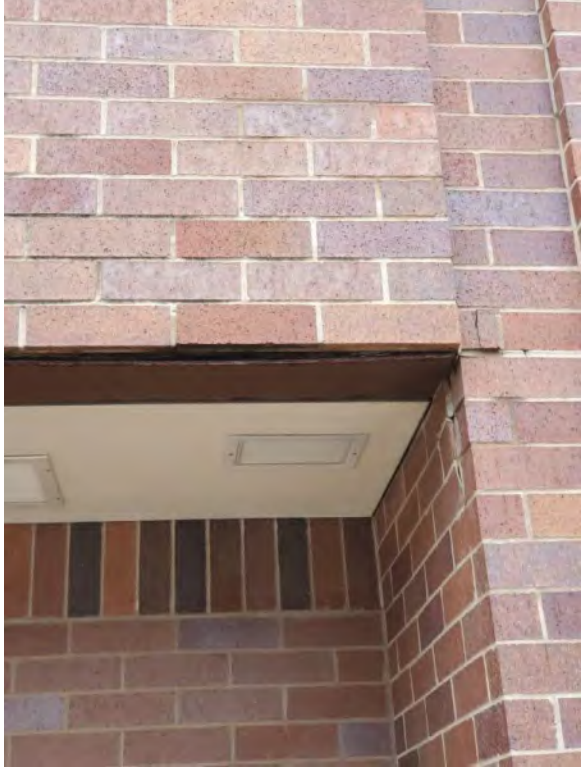
<p>Brick failure, pop-out and rippling showing on the E side of the building. This area should be repaired soon.</p>
13	ARCH

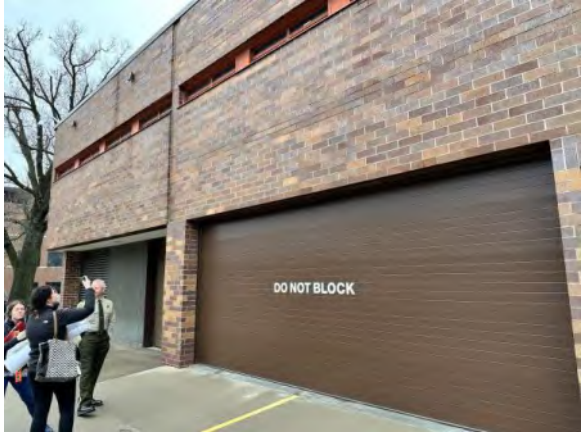
<p>Overview of the sally port door indicating fair condition. Brick rippling can be seen on this face and should be monitored for worsening condition(s.)</p>
14	ARCH

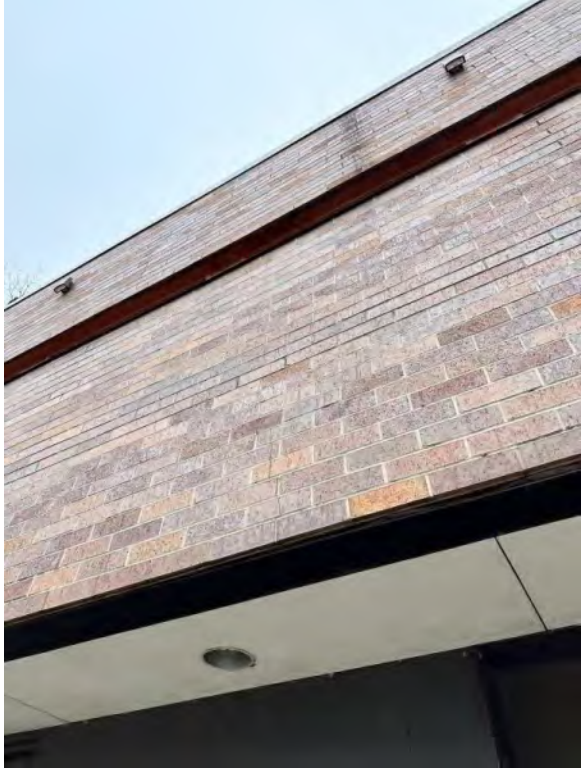
<p>East side brick condition as viewed from public walk. Brick movement, moisture issues, and support angle condition can all be seen. This area should be repaired with other exterior items when possible.</p>
16	STR

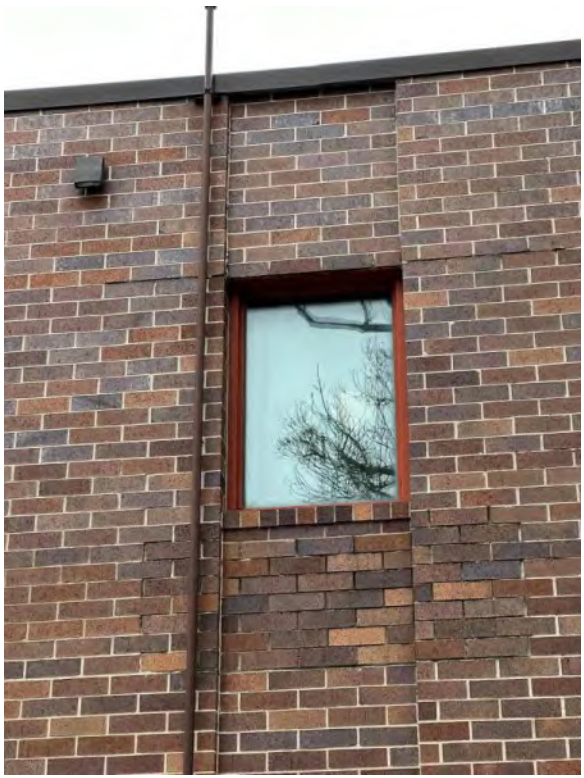
A photograph showing a section of a brick wall on the second floor. A window is visible, and there is a noticeable dark stain or area of discoloration on the brickwork above and around the window, indicating moisture infiltration. A vertical pipe or downspout is visible to the left of the window.	<p>Brick condition on SE corner of the building around upper window showing moisture infiltration into the exterior façade. Should be repaired when feasible. This condition is indicative of many areas of the exterior brick, particularly on the East face (where we believe the brick likely doesn't dry out as quickly.) Without exploratory investigation it is difficult to verify but we believe there are multiple drainage and structural deficiencies throughout the brick façade on the second floor.</p>
18	STR

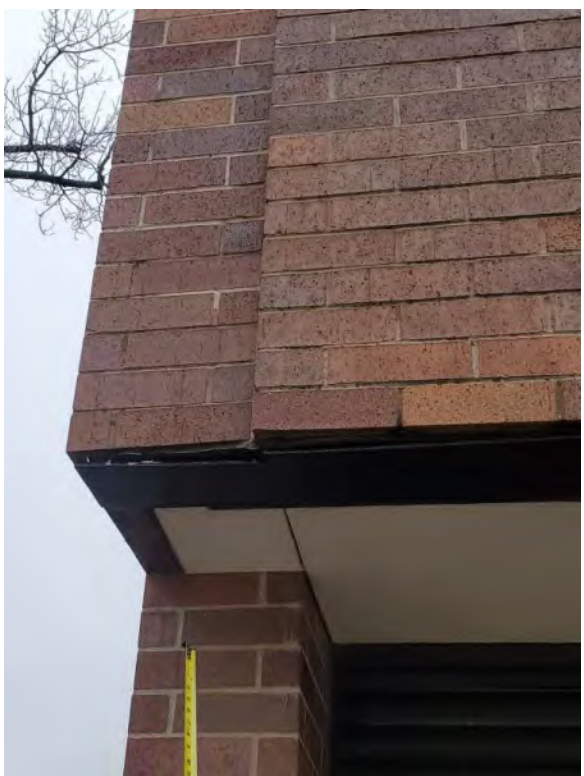
A photograph showing a close-up of a brick support angle. There is a significant gap between the brickwork and the support structure. The bricks appear to be pulling away, and there is visible moisture infiltration. A yellow measuring tape is visible at the bottom of the frame for scale.	<p>SE corner brick support angle. Support angle gap is very large and pulling away. Brick movement evident above and below. Moisture infiltration evident. Should be repaired soon.</p>

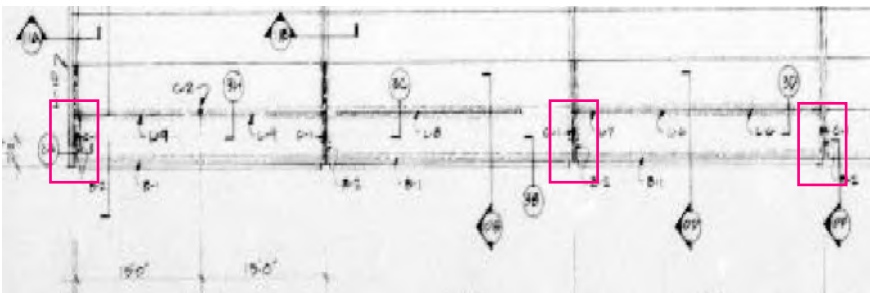
3. The overhang design and soffit construction was very poorly thought-out in terms of water management. The structure isn't well designed to deal with water that undoubtedly enters the exterior wall cavity and drains down to the overhang. There are cotton rope weeps (minimal and not consistently-spaced) and no other apparent method of moisture and water control. A few areas have small vents but the majority of the soffit area is unvented.

E/SE portion of the second story where 4' backspan into the building can be noted.

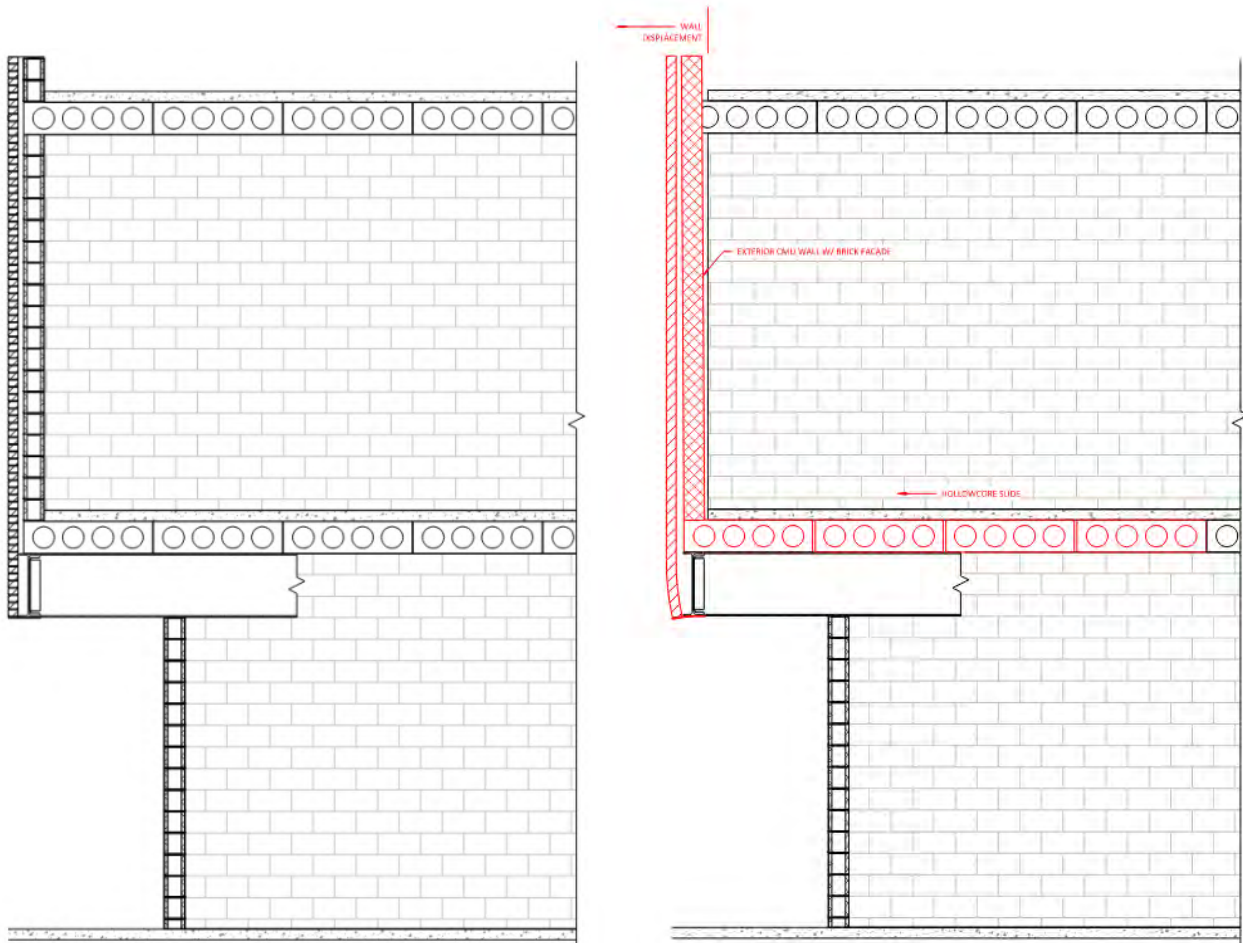
Estimated as-designed condition

Estimated current condition

As previously stated, the cantilever detail was a poorly conceptualized one and added unnecessary complexity to a building that wasn't "asking for it." A simpler condition of a flush top-to-bottom wall would have eliminated the possibility of supplemental support needs on the upper level, possibility of water infiltration and sag, and provided a bit more square footage – likely for less cost. The cantilever section masonry weeps/drainage are insufficient and there are no stiffeners along the support angles to prevent bending. There are no drip edges designed at the edge of the cantilever. The hollow-core floor/ceiling system as well as the outside wall are slowly shifting outward over time creating gaps in the planks and showing brick fatigue and support angle failures. As these failures occur and gaps open up, the problem will continue to exacerbate, and gravity will begin to work on the condition even more. The condition is minimally present on the ground floor but overhead conditions will begin to affect that over time as well. This condition should be corrected and repaired. It is unknown how quickly the conditions will deteriorate but they are showing significant signs thereof. This will be a significant operation that will affect jail operations and likely require a phased approach.
