# Site Accessibility Evaluation

## Bayertown Shed

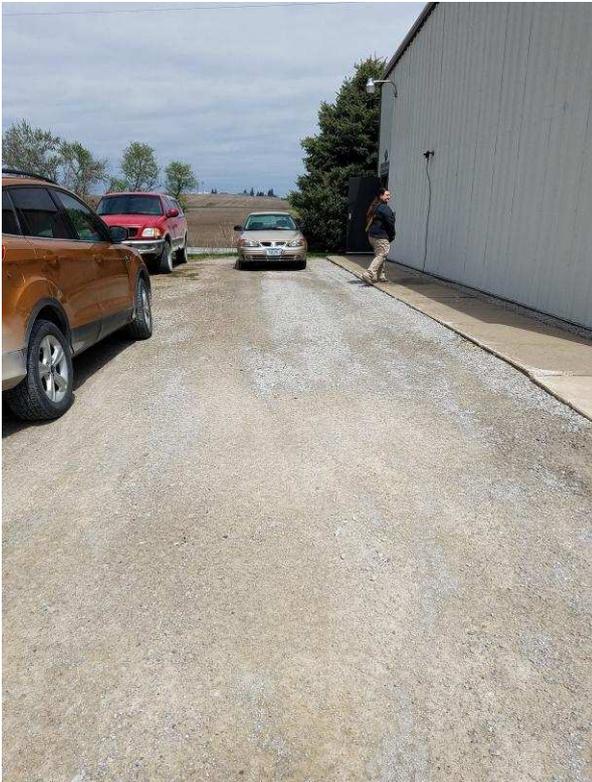
Total Number of Parking Spaces Provided in Parking Facility	Minimum Number of Required Accessible Parking Spaces
1 to 25	1
26 to 50	2
51 to 75	3
76 to 100	4
101 to 150	5
151 to 200	6
201 to 300	7
301 to 400	8
401 to 500	9
501 to 1000	2 percent of total
1001 and over	20, plus 1 for each 100, or fraction thereof, over 1000

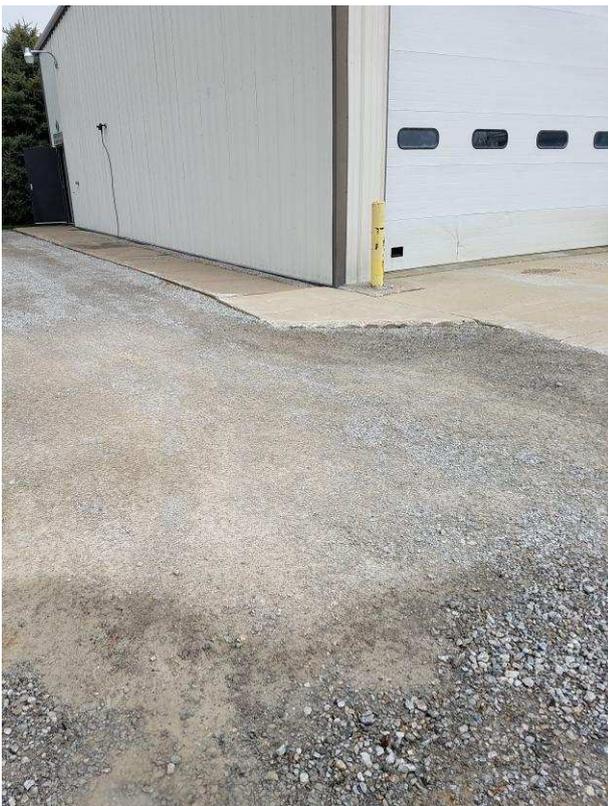
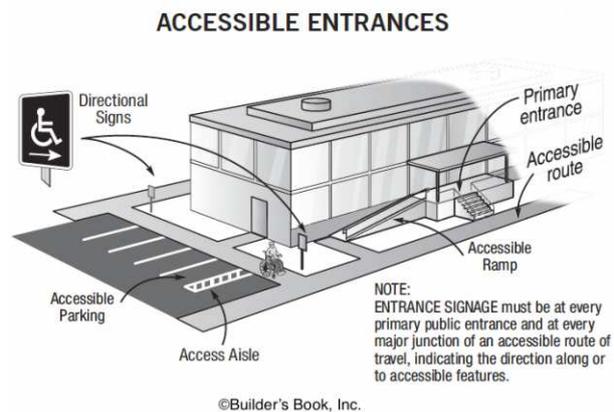
**Finding #2 Additional Finding Photos**

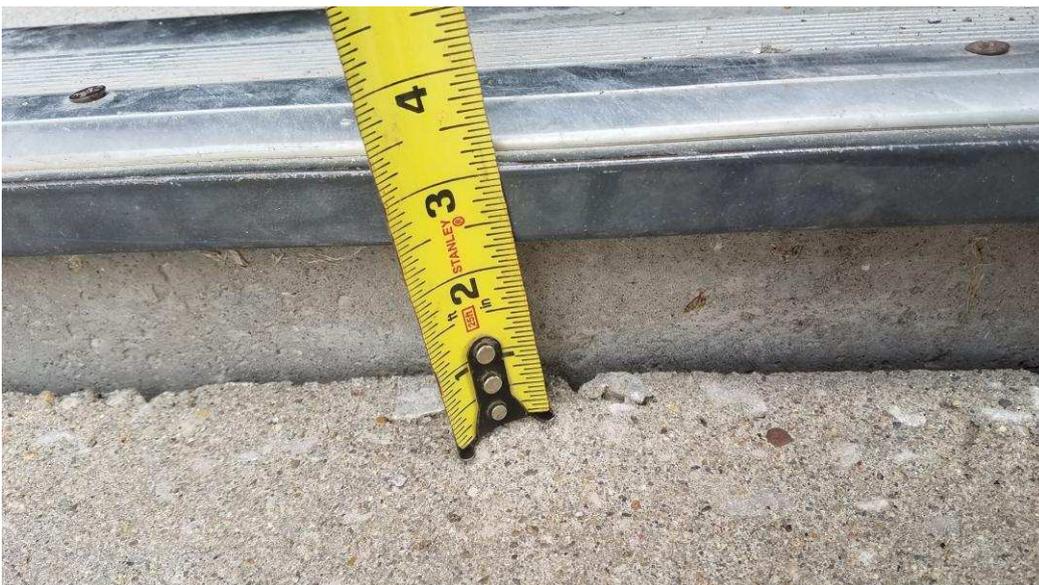
**Finding #3 Additional Finding Photos**

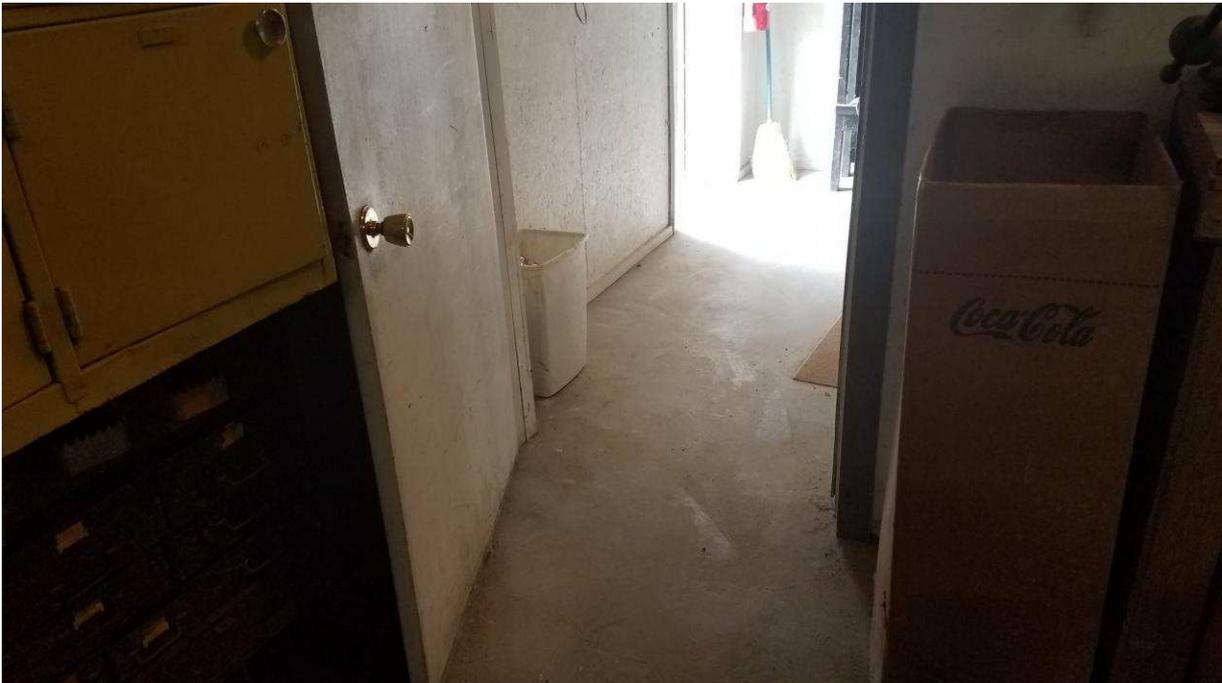
For all doors along the public circulation route, replace hardware with lever hardware or hardware operable without a tight pinch or grasp

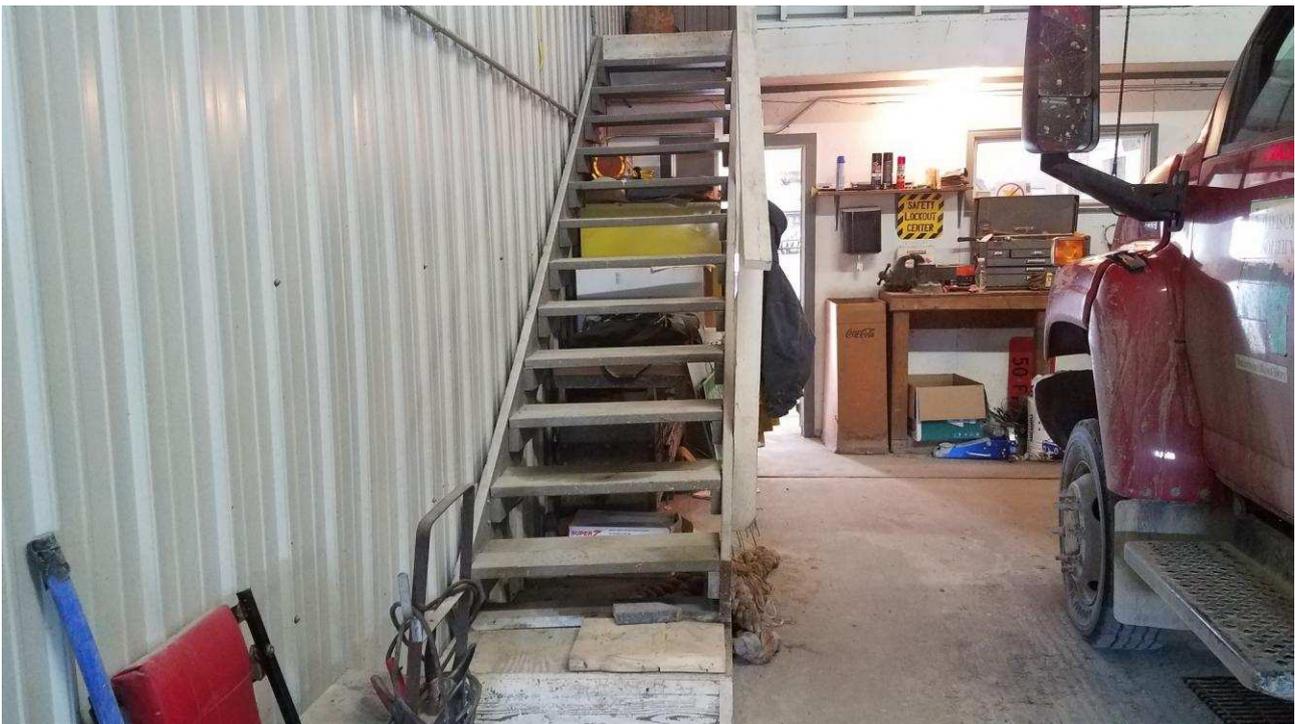
No AR to upper level employee area, leave as is, and reassign duties if an employee with disabilities requires access here

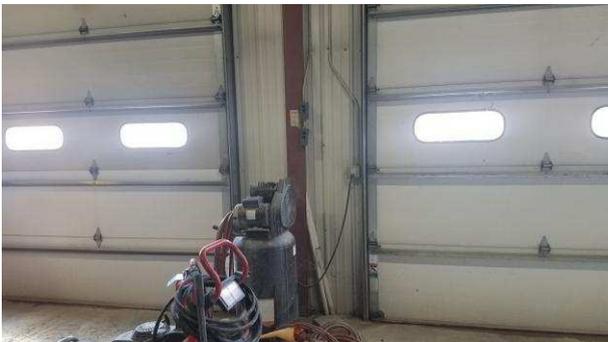
For deficit, leave as is, employee work area pursuant to 2010 Standards 106.5 Defined Terms, until an employee with a disability works here

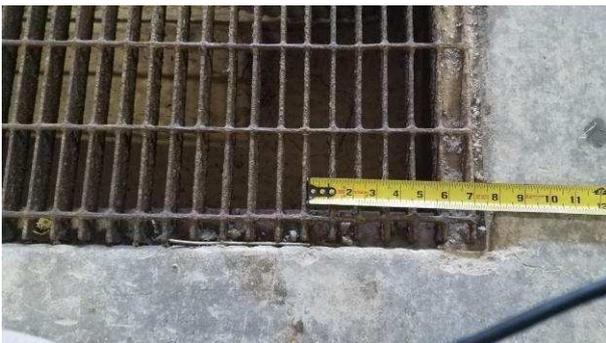
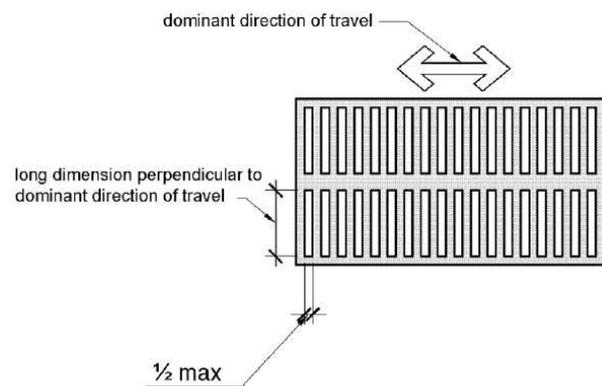
**Finding #7 Additional Finding Photos**

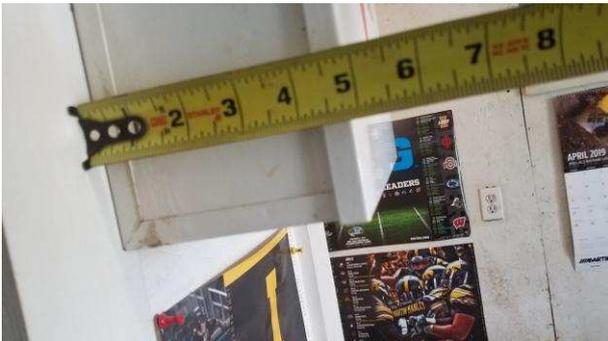
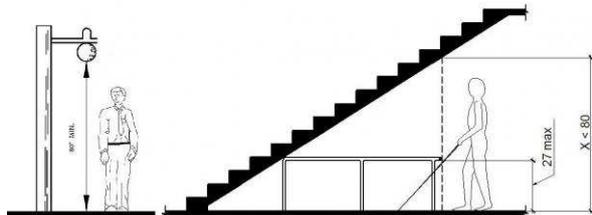
**Finding #8 Additional Finding Photos**

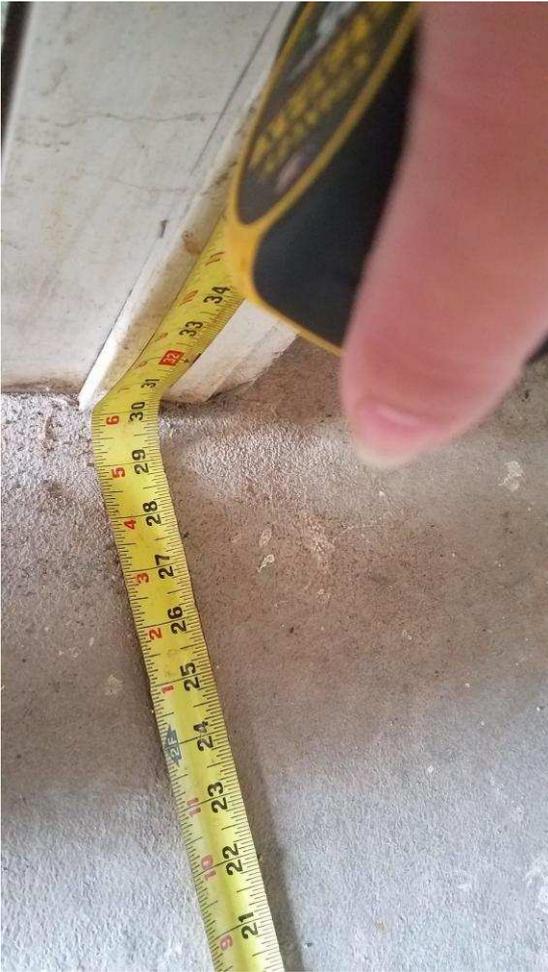
**Finding #9 Additional Finding Photos**

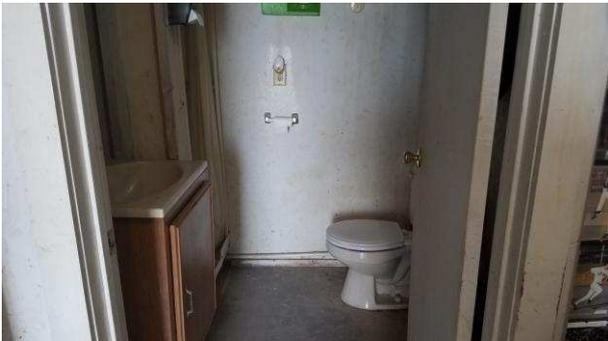
**Finding #10 Additional Finding Photos**
