# Site Accessibility Evaluation

**Pechman Creek Delta**

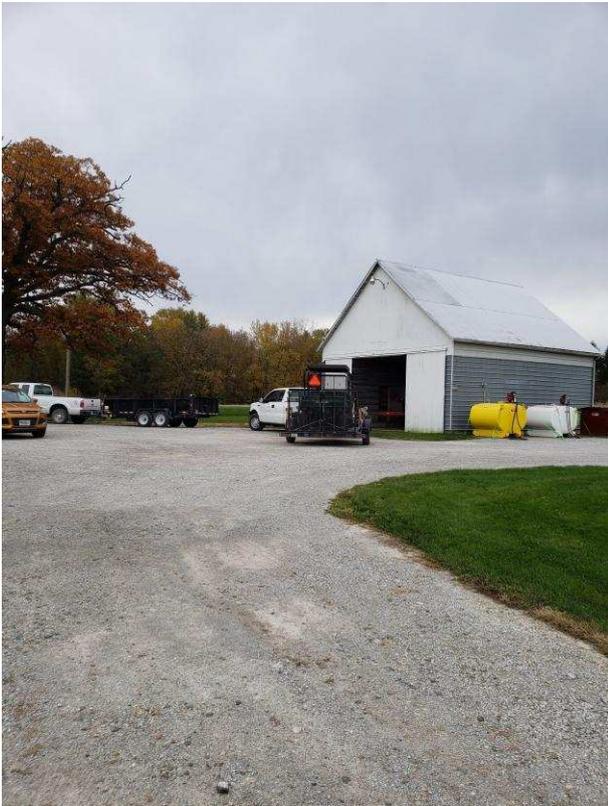
Total Number of Parking Spaces Provided in Parking Facility	Minimum Number of Required Accessible Parking Spaces
1 to 25	1
26 to 50	2
51 to 75	3
76 to 100	4
101 to 150	5
151 to 200	6
201 to 300	7
301 to 400	8
401 to 500	9
501 to 1000	2 percent of total
1001 and over	20, plus 1 for each 100, or fraction thereof, over 1000

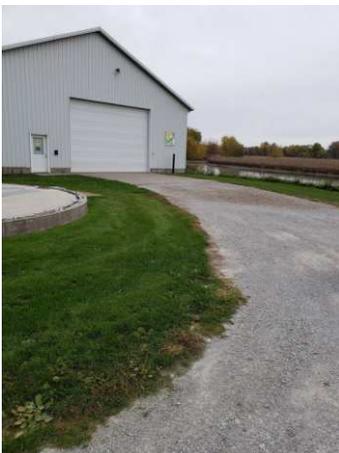
**Finding #2 Additional Finding Photos**

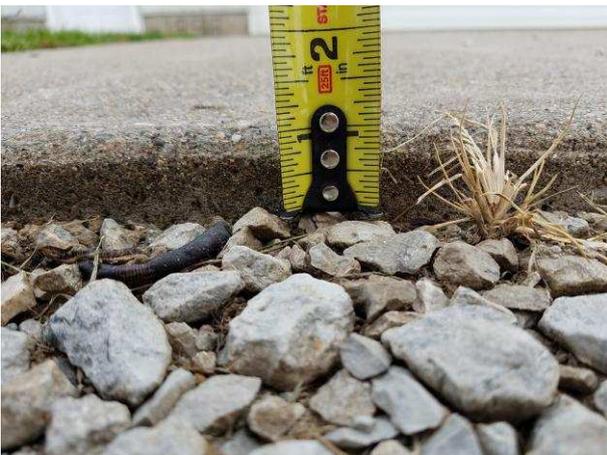
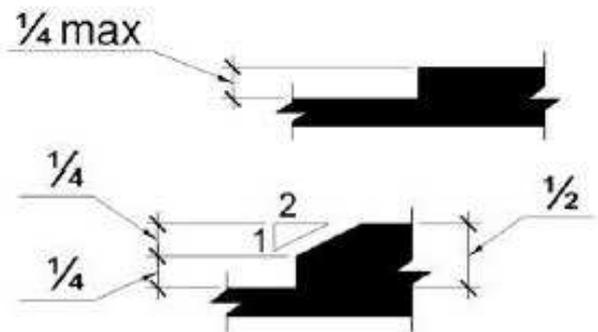
**Finding #3 Additional Finding Photos**

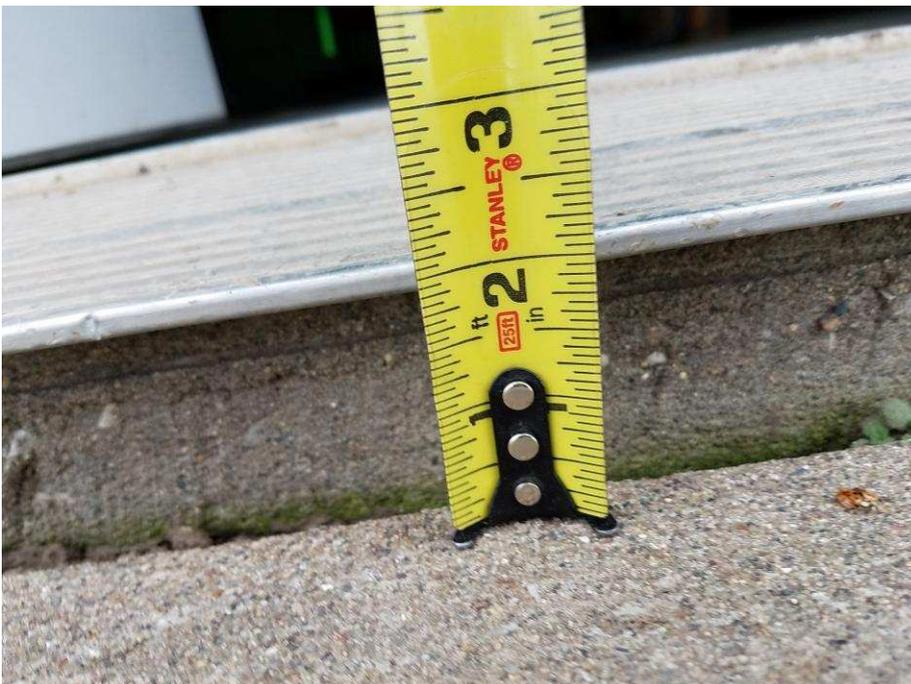
**Finding #4 Additional Finding Photos**

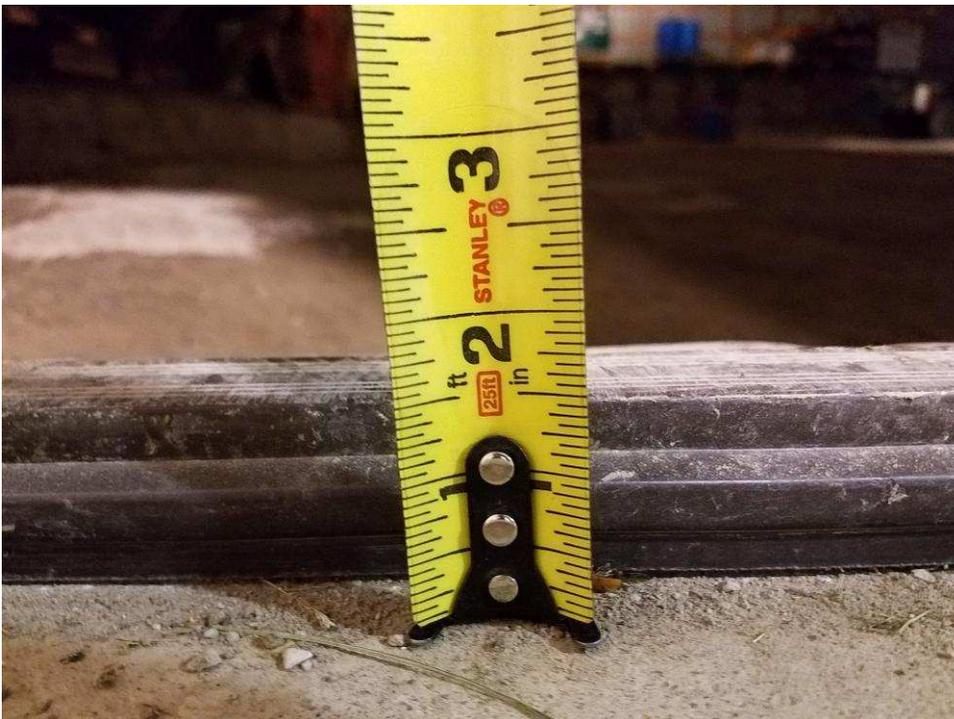
**Finding #5 Additional Finding Photos**

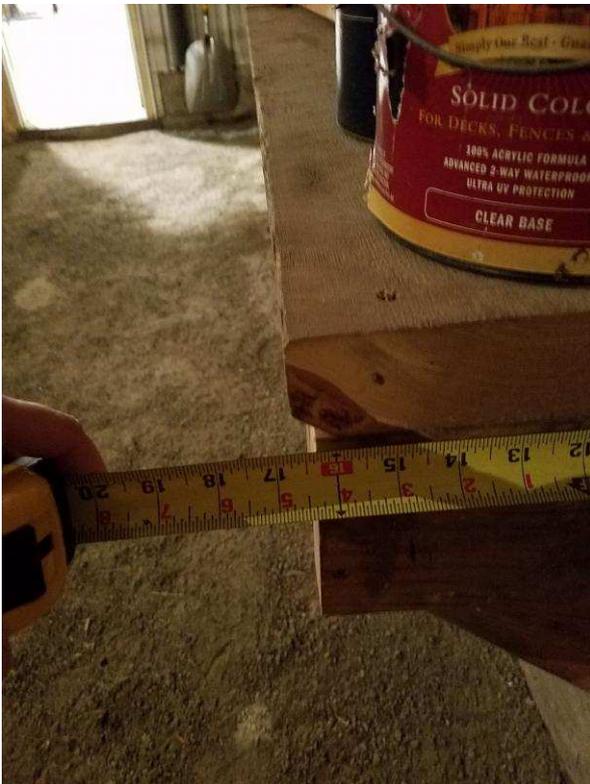
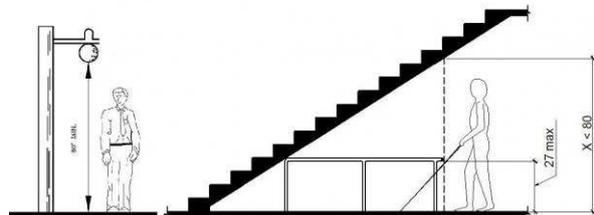
**Finding #6 Additional Finding Photos**

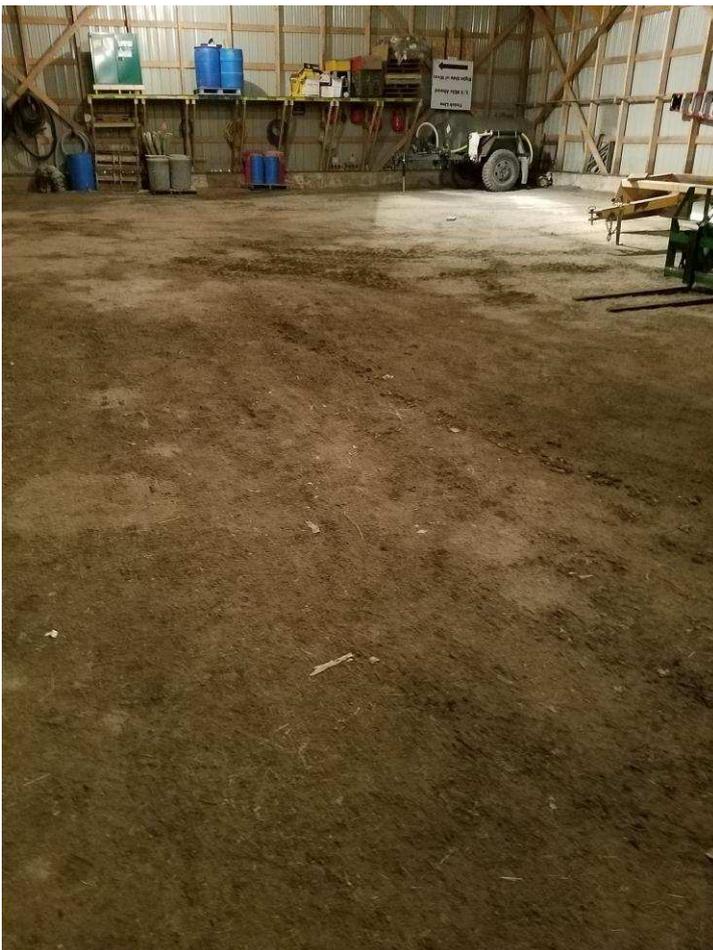
Leave as is, dirt floor, employee area

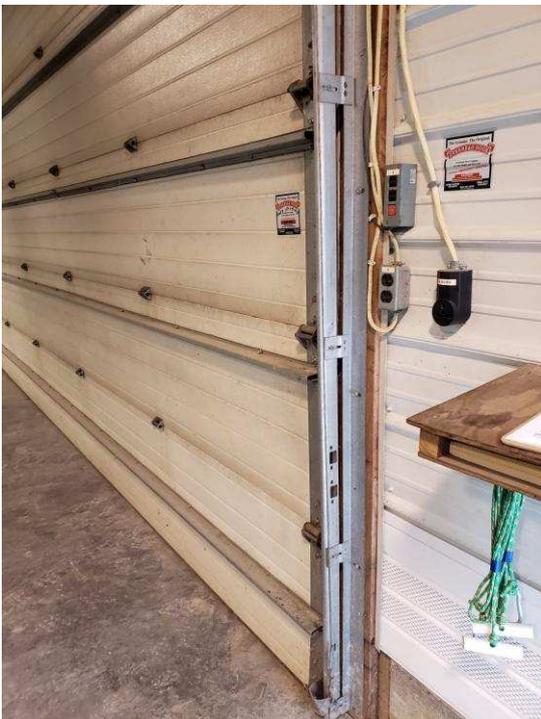
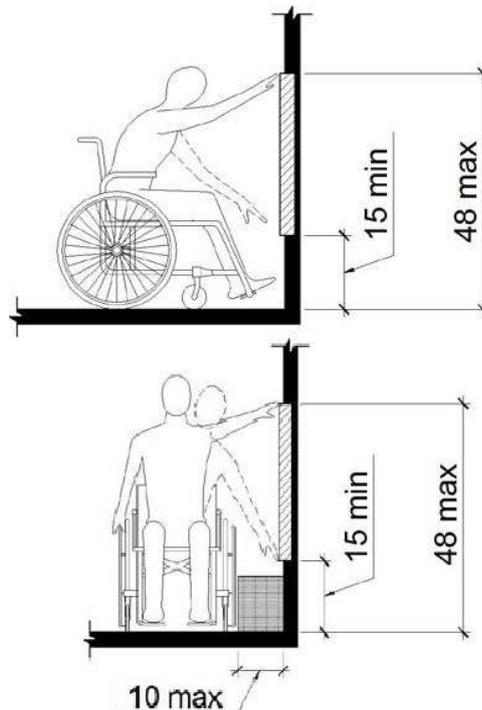
Finding #9 Additional Finding Photos

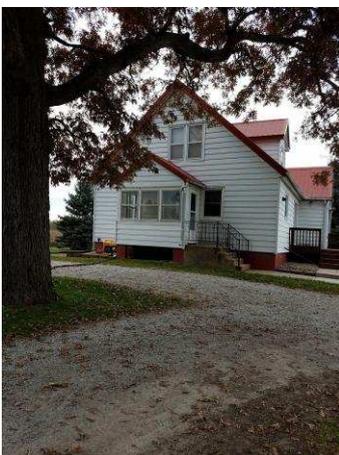
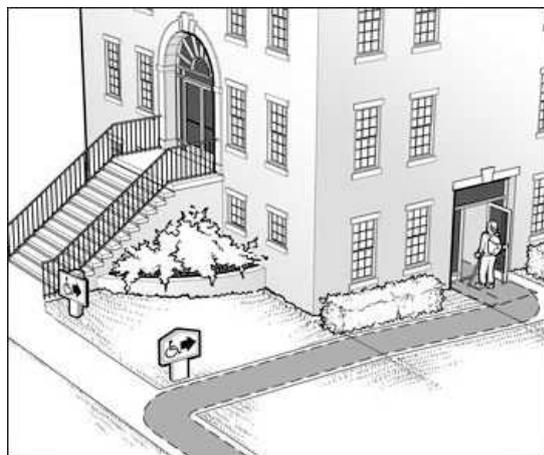
**Finding #10 Additional Finding Photos**
