# Site Accessibility Evaluation

**Misc Use/Storage**

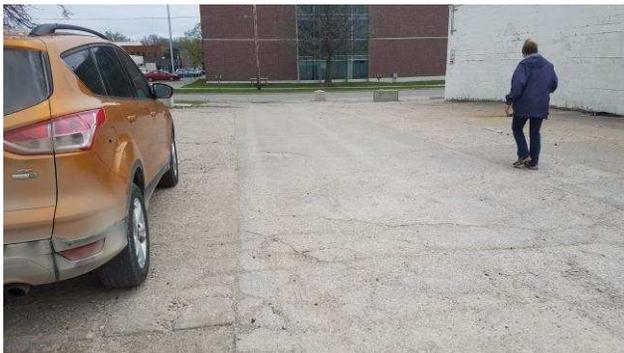
Total Number of Parking Spaces Provided in Parking Facility	Minimum Number of Required Accessible Parking Spaces
1 to 25	1
26 to 50	2
51 to 75	3
76 to 100	4
101 to 150	5
151 to 200	6
201 to 300	7
301 to 400	8
401 to 500	9
501 to 1000	2 percent of total
1001 and over	20, plus 1 for each 100, or fraction thereof, over 1000

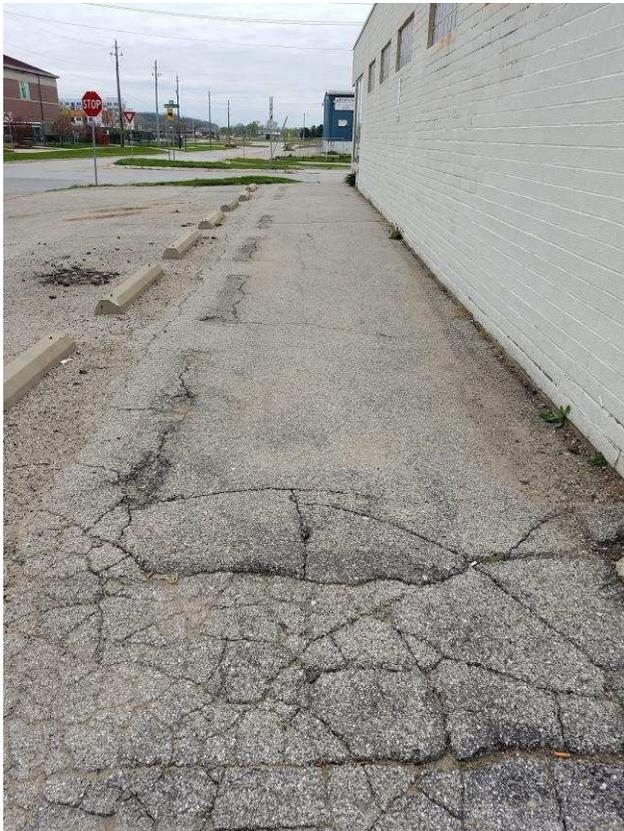
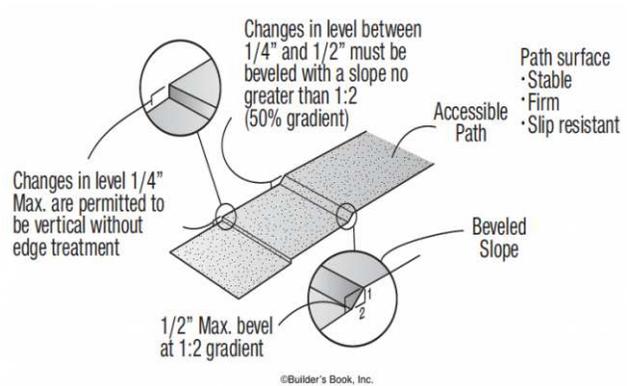
**Finding #2 Additional Finding Photos**

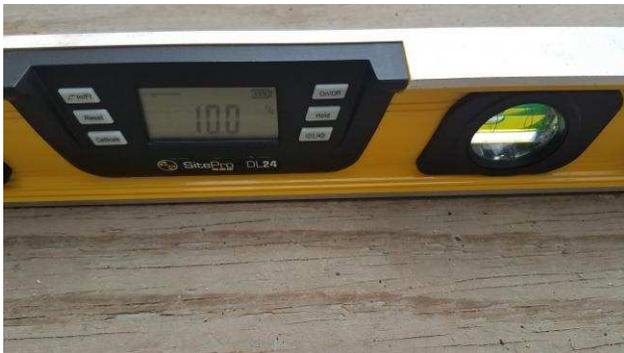
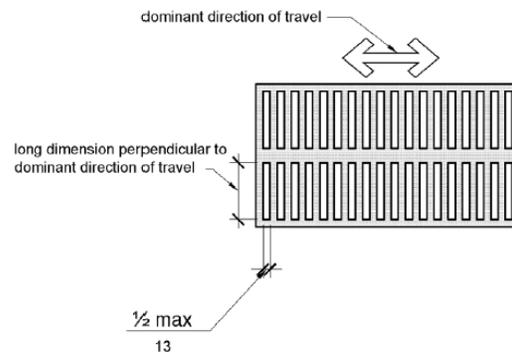
### Finding #3 Additional Finding Photos

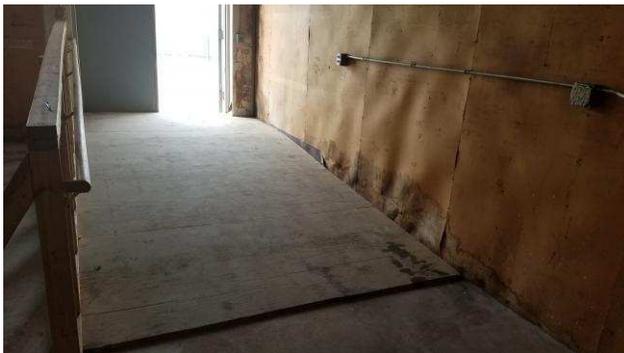
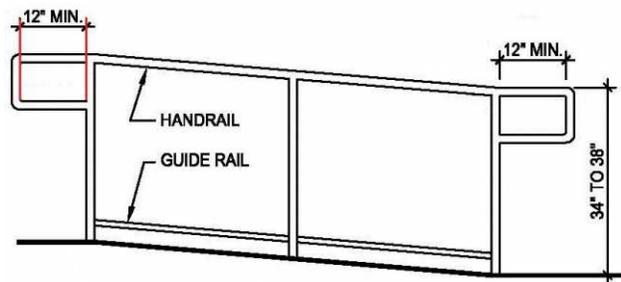
Install handrails that are rounded and/or extend to the ground, with handrail extensions and mounted 34" to 38" aff

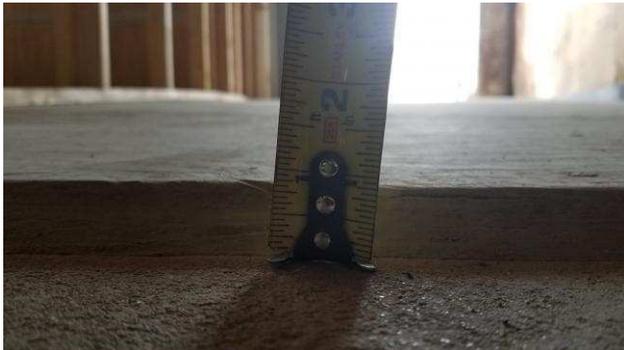
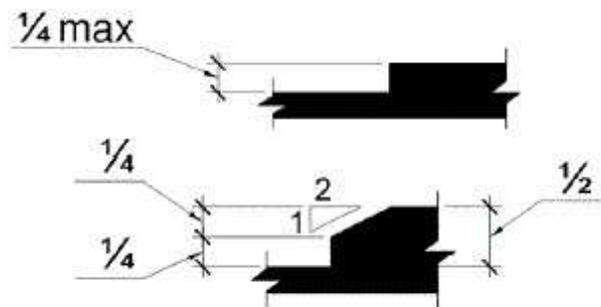
**Finding #5 Additional Finding Photos**

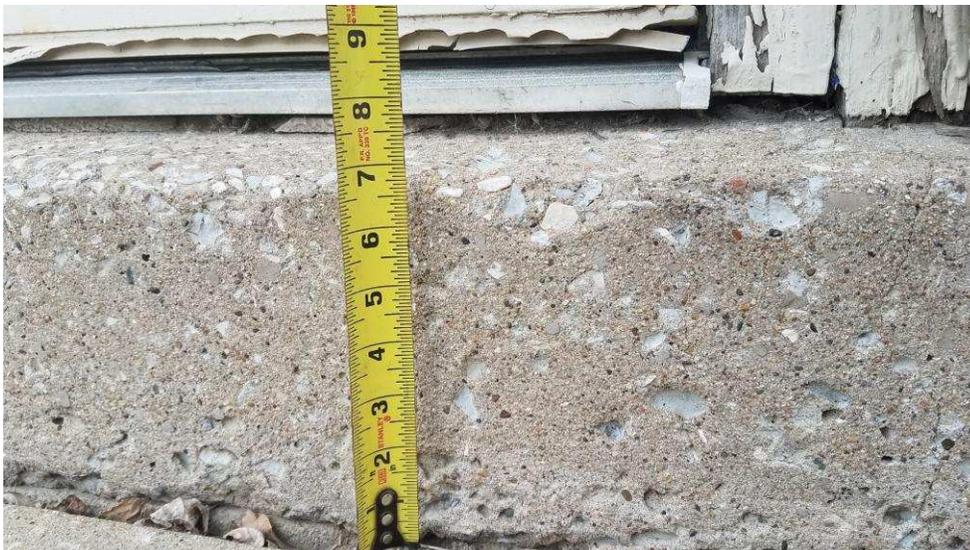
Finding #6 Additional Finding Photos

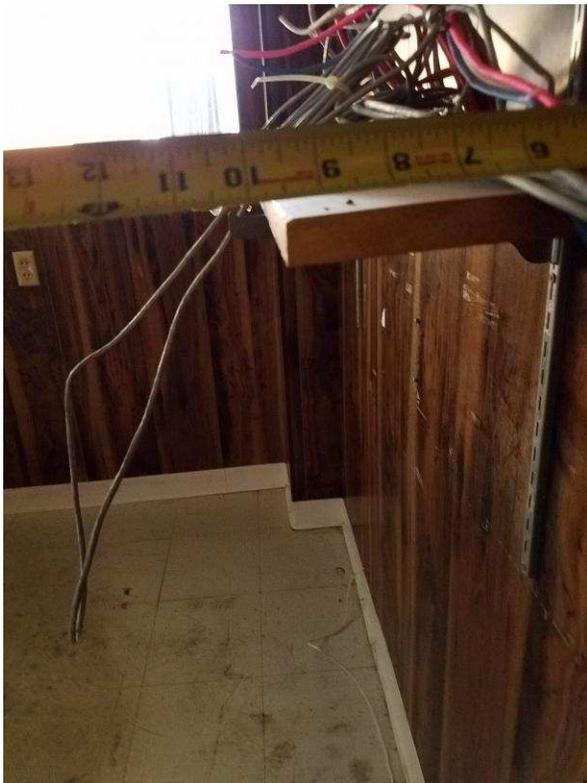
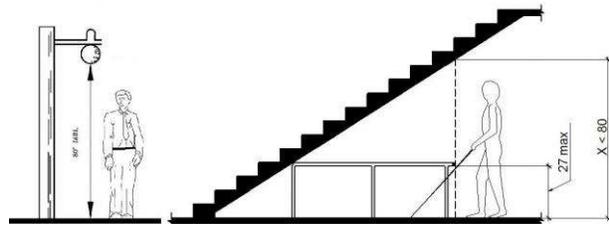
**Finding #8 Additional Finding Photos**

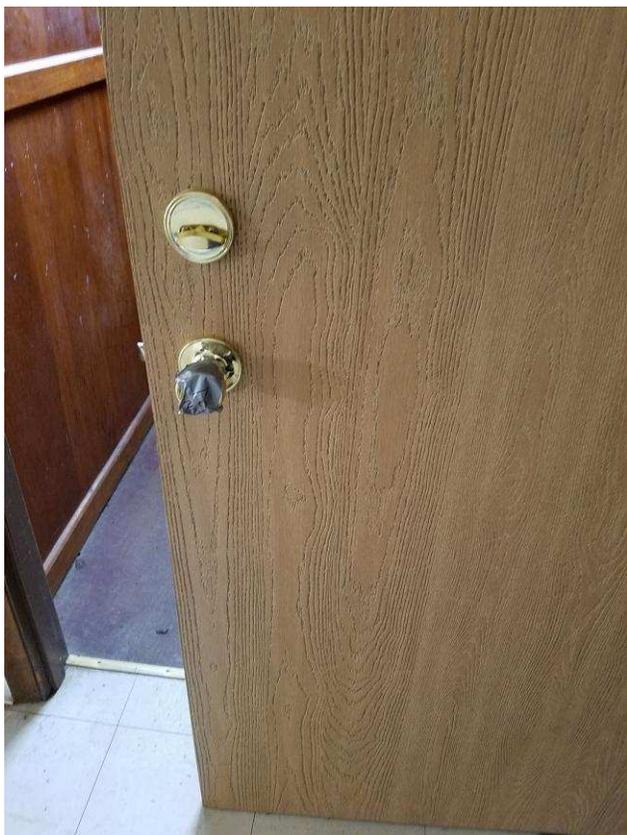
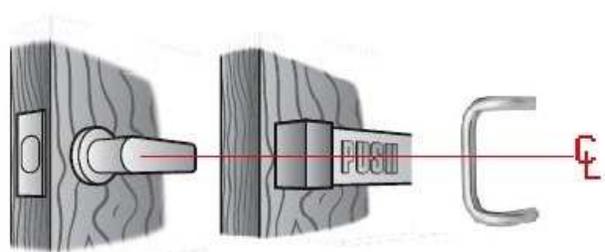
Lever      Panic Bar      Loop Handle

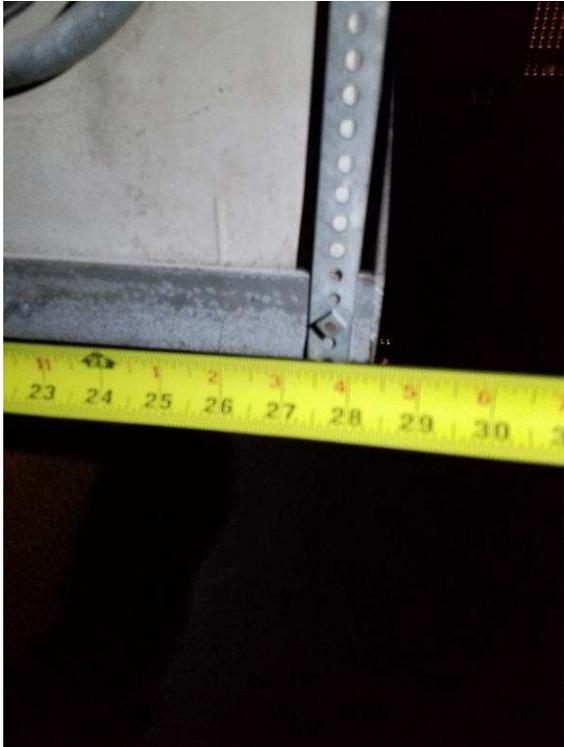
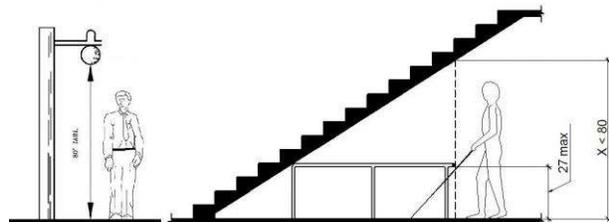
### Finding #10 Additional Finding Photos

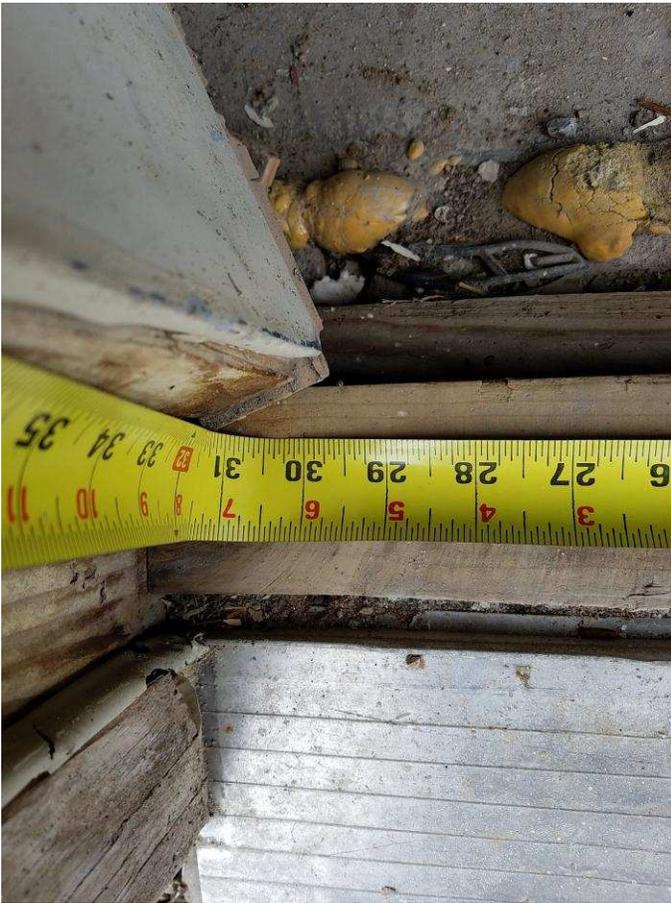
**Finding #11 Additional Finding Photos**

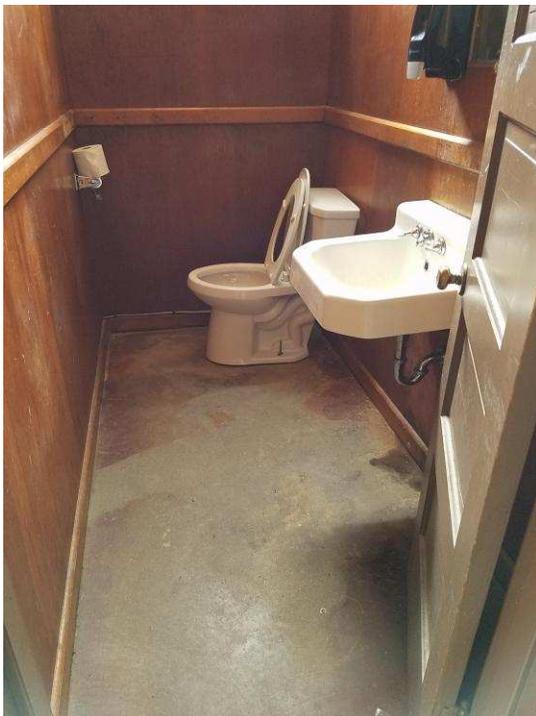
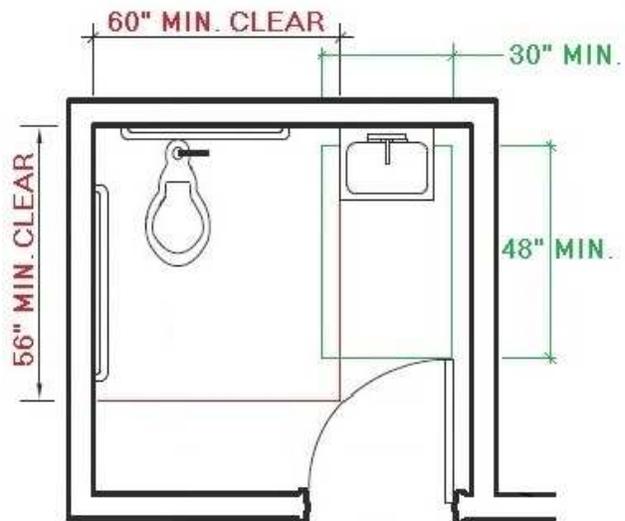
Create a compliant wheelchair accessible restroom and correct all features to be accessible

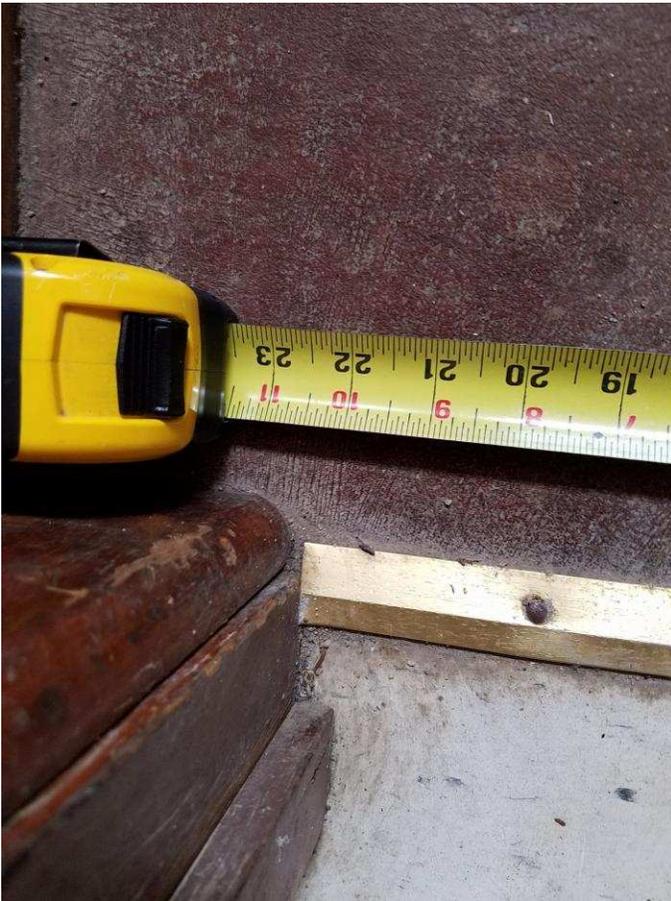
**Finding #13 Additional Finding Photos**

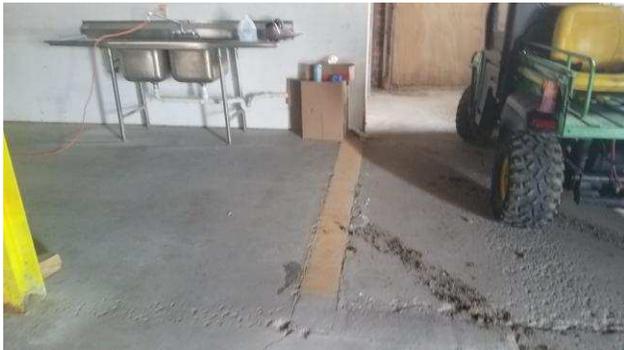
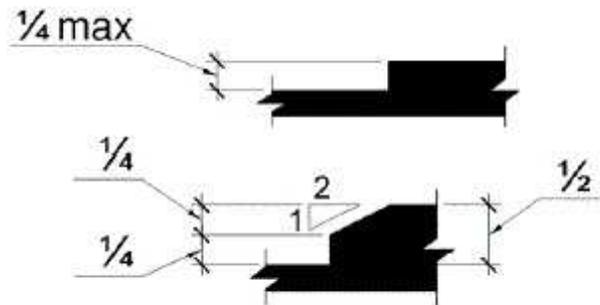
## Main Area - Fire Dept

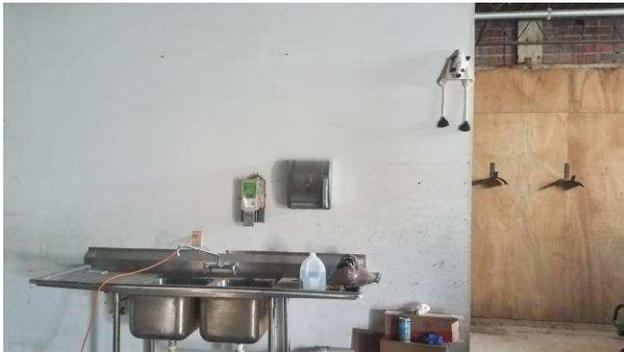
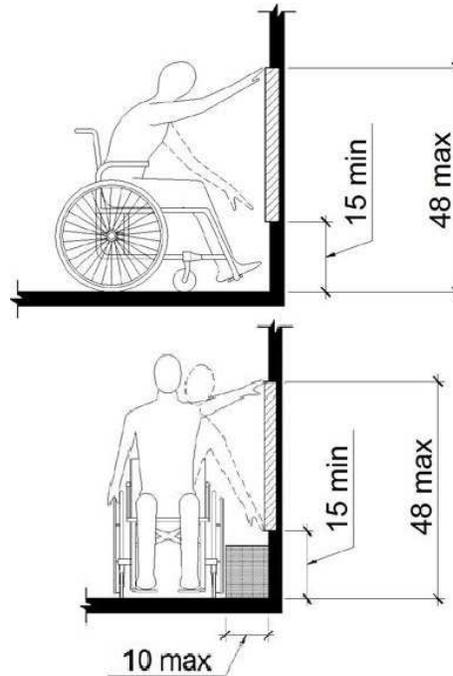
## Main Area - Fire Dept

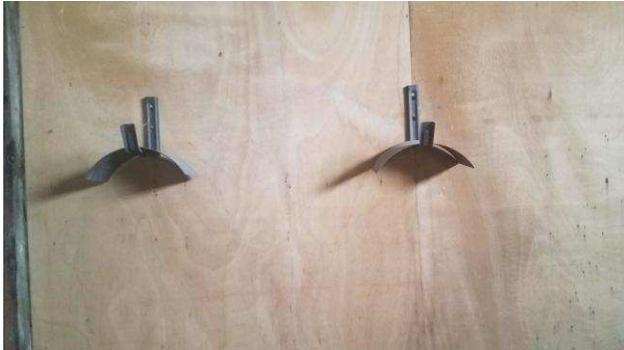
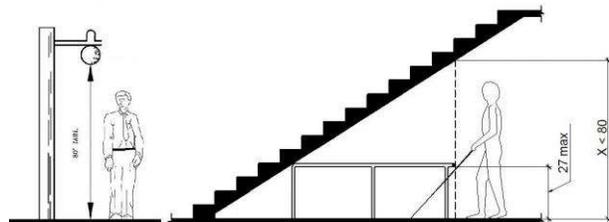
Main Area - Fire Dept

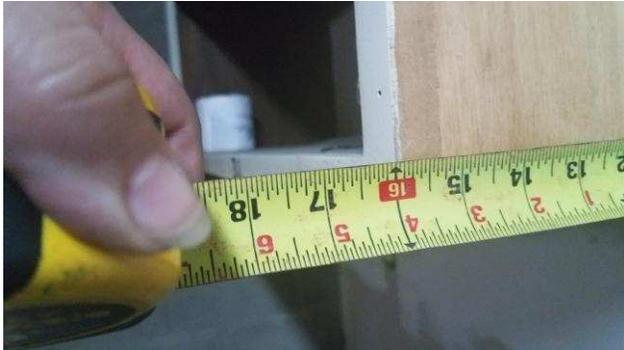
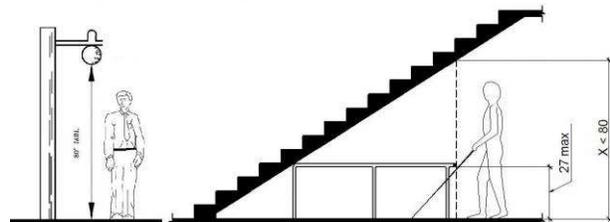
**Finding #18 Additional Finding Photos**

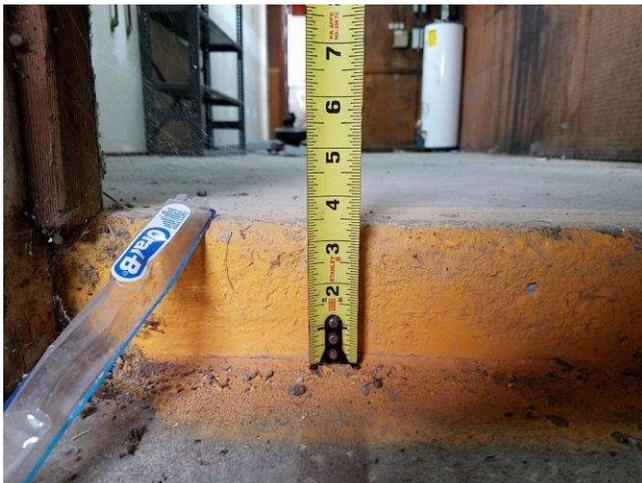
**Finding #19 Additional Finding Photos**

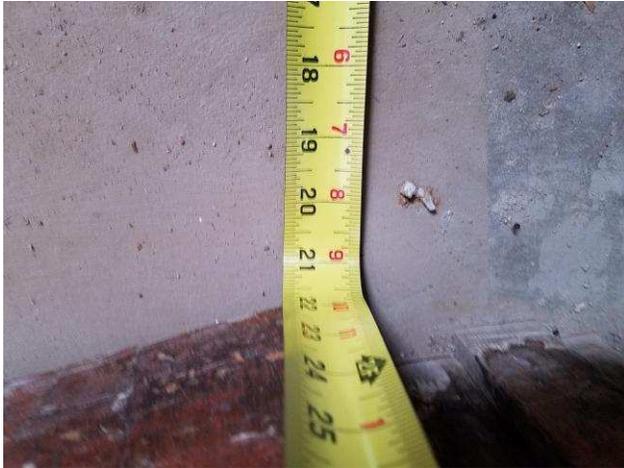
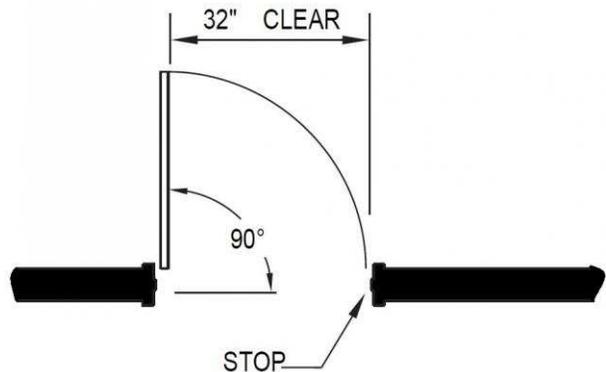
**Finding #20 Additional Finding Photos**

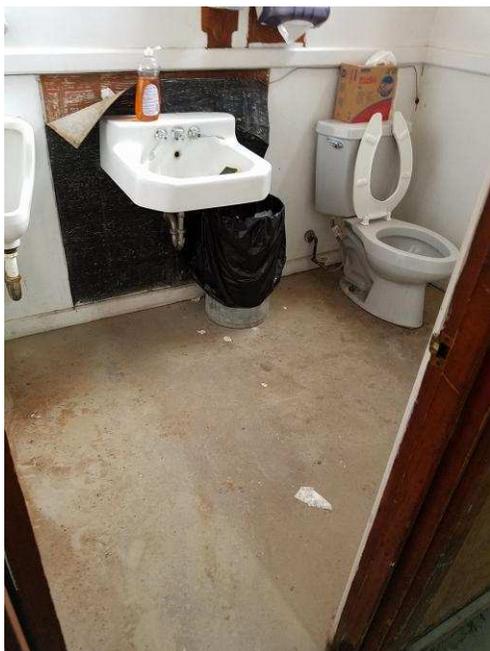
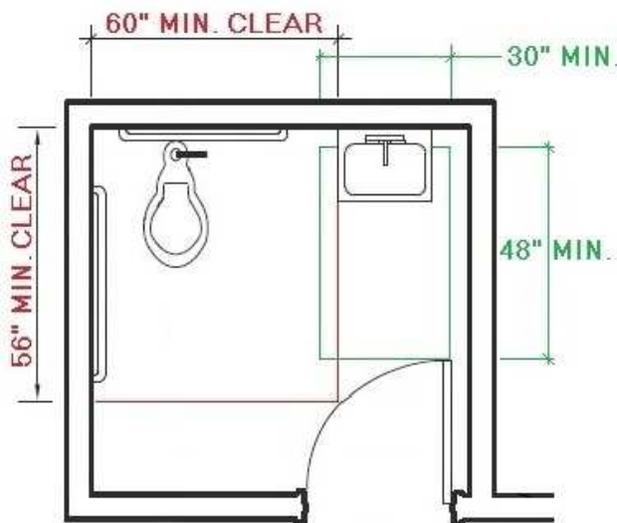
Create a compliant wheelchair accessible restroom and correct all features to be accessible
