RE: Carex Hills - Site Plan

On behalf of Carex Properties LLC, Curtis Schoenthaler, we are submitting a combined Preliminary and Final Plat for creation of a 1 Lot subdivision located in the SE ¼ of the SE ¼ of Sec. 11-T79N-R7W IWV Road SW in Johnson County, Iowa. The property was previously approved for rezoning from Ag to C-Ag and is 9.23 acres in size.

PRELIMINARY AND FINAL PLAT CAREX HILLS JOHNSON COUNTY, IOWA

SENSITIVE AREAS EXHIBIT CAREX HILLS JOHNSON COUNTY, IOWA

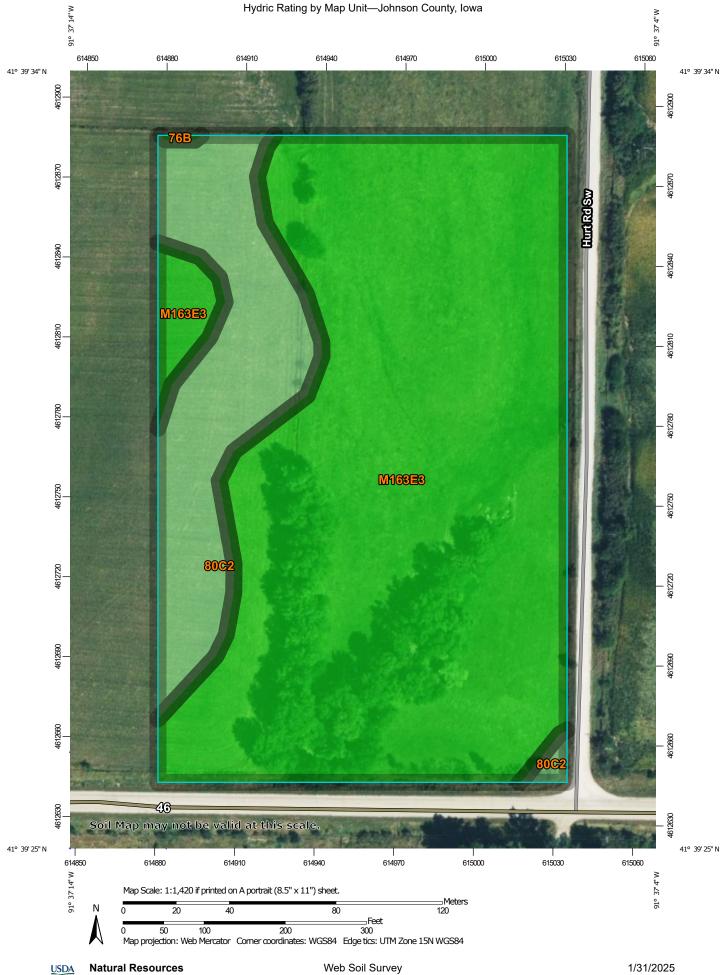
| Designed by: LRS | Scale: N.T.S. | FIGURE 1: SITE LOCATION & VICINITY MAPS | MMS CONSULTANTS, INC. | M | |

The following sensitive areas study has been conducted for the approximately 8-acre study area located at the NW corner of the intersection of IWV Road and Hurt Road SW. The study area is located in the SE1/4, SE1/4 of Section 11, Township 79 North, Range 7 West in Johnson County Iowa. A Site Location and Vicinity Map are presented in Appendix A as Figure 1.

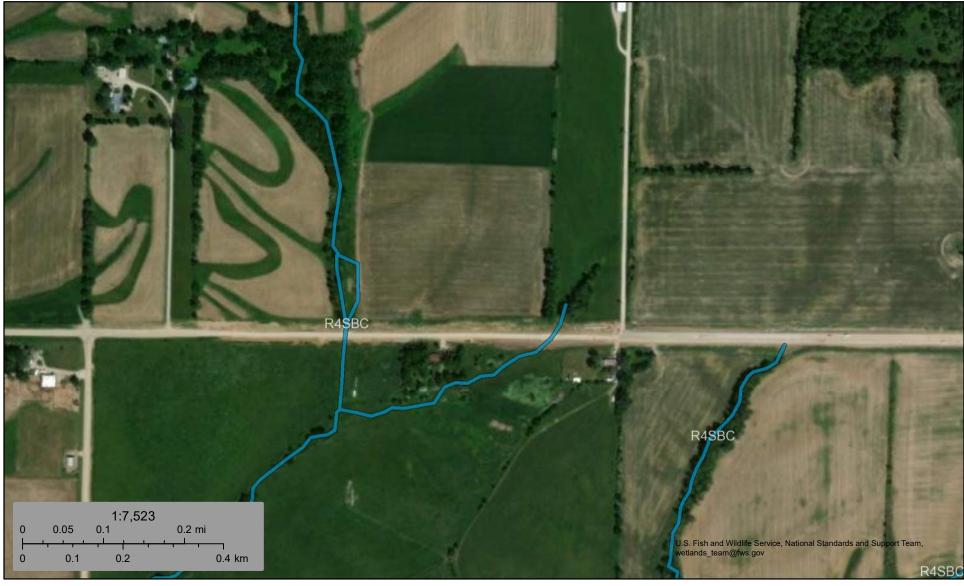
U.S. Fish and Wildlife Service **National Wetlands Inventory**

The USDA NRCS hydric soils map, presented in Figure 3 of Appendix A, shows the majority of the study area is mapped as 0% hydric, with approximately 20% mapped as 5% hydric. The U.S. Fish and Wildlife Service's National Wetland Inventory (NWI) map, presented in Figure 4, indicates the presence of the stream channel. The USGS Quad map indicates the presence of a few drainageways within the site.

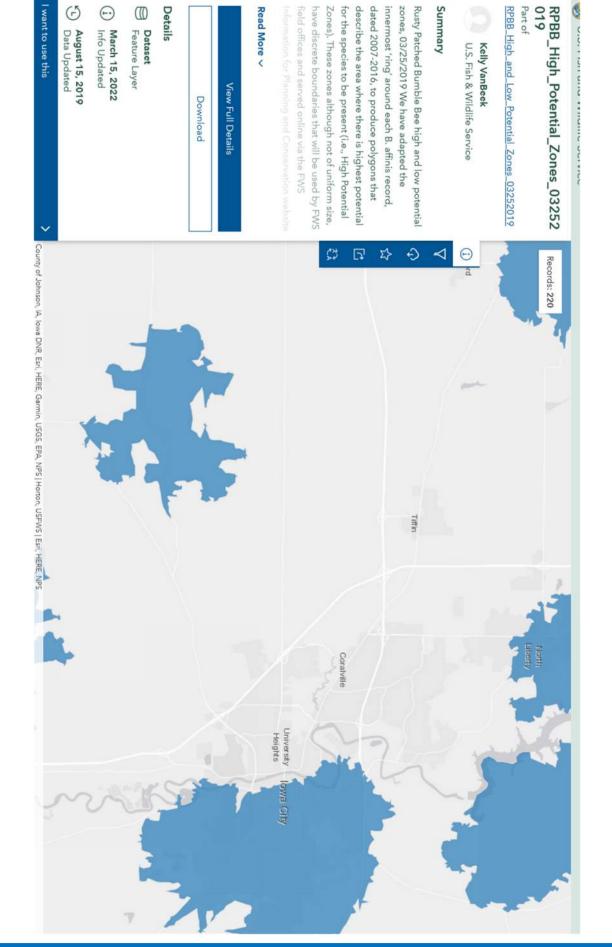
| Designed by: | Scale: | FIGURE 6: Rusty Patched Bumble Bee Map (USFWS) | MMS CONSULTANTS, INC. | | |

The Rusty Patched Bumble Bee (RPBB) map from the Fish and Wildlife Service (USFWS) was also reviewed to determine if the study area lies within any 'High Potential Zones'. The map, presented in Appendix A as Figure 6,

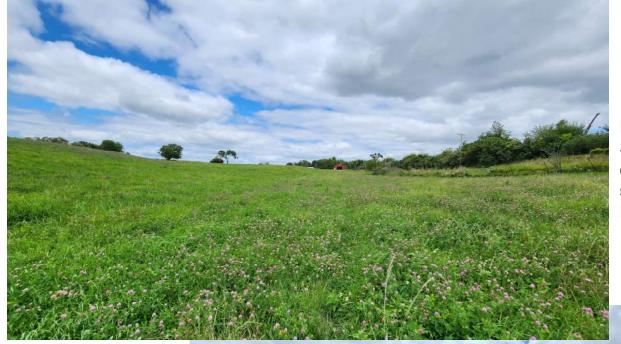
Photo 1 (left): Standing at north edge of proposed subdivision looking north.

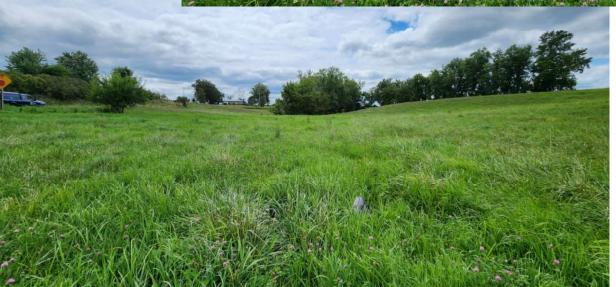
Photo 3 (left): Standing in grass swale near wetland sample point 4.

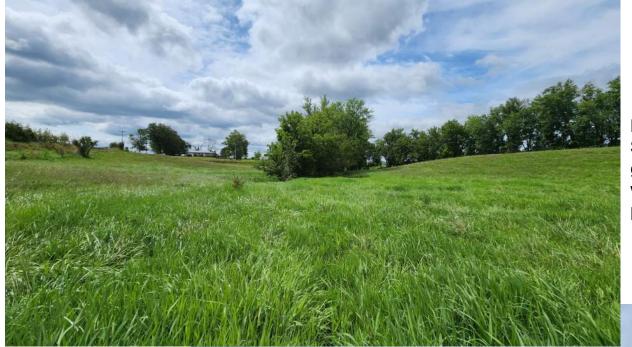
Photo 4 (left): Standing within grass swale near wetland sample point one.

Photo 5 (right): Standing within central grass swale near wetland sample point two.

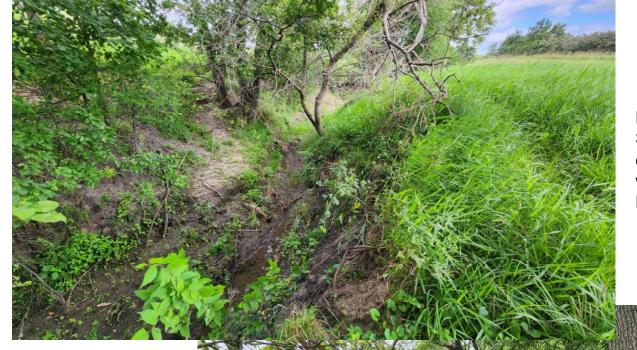
Photo 7 (left): Standing along east side of watercourse, looking north.

Photo 8 (right): standing within channel of watercourse looking south.

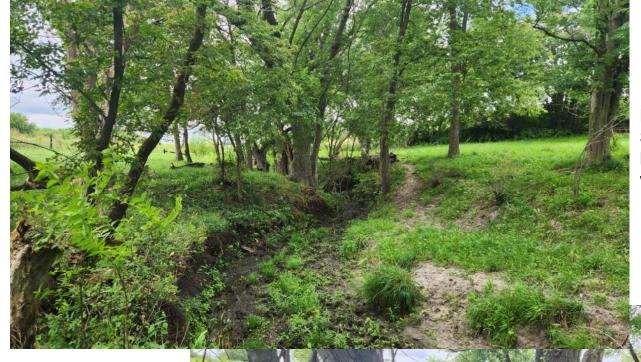
Photo 10 (left): **Standing along** bank looking at watercourse.

Photo 11 (right): Looking at the farthest south reaches of watercourse.

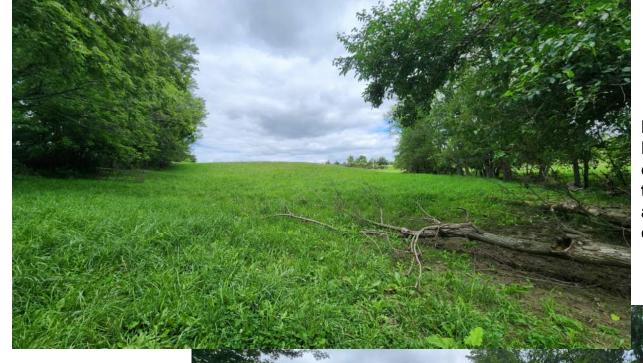
Photo 13 (left): Looking north clearing between treed fence row and treed stream channel.

Photo 14 (right): Looking south at clearing between stream channel and fence row.

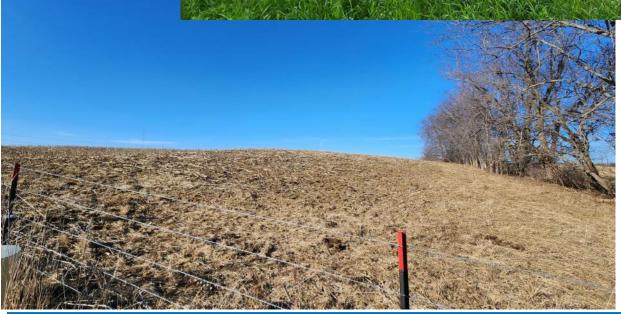
Photo 15 (left): Looking at row crop west of treed fence row.

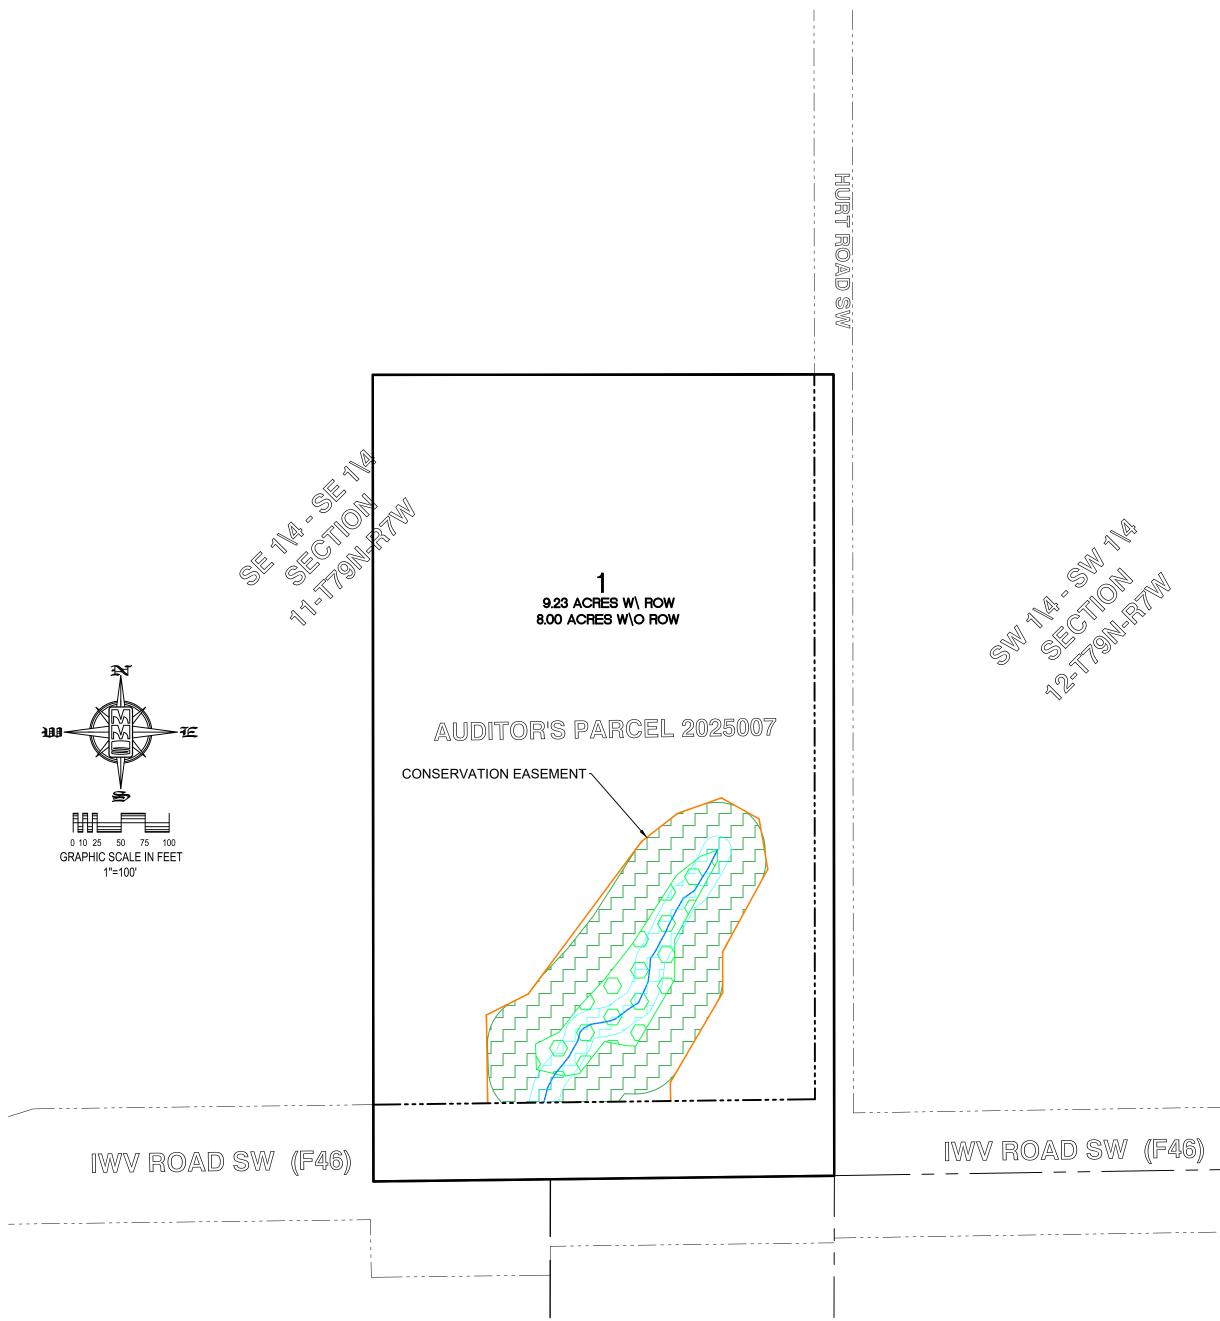
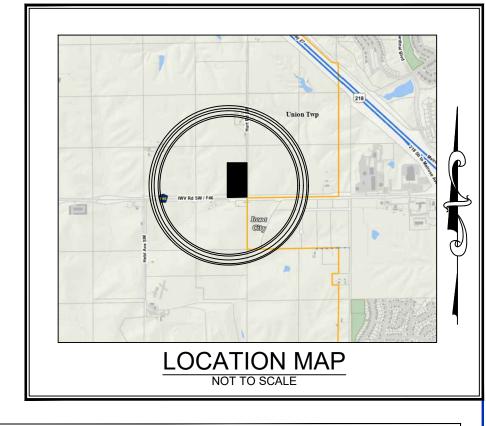
9.23 ACRES

- A CONSERVATION EASEMENT HAS BEEN ESTABLISHED TO PROTECT SENSITIVE AREAS AND ASSOCIATED BUFFERS. PLEASE REFER TO THE CONSERVATION EASEMENT AGREEMENT RECORDED WITH THIS SUBDIVISION FOR A LIST OF ALLOWED AND PROHIBITED USES WITHIN THE CONSERVATION EASEMENT.
- THE CONSERVATION EASEMENT SHALL BE FLAGGED ON SITE PRIOR TO ANY CONSTRUCTION ACTIVITIES. AN ONSITE PRE-CONSTRUCTION MEETING SHALL BE HELD PRIOR TO THE COMMENCEMENT OF ANY GROUND DISTURBING ACTIVITIES.
- PRIOR APPROVAL FROM THE COUNTY IS REQUIRED FOR ANY MODIFICATION TO THE CONSERVATION EASEMENT.
- COLOR VERSIONS OF THIS EXHIBIT ARE AVAILABLE ON FILE AT JOHNSON COUNTY PDS, ALONG WITH THE ACCOMPANYING SENSITIVE AREAS REPORT
