SHERIFF'S HQ/JAIL

STRUCTURAL CONDITION ASSESSMENT
511 South Capitol Street

April 28th, 2023

PREPARED FOR:
Brad Kunkel – Johnson County Sheriff

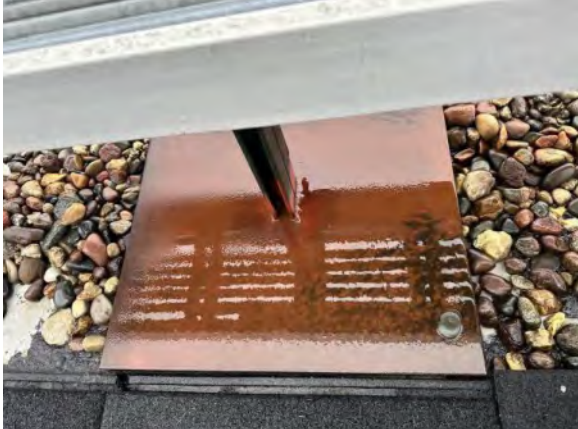
<p>Structural stanchion for mechanical lines running on the roof. No issues of note.</p>
5	STR

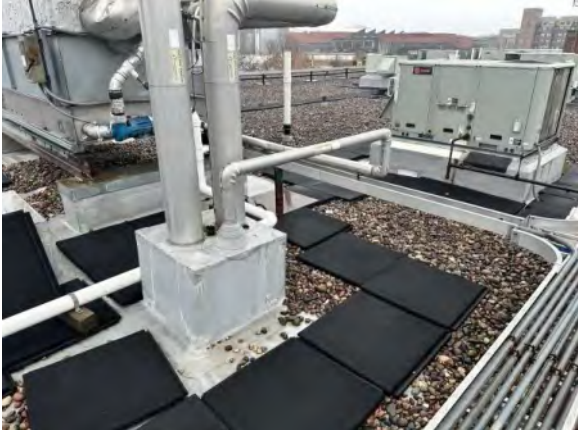
<p>Mechanical curbs and equipment near the center are of the roof. Entire roof experiences multiple leaks in various locations due to age.</p>
6	STR

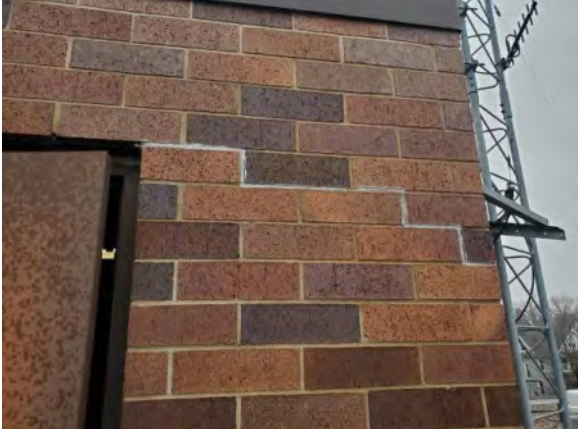
<p>Brick exterior stairwell walls at the North section of the roof access. Brick showing signs of cracking/movement (sealed.) This should be monitored as we believe it is tied to movement of the exterior walls on the second level.</p>

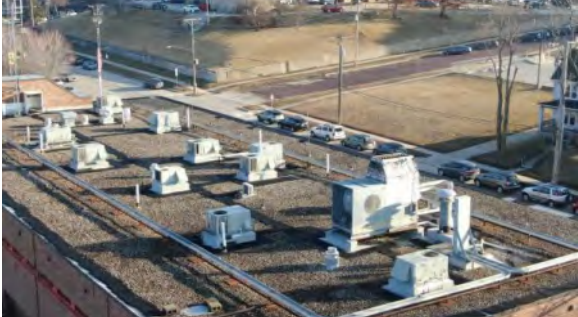
<p>Overall view of the roof with the drone. Roof could be periodically monitored fairly quickly and easily with a drone to keep an eye on possible issues related to structure below. Entire roof experiences multiple leaks in various locations due to age.</p>

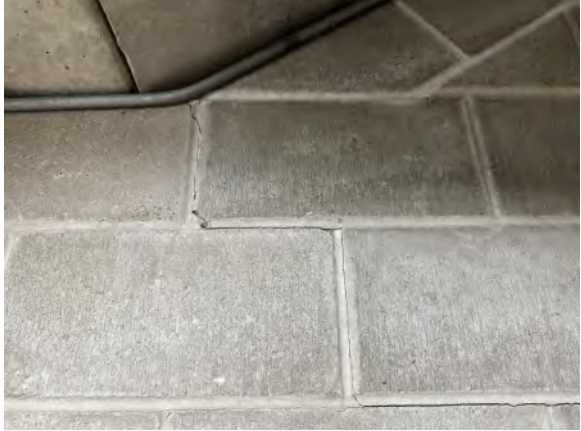
<p>CMU wall below hollow-core ceiling joint in the North stairwell. Joint cracking directly adjacent to pulled joint indicating related condition. Monitor for worsening condition(s.)</p>
5

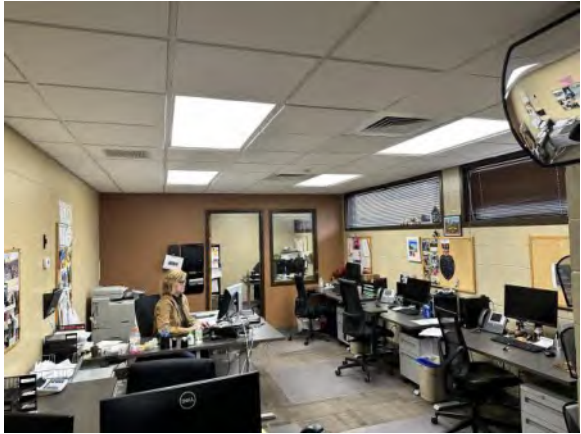
<p>Main level administrative space. No issues noted structurally. Multiple ceiling leak locations from prior events.</p>
<p>15</p>	<p>STR</p>

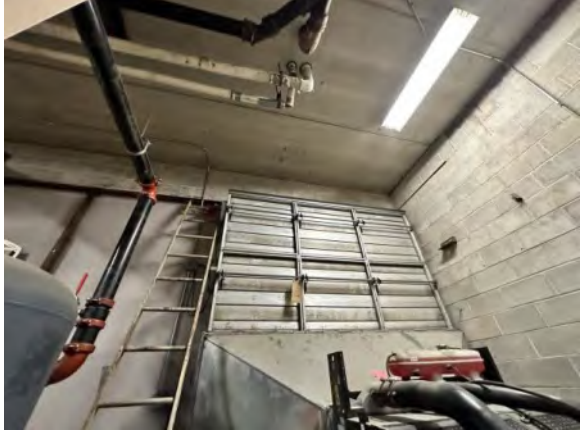
<p>Generator louvre area within the sub-basement mechanical room. This corner is showing some shifting of CMU and a lintel displacement. Area should be monitored for worsening condition(s.)</p>
21	STR

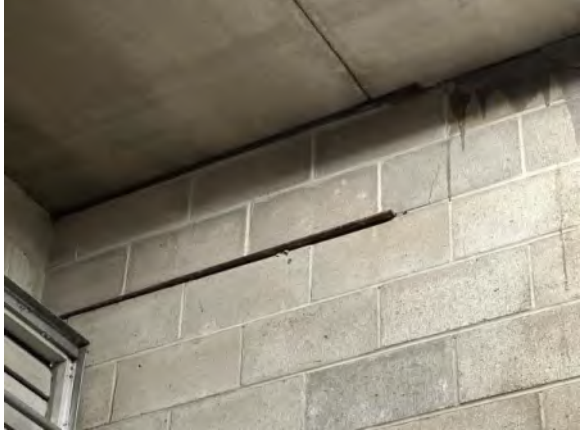
Shifted lintel near the generator louvre in the sub-basement mechanical room. Monitor for additional cracking/shifting.
24	STR

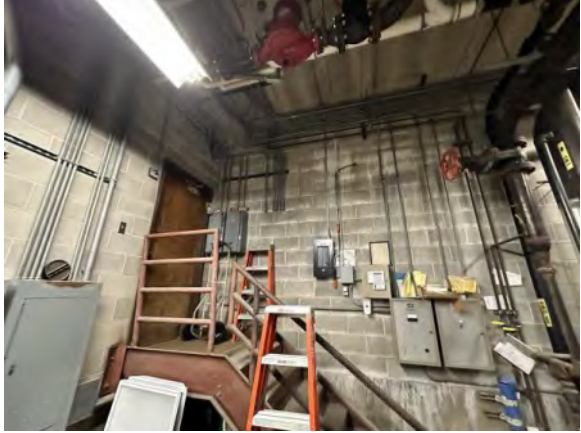
North wall of mechanical sub-basement (shared with sally-port) which shows a high amount of moisture buildup and efflorescence. Indicative of poor ventilation and waterproofing. Monitor. Items like this will exacerbate degradation of building elements.

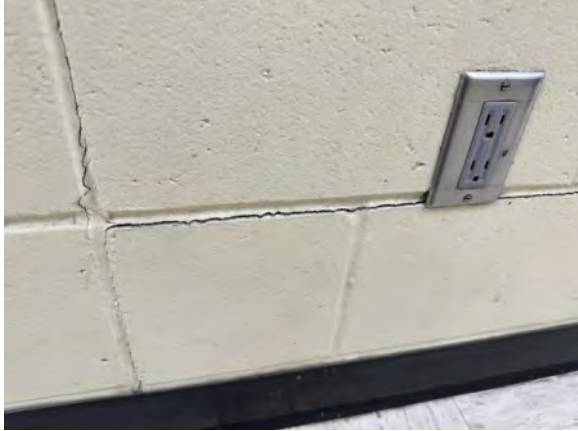
<p>Base of wall near kitchen. Wall cracks throughout the area. Monitor for worsening condition(s.)</p>
<p>17</p>	<p>STR</p>

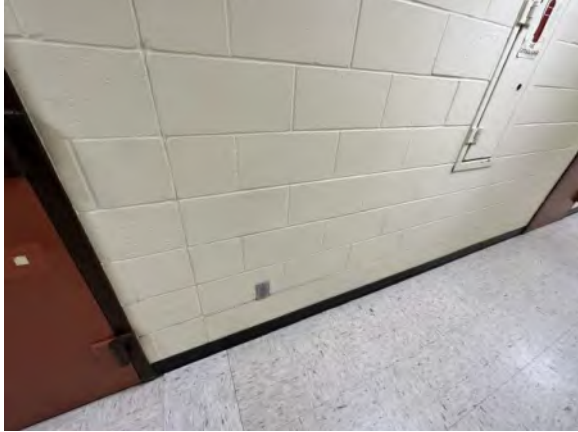
<p>Another example of door cracking around the frame of the door in the upper central corridor. Monitor for worsening condition(s.)</p>
<p>18</p>	<p>STR</p>

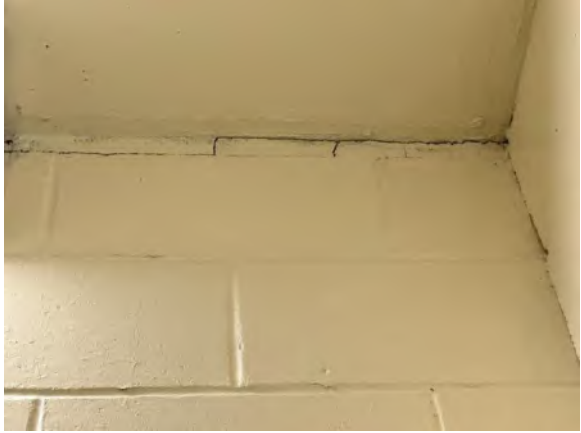
<p>Ceiling and wall interface in common area within a cell. This area is on the NE portion of the building and shows fairly significant slippage and cracking. Monitor for worsening condition(s.)</p>
<p>20</p>	<p>STR</p>

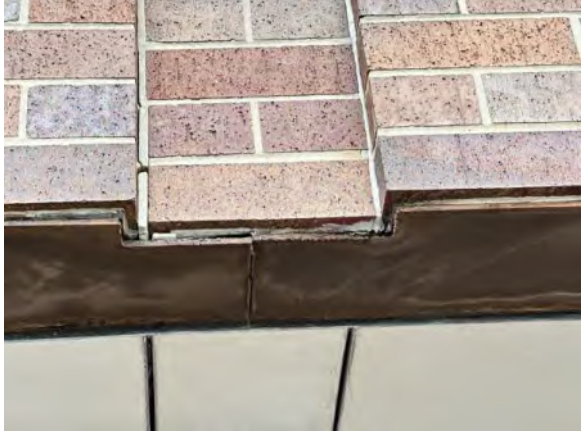
<p>Building edge on West side of exterior showing bearing plate separation from the building exterior and poor drainage condition. Joints failing in the masonry façade. This area should be repaired soon.</p>
3	STR

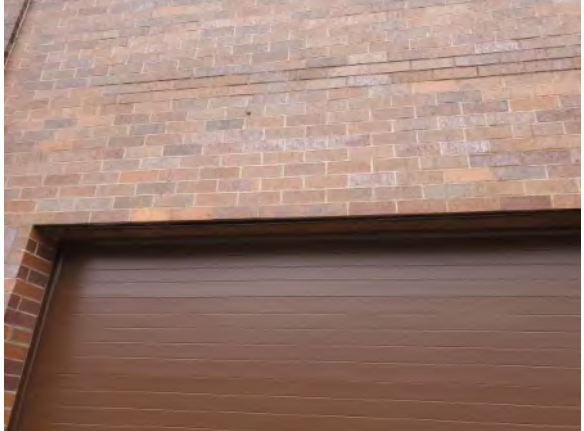
<p>View above the sally port door. Brick rippling can be seen on this face and should be monitored for worsening condition(s.)</p>

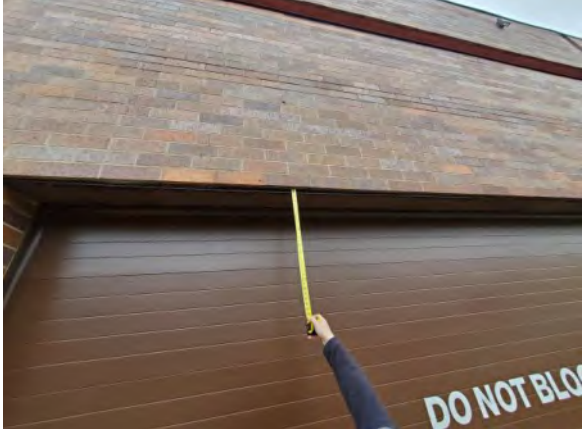
<p>Measuring gap on support angle near sally port door – near 1"</p>

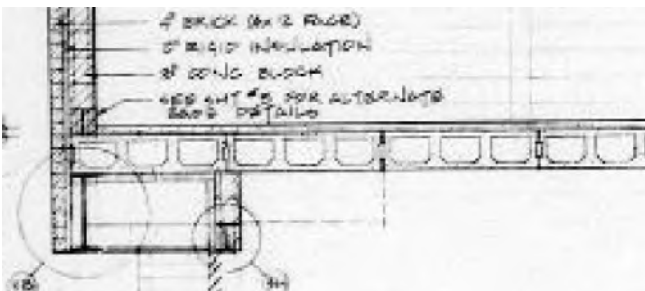
Detail of overhang construction

3. The overhang design and soffit construction was very poorly thought-out in terms of water management. The structure isn't well designed to deal with water that undoubtedly enters the exterior wall cavity and drains down to the overhang. There are cotton rope weeps (minimal and not consistently-spaced) and no other apparent method of moisture and water control. A few areas have small vents but the majority of the soffit area is unvented.
